LARNACH'S FARMSTEAD
OTAGO PENINSULA
DUNEDIN
SITE I44/412

ARCHAEOLOGICAL REPORT ON
WOOLSHED BUILDING
FOR
HEREWEKA/HARBOUR CONE TRUST
ARCHAEOLOGICAL AUTHORITY 2017/521
REVISION 1

P.G. PETCHEY
SOUTHERN ARCHÆOLOGY LTD.
2018

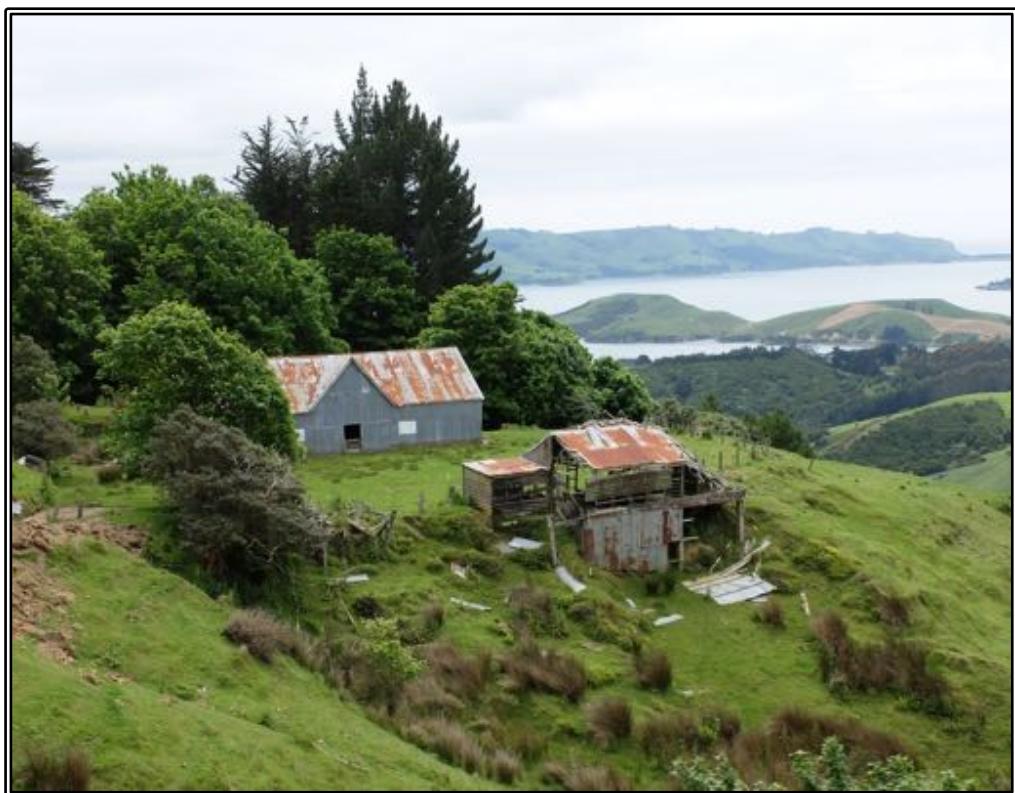
Figure 1

Larnach's Farmstead in November 2017. The small building closer to the camera is the subject of this report. Its state of dereliction is obvious in this view.

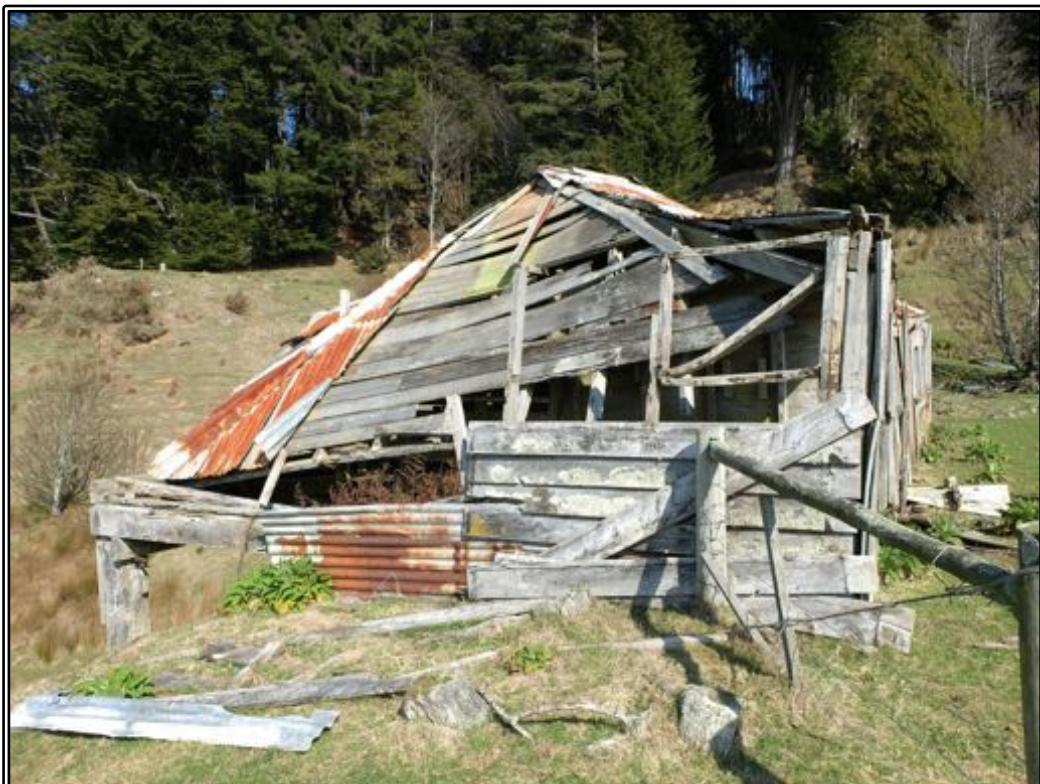
Figure 15
The collapsed east wall, with the collapsed hip roof, in 2017.

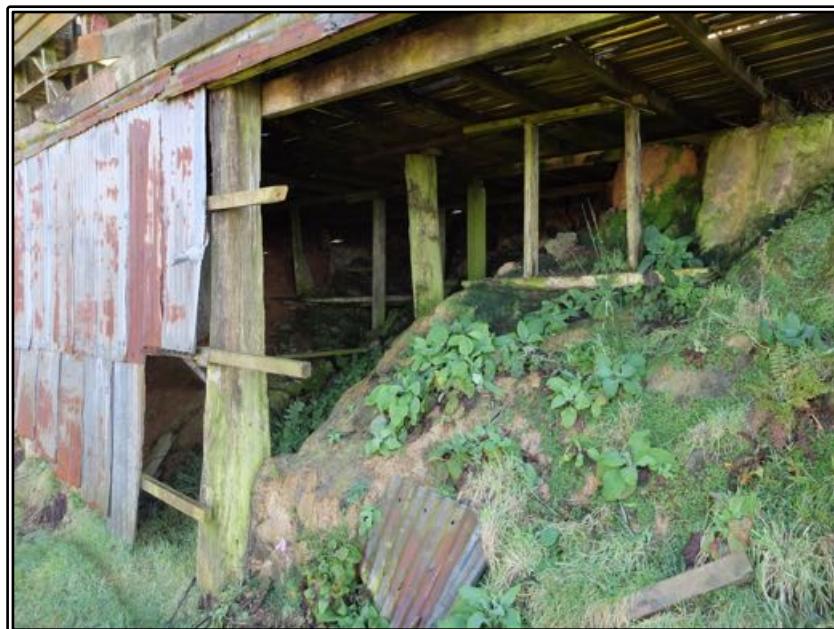
Figure 17 (Above)

The rear of the building, showing one of the main rear posts and the mixture of posts under the floor.

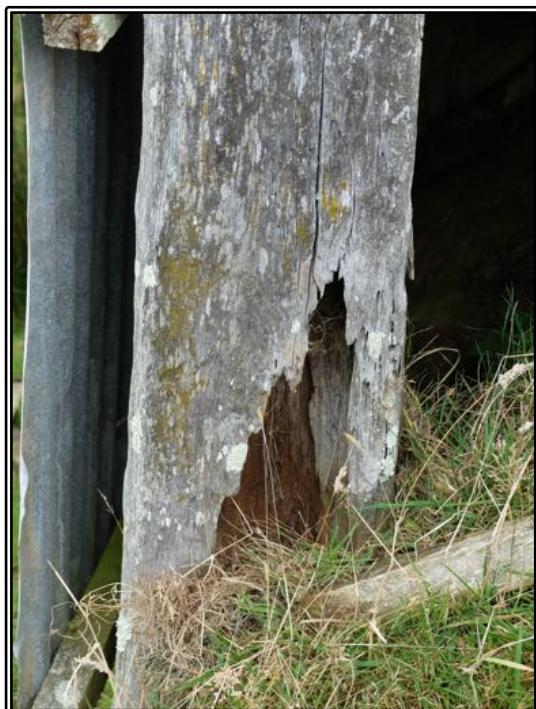
Figure 18 (Left)

A large pocket of decay in the base of one of the main support posts at the rear of the building.

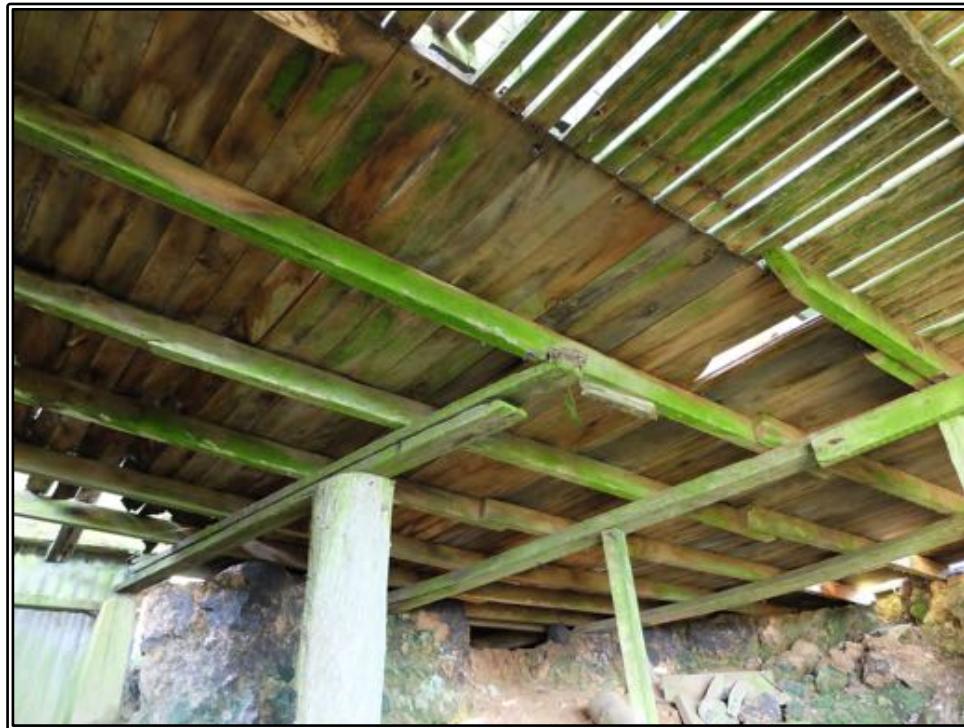
Figure 21

Underfloor view, showing the lightweight and ramshackle nature of the floor construction. The posts vary from heavy to very lightweight, the bearers were lightweight or missing, and the joists were lightweight or missing. Joints were simply nailed, and were not supported by a post.

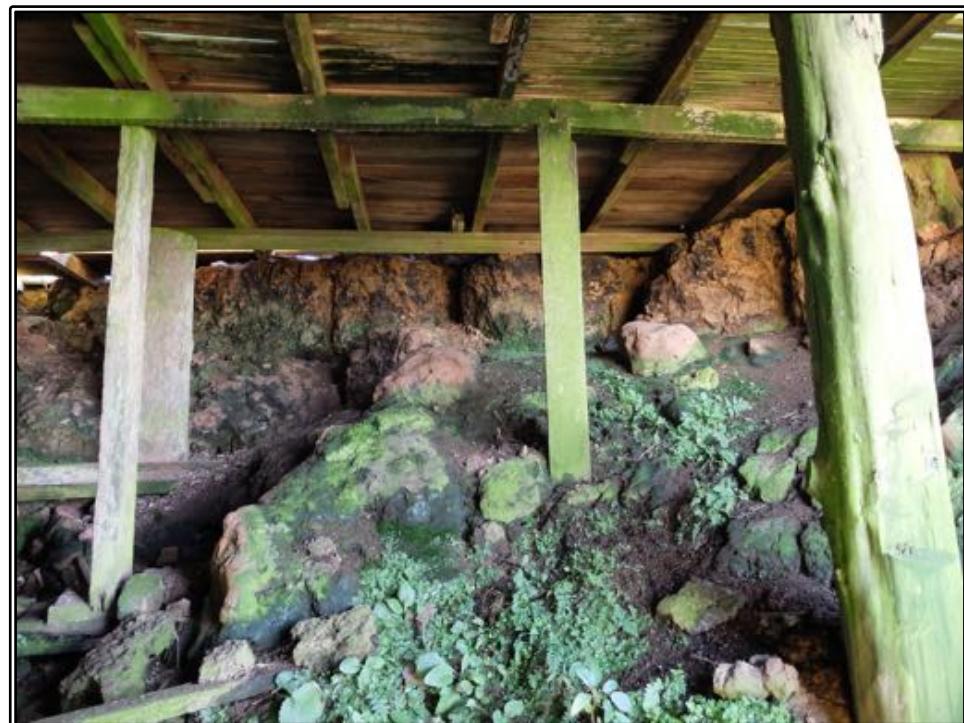
Figure 22

Another underfloor view, showing the mixed quality of the construction.

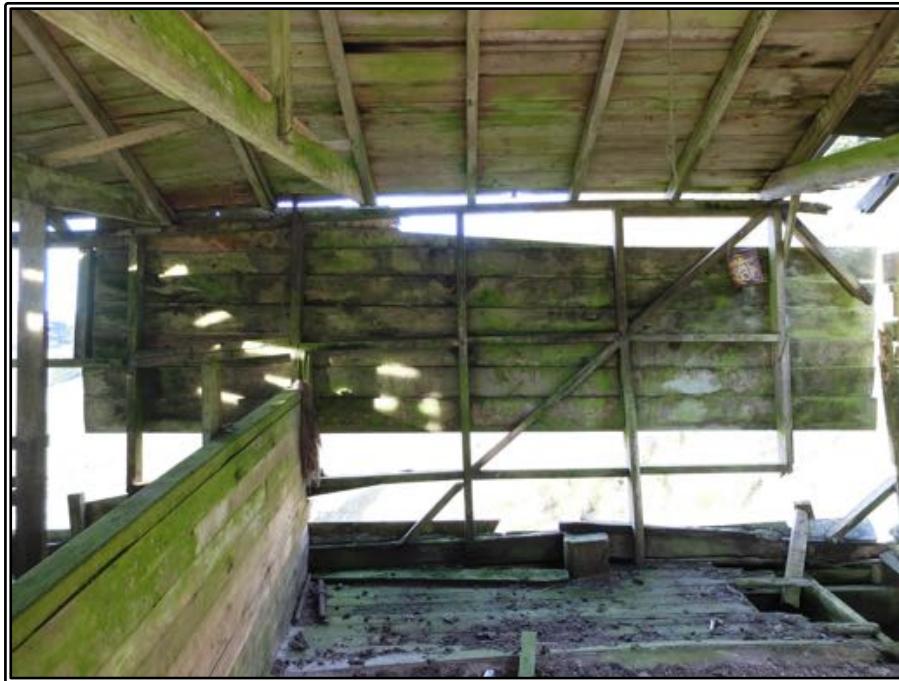
Figure 23
The rear wall
framing, of very
lightweight
conventional
construction with
widely spaced (37.5
inches centre to
centre) studs. By
this date (2018) the
wall was on the
verge of collapse.

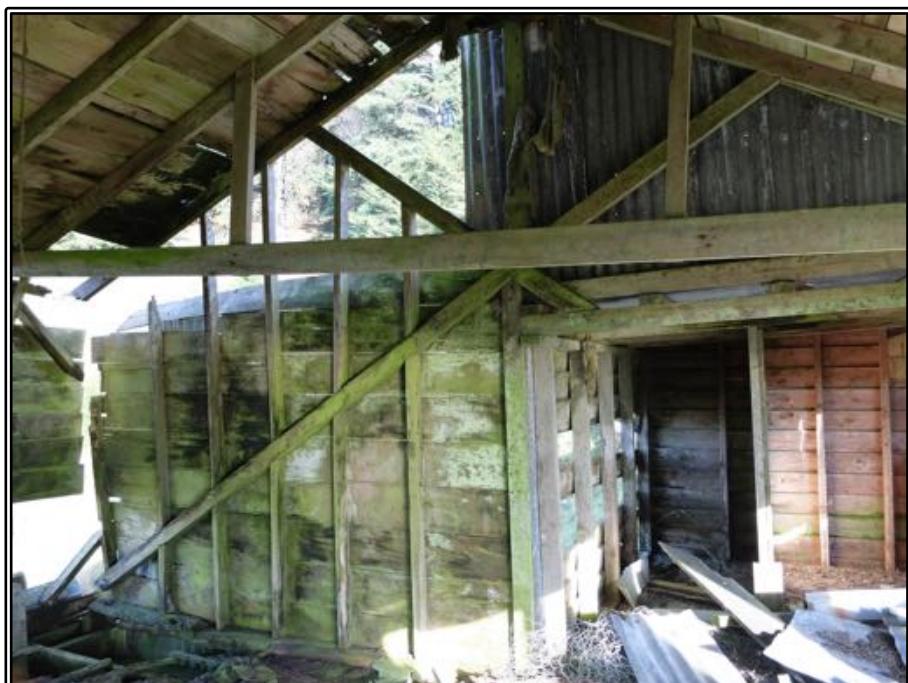
Figure 24
The western end
wall showing the
cross-brace. This
cross-brace is
probably the main
reason the building
was still standing
in early 2018. Note
the close spacing of
the studs in this
wall (19 inches
centre to centre).

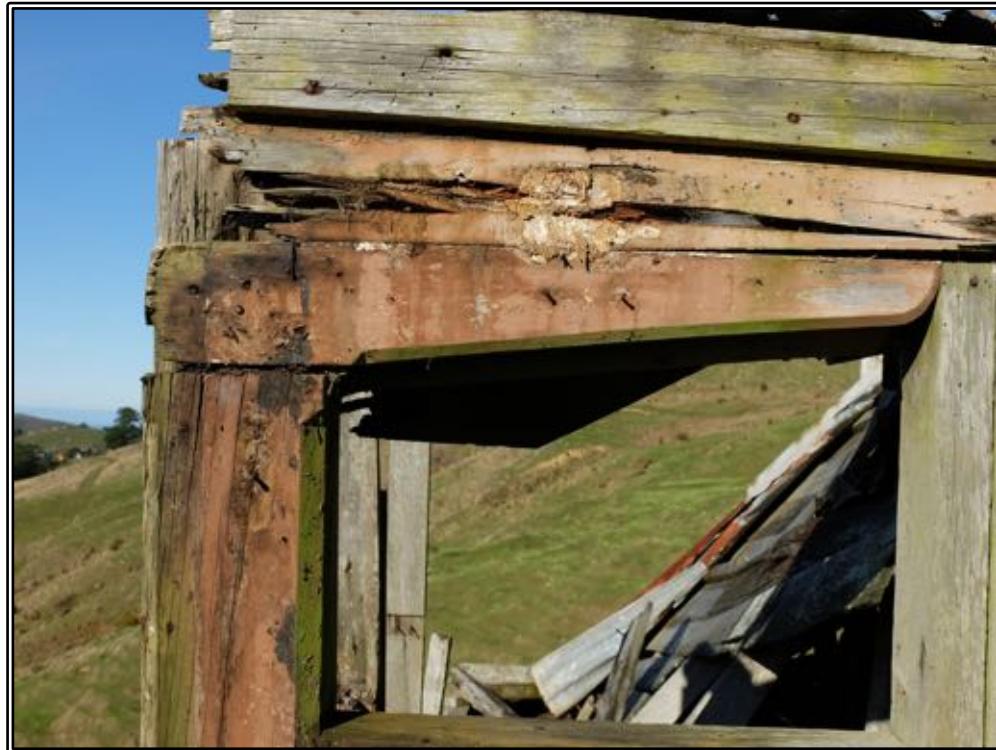
Figure 27

Detail of the easternmost corbel, which had been cut off when the structure was shortened.

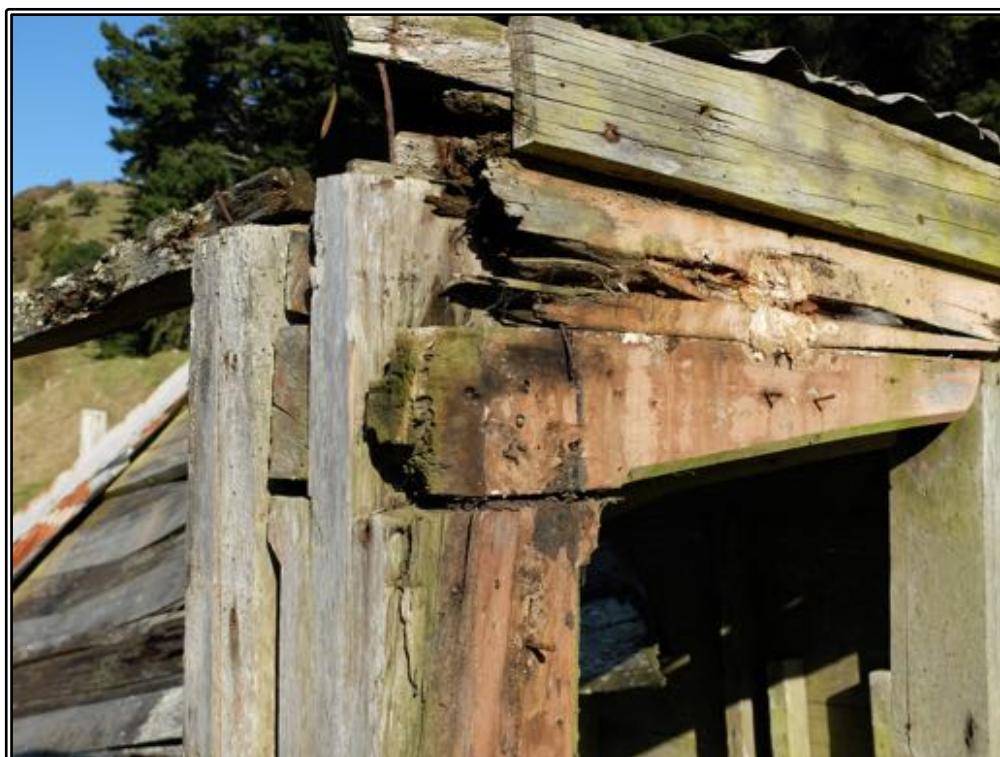
Figure 28

Another detail of the easternmost corbel, with the tenon on the end of the post exposed where the corbel had been cut through. Note that the tenon extended through both the corbel and the plate.

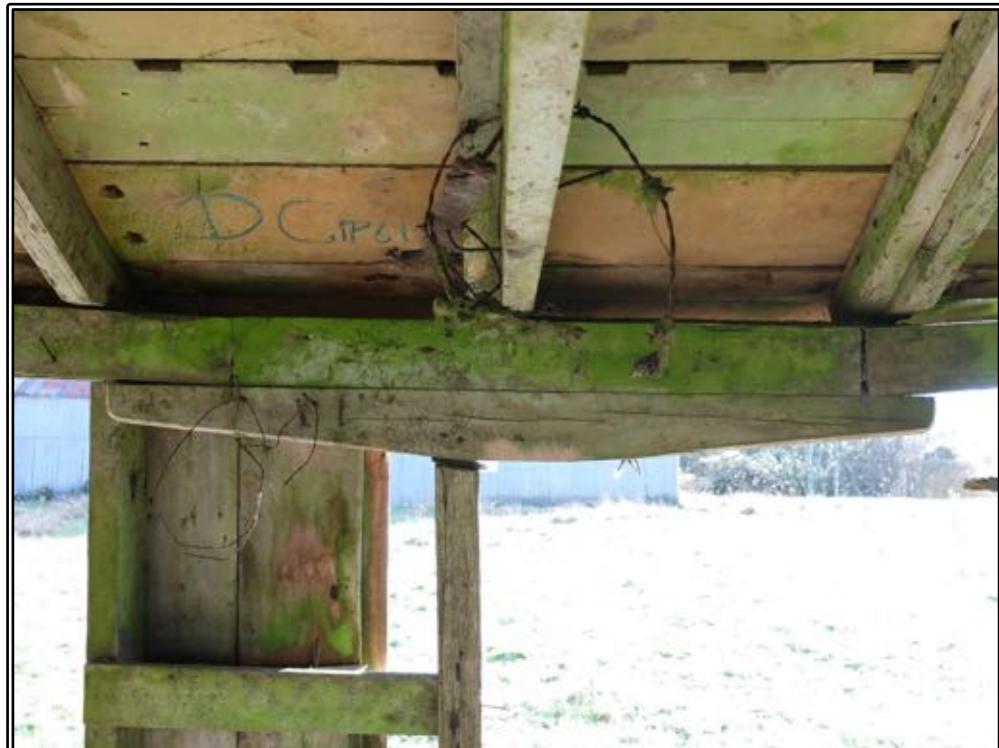
Figure 30

View out from inside the building, showing an intact corbel, no longer supported from below by a post. Note also the sarking board with notches cut out of it: clear evidence that it has been recycled from elsewhere.

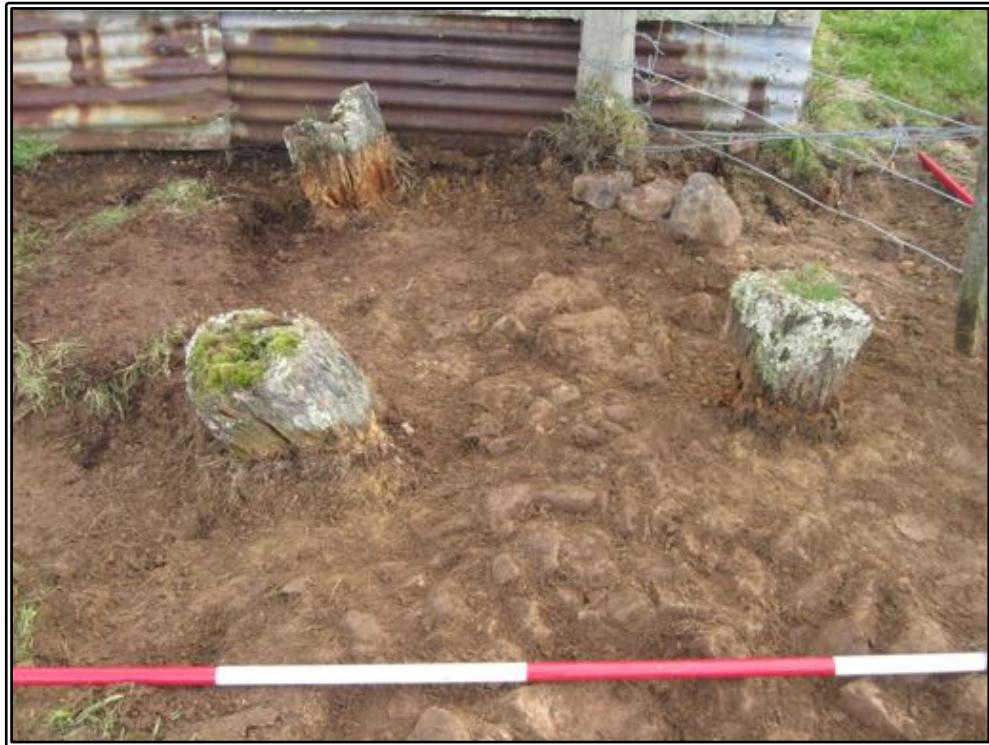
Figure 43

This excavation revealed a rough rubble surface with three timber piles set into the ground (Figures 43 and 44), suggesting that the building once extended 5 feet (1.5m) further in this direction (see Figure 16 above). The excavation also found a small amount of artefactual material, including a bottle and a file (discussed in more detail below).

Overall the main result of the investigation was confirmation that the building had been shortened at this end by approximately 5 feet (1.5m).

Timber piles and rock rubble surface exposed during the excavation. View looking towards the west.

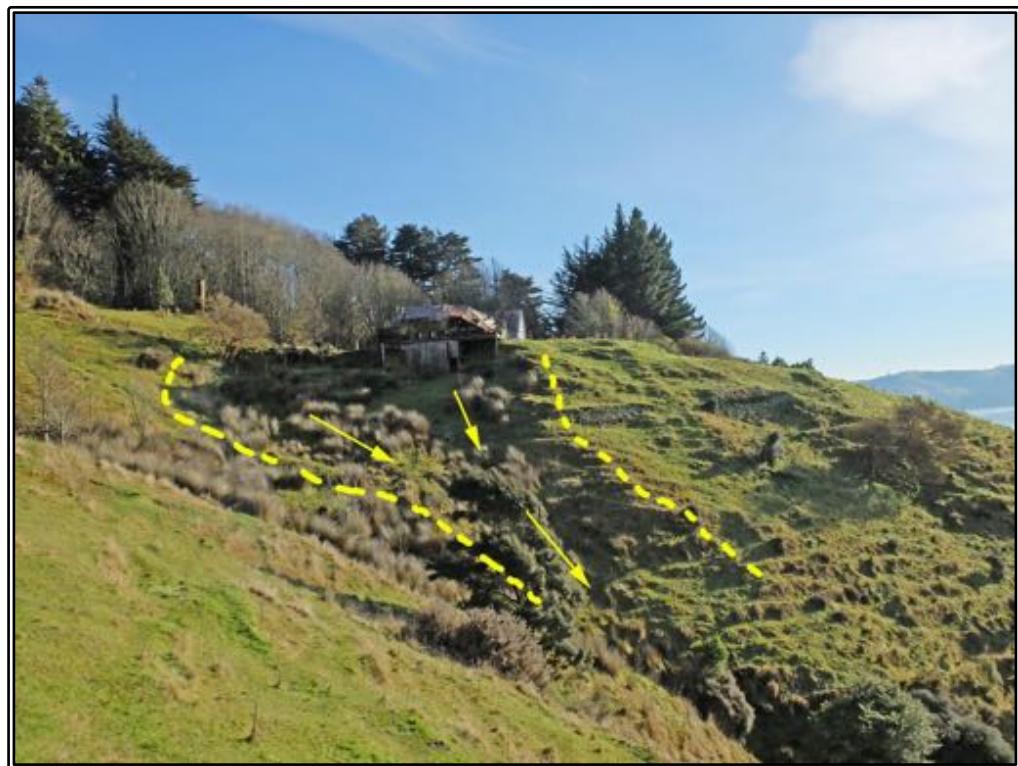
Figure 66

As stated in point 7 above, there is evidence that a slip has carried away part of the farmyard terrace, and almost certainly damaged the original building. The farmyard terrace itself is the result of cut and fill work on a spur to create a level area large enough for Larnach's intended fully-enclosed farmyard; from the lie of the land it appears most likely that the main line of the spur originally ran through the middle of the farmyard area. The cutting and filling carried out by Larnach's workmen created a large space, but there were probably stability issues that soon appeared. In particular there are two areas of revetment on the SE slope below the farmyard (B in Figure 63, and Figure 65) that suggest additional works were required there to stabilise the slope. The terracing works also apparently exposed a small spring or seep at the foot of the slope on the west side of the yard, which is still active today and keeps this area wet. The water from this seep runs off the edge of the terrace, and this combined with rainfall runoff appears to have caused the south side of the terrace to slip away: 'C' in Figure 63 shows where slip scarring was still clearly visible in 1942, and Figure 64 shows how much further the slip had progressed by 2007. The extent of the slip is visible today when viewed from the south (Figure 66). As described above, the area under the building still had an obvious erosion gully, a legacy of this instability and possibly the product of water continuing to run under the building at times.

The area of the slip that probably destroyed the original Larnach-era building.
