Condition Report: The First Lime Kiln on Otago Peninsula

By Carl Murray and Stuart Griffiths (March 2019)

**Report for Hereweka/Harbour Cone
Management Trust**

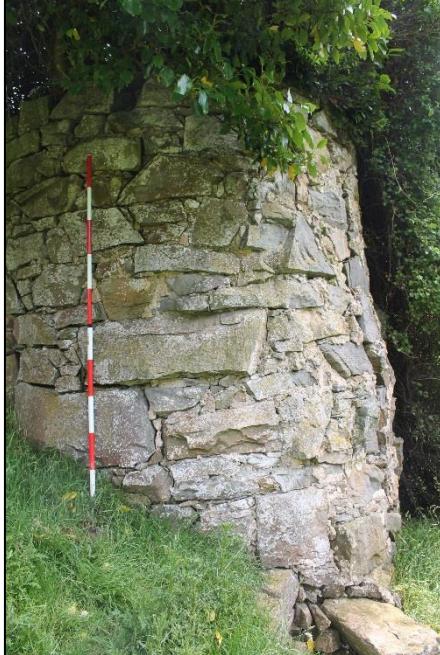
Feature Number/Description	Photographs
<p>Feature 1: Lime Kiln</p> <p>The lime kiln ruin is a masonry structure made from local limestone, as well as volcanic tuff and brick. Very coarse lime mortar was used as a binding agent for the masonry work. The structure has three main chambers: the charging bowl, firebox, and drawing eye. The lime kiln has been built into the side of a hill facing east. The structure is approximately five metres long (east to west), two metres wide (north to south), and six metres high. A more detailed examination of the condition of the lime kiln is offered below.</p> <p>GPS coordinates: E2326615; N5479510</p>

<p>Figure 4. The drum or charging bowl of the lime kiln (looking north).</p>

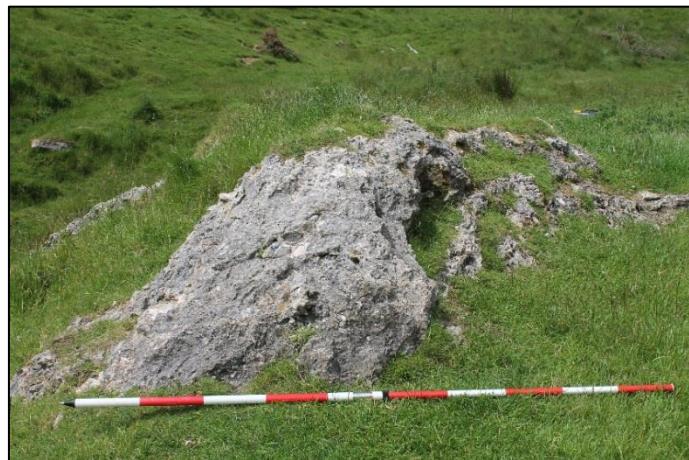
The tailings dump is approximately 16m long and 10m wide. The feature is vulnerable to weathering and trampling damage from cattle.

Figure 5. Tailings dump north-east of the lime kiln (looking south).

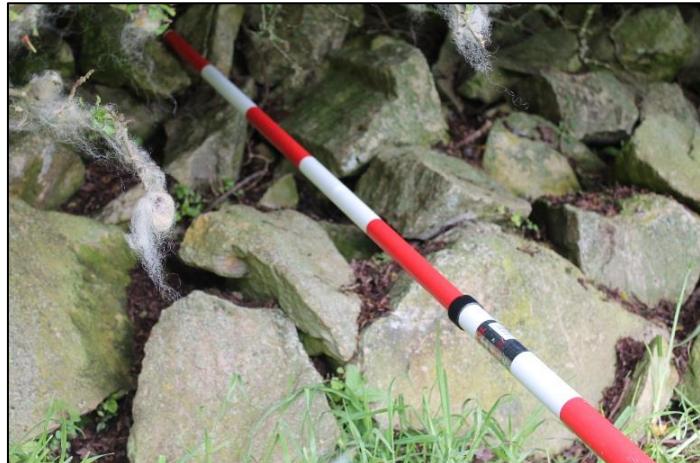
This area is approximately five metres in diameter. This feature is vulnerable to damage from cattle as wool was observed scattered around the area from livestock taking shelter under the tree.

Figure 6. Pieces of limestone charge discarded near the lime kiln. Finely dressed limestone was also observed in this area.

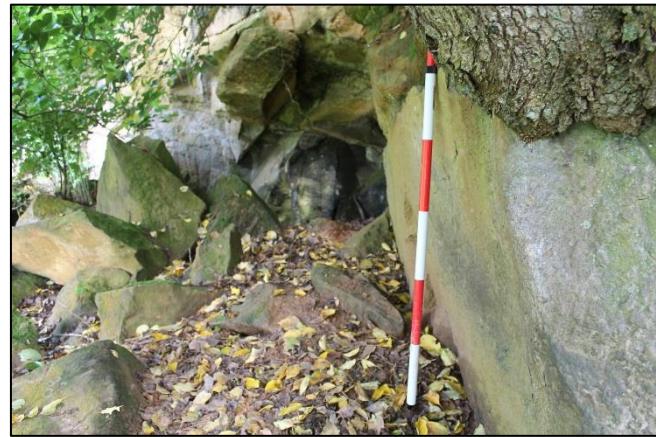
Approximately 15m south-west of the kiln is a large limestone quarry. The quarry area is approximately 15m wide by 7m high. The quarry could extend further south however this area was obscured by vegetation. The outcrop likely extended out to the area east which is now a swamp. Large quarry cut limestone boulders are scattered around the base of the quarry. This feature is vulnerable to damage from weathering, vegetation and cattle.

Figure 7. Limestone Quarry (large): note the quarry cut limestone blocks at the base of the quarry and the tree growing out of the quarry face.

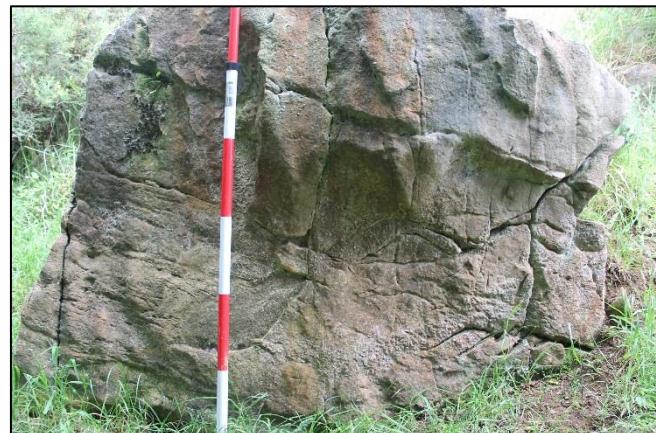
Approximately 10m south-west of the kiln is a smaller limestone quarry. The quarry area is approximately 1.8m wide by 1.2m high. Tool marks are exhibited on the top of this outcrop and other markings are likely tool marks which have been weathered. This outcrop is above the charging bowl of the lime kiln and is likely a remnant of the main outcrop used to quarry limestone. This feature is vulnerable to weathering and cattle damage.

Figure 8. Limestone Quarry (small) to the south-west of the lime kiln (looking west).

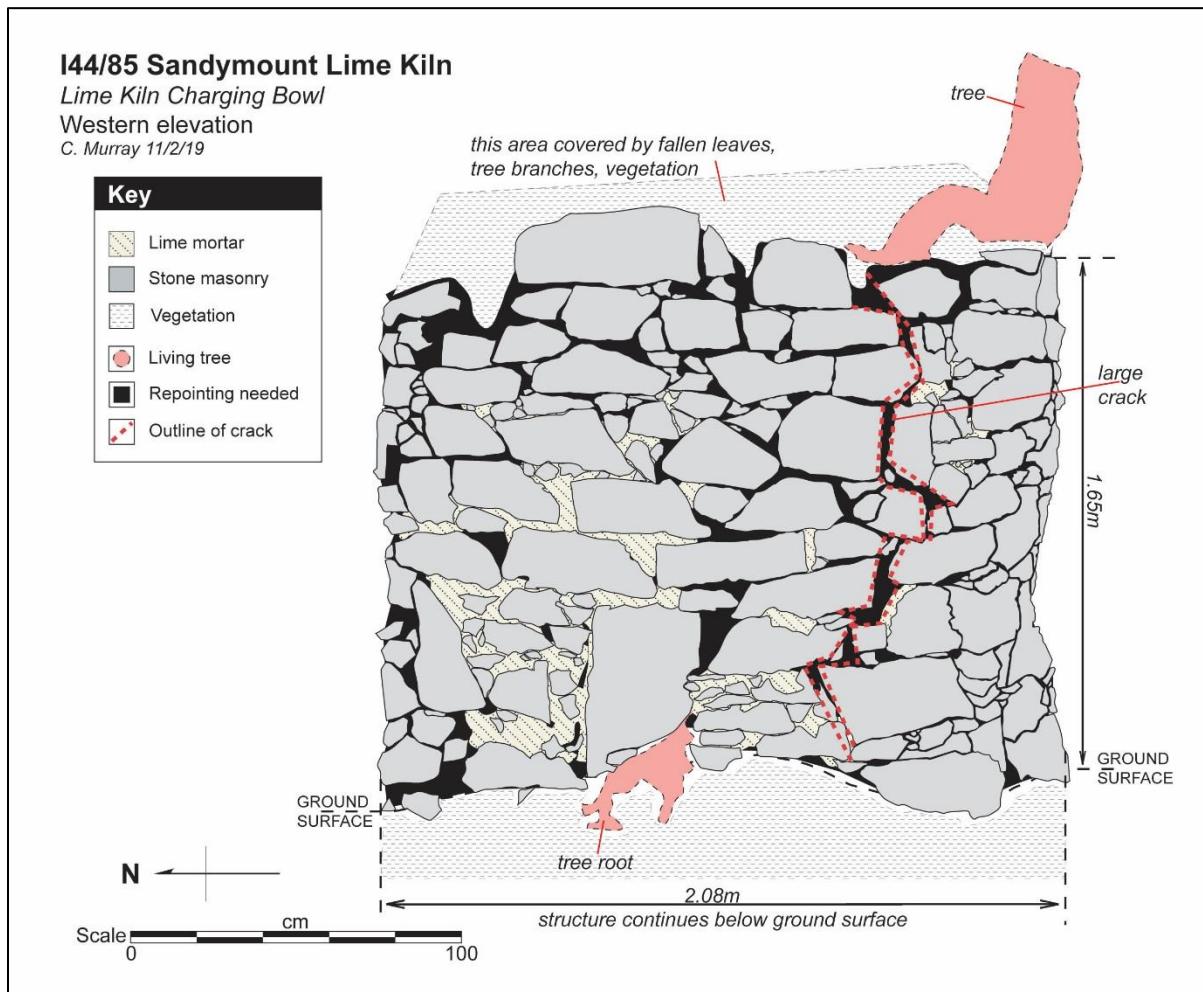
Figure 9. Lime kiln: Western elevation exhibiting the top section of the structure (charging bowl). A large crack is exhibited in the masonry and a tree is growing on top of the drum with a large root protruding through the base of the masonry.

A large crack is observable in the eastern face of the charging bowl which is highlighted by the red dashed line in Figure 9 and is also shown in the photograph Figure 10 (left). The crack is approximately 8cm at its widest span and is also being pushed out obliquely at approximately 5cm. A tree growing out of the top (southern section) of the charging bowl (Figure 10) is likely responsible for the crack with a root base that is pushing the top of the bowl out to form a bulge. This bulge is exhibited along the southern edge of the charging bowl in Figure 9. A root growing through the masonry at the base of the central eastern face (see Figure 11: left) has made a large void in the masonry approximately 15cm wide by 45cm high.

To stabilize the charging bowl, reinforcement with a steel brace, capping of the top courses and repointing in the stonework will need to be done. The large cracks should be mortared and monitored after tree removal to examine if there is any movement in the cracks. The oblique movement of the crack should also be monitored after tree removal, as pressure from the tree's root base is the likely cause of the bulging out of the drum causing the crack to move outward as well as apart.

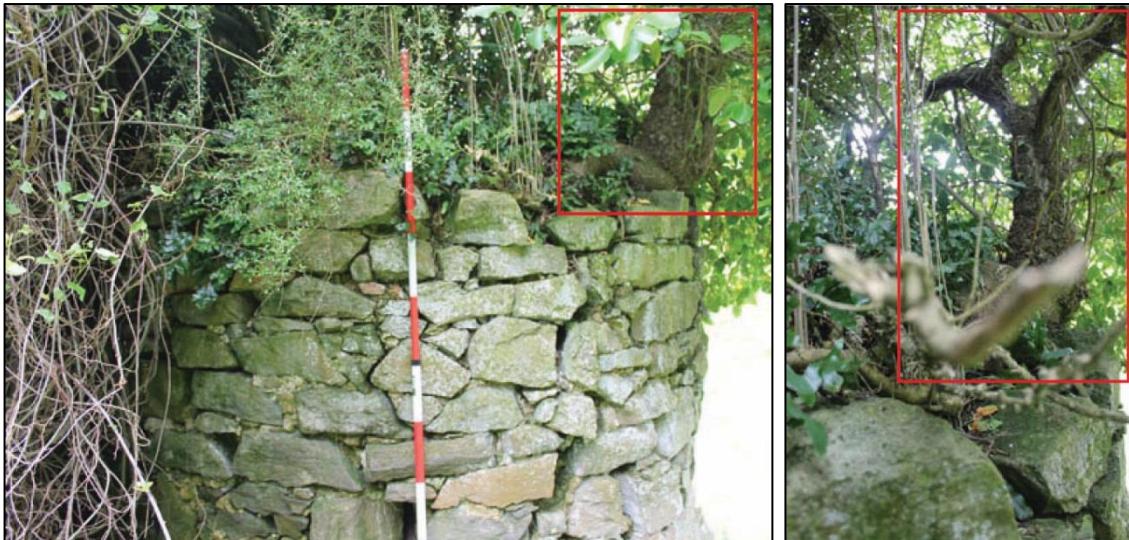
Figure 10. Tree growing out of charging bowl (outlined in red): looking east. Note the crack to the right of the stadia pole (left); looking south-east (right).

The limestone used in the masonry is in good condition, the tree has likely protected this part of the kiln from weathering. However, the pushing out and loosening of the masonry by the tree base has allowed erosive processes to remove the mortar. Remnant limestone mortar is still visible in the eastern face (see Figure 9), but most of this section of the lime kiln will need repointing. The top of the kiln is covered in vegetation (see Figure 11; right), so a total wall thickness was not attainable. The top

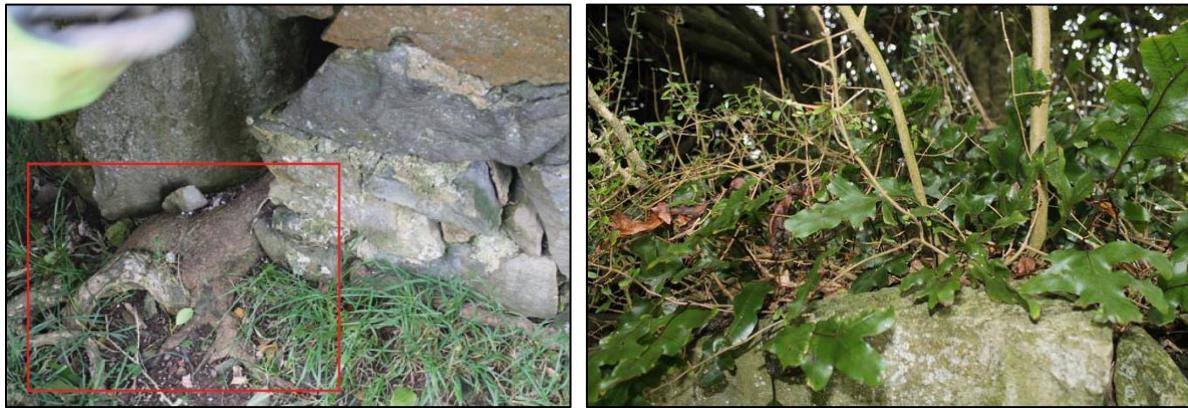
course of stone work is sitting quite loosely with most of the mortar having been removed. The vegetation is aiding in keeping the masonry fixed in place but will need to be removed and the top courses repointed.

Figure 11. A large tree root (outlined in red) pushing through the masonry and making a large crevice (left); Vegetation growing out of the charging bowl (right).

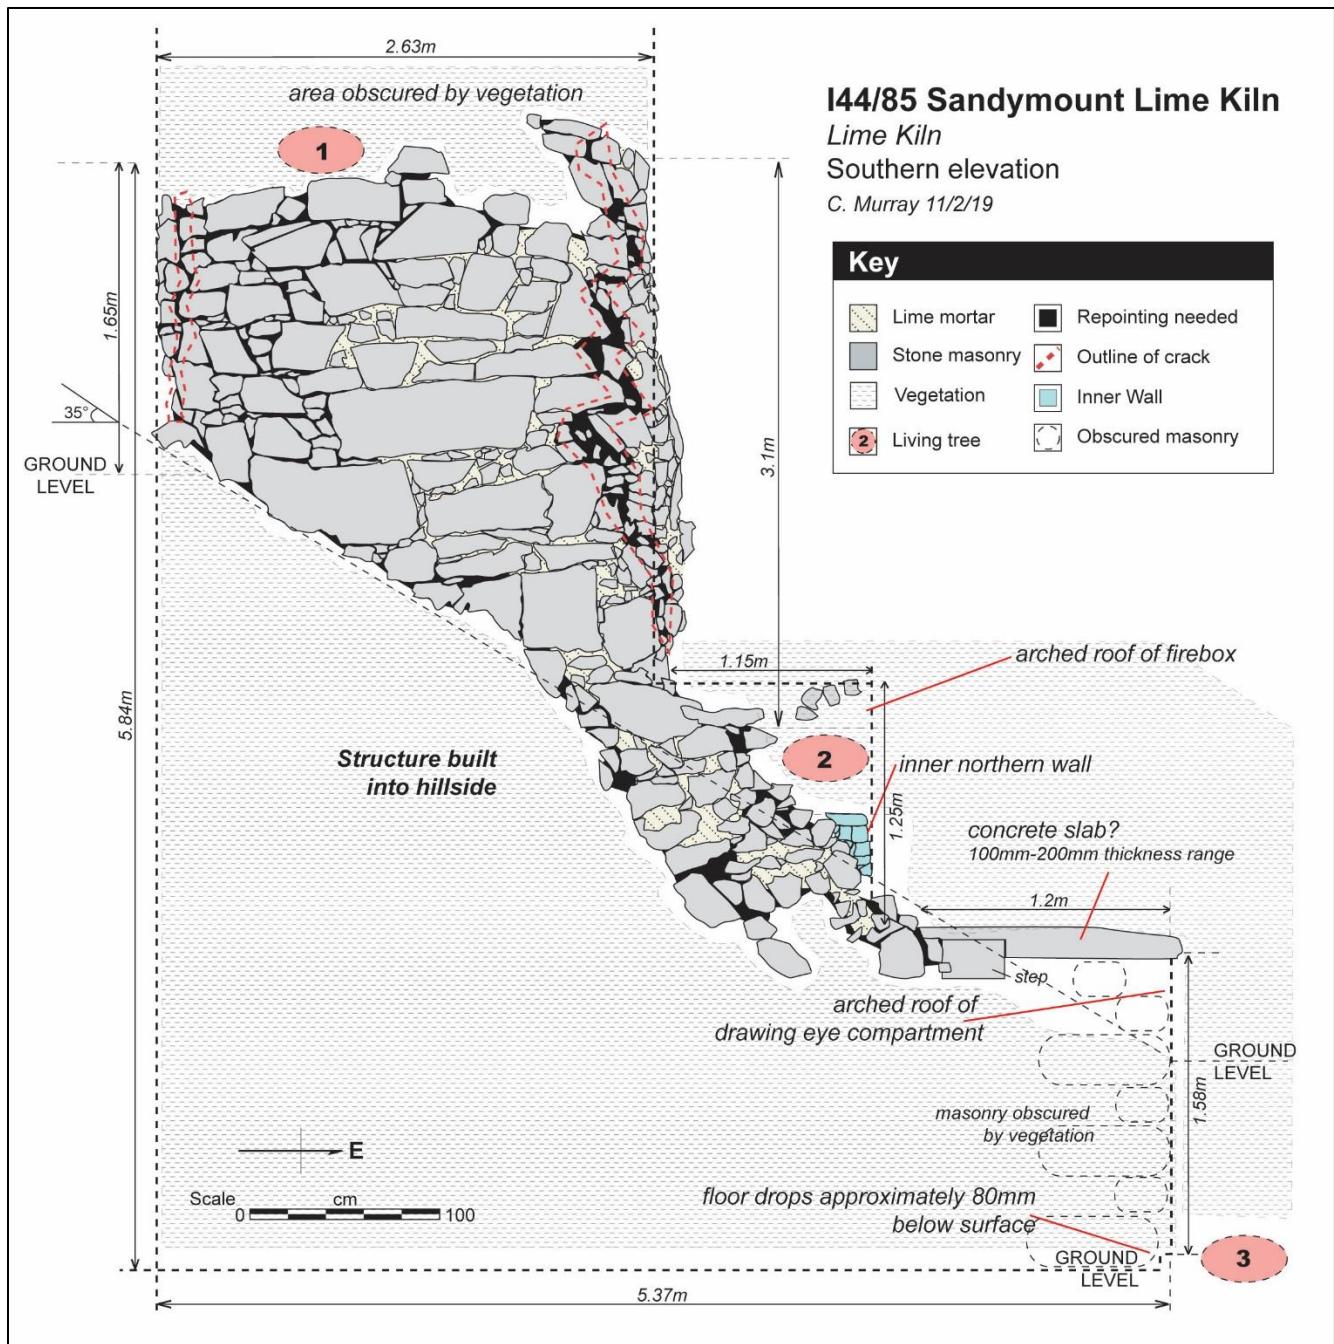
Three trees growing in or close to the structure are exhibited in Figure 12 as the red shaded circles with numbers one to three. Tree number one (in the charging bowl) has been discussed above (see Figure 9 and Figure 11). Tree number two in Figure 12 is growing out of the arched roof of the firebox. It has destroyed a large section of the roof and is pushing the southern wall out on an angle of approximately 22° to the

The masonry work observed in the southern face of the charging bowl is quite well preserved. The darker areas in Figure 12 behind the stone work are areas that need repointing. The top stone courses of the structure need to be stabilized and capped when the vegetation is removed, to inhibit water from entering the masonry. The crack in the western side of the charging bowl has been discussed, however, a larger crack on the eastern side can be observed in Figure 12 (outlined in the red dashed line). The crack is better observed looking north-west (Figure 14: left) displaying a large gap of about 20cm halfway down the charging bowl. Looking at the crack from the south (Figure 14: right) exhibits the oblique sideways movement of the crack which protrudes in a south-east direction approximately 5cm. The sideways movement of this crack suggests the drum is being pushed out by the trees root base rather than structural failure. This should be confirmed by an engineer prior to any physical conservation work being undertaken, as any foundational weakness could be hazardous to those working on the site.

Figure 12. Southern elevation of the lime kiln.

The three trees which are growing in and around the lime kiln were observed to be damaging the integrity of the structure and need to be removed. The masonry around the trees in the firebox and drawing eye chambers will need to be secured before their removal as the trees are holding some of the masonry blocks in place. Prior to tree removal, advice should be sought from an engineer as to whether the root base of the tree growing in the entryway of the drawing eye chamber may compromise the foundations if it is removed. Erosion around this area should also be checked as it could be a contributing factor to slumping if it is occurring. There is also suggestion that slumping directly south of the firebox may be occurring which should also be checked by the engineer as this could be a contributing factor to the large cracks in the charging bowl and the lean on the southern wall of the firebox. A well braced scaffold should be placed around the structure prior to any remedial work being done.

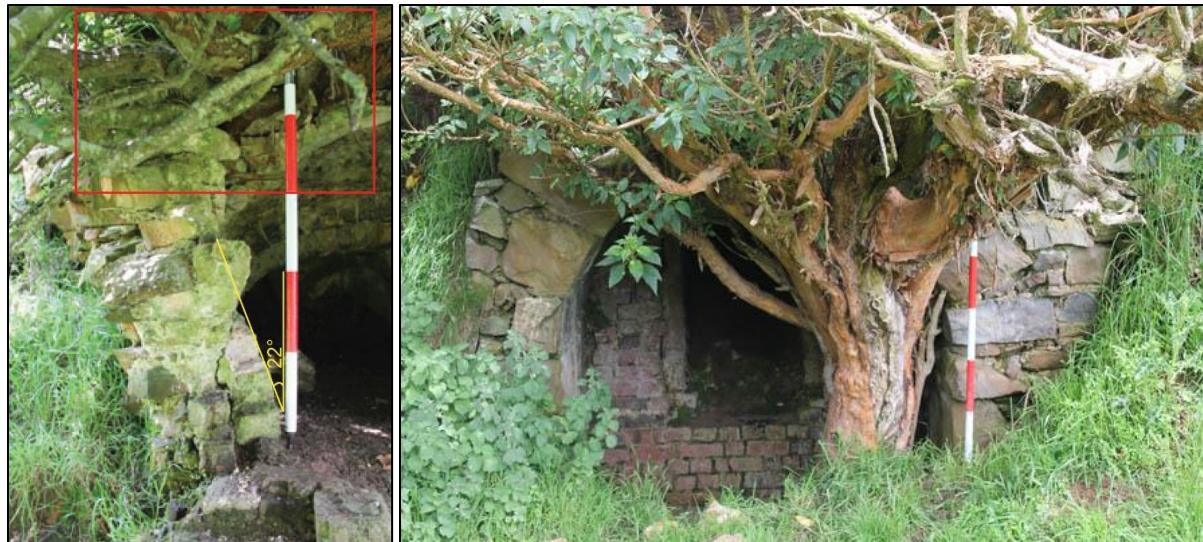
south (see Figure 13: left). Tree number three in Figure 12 is growing at the eastern base of the structure, in the entryway to the drawing eye chamber (see Figure 13: right). This tree is destroying the apex of the stone arch entryway to the drawing eye compartment and has likely got a root base which extends under the foundations of the structure.

The stone work in the roof of the firebox was largely obscured by vegetation. The outer southern wall of the firebox has been pushed out by tree growth (Figure 13: left). The stonework in the outer southern wall is very unstable and needs to be stabilized (see Figure 15). The larger quoins which are missing in this section, are likely the blocks strewn down the hill just south of the firebox entry. A large slab which is the entryway platform to the firebox and the roof of drawing eye compartment is interpreted to be concrete. A dressed limestone step was observed leading up to the concrete platform.

Figure 13. Tree growing out of the firebox roof, looking west (outlined in red: left); Large tree growing in the entryway to the drawing eye chamber, looking west (right).

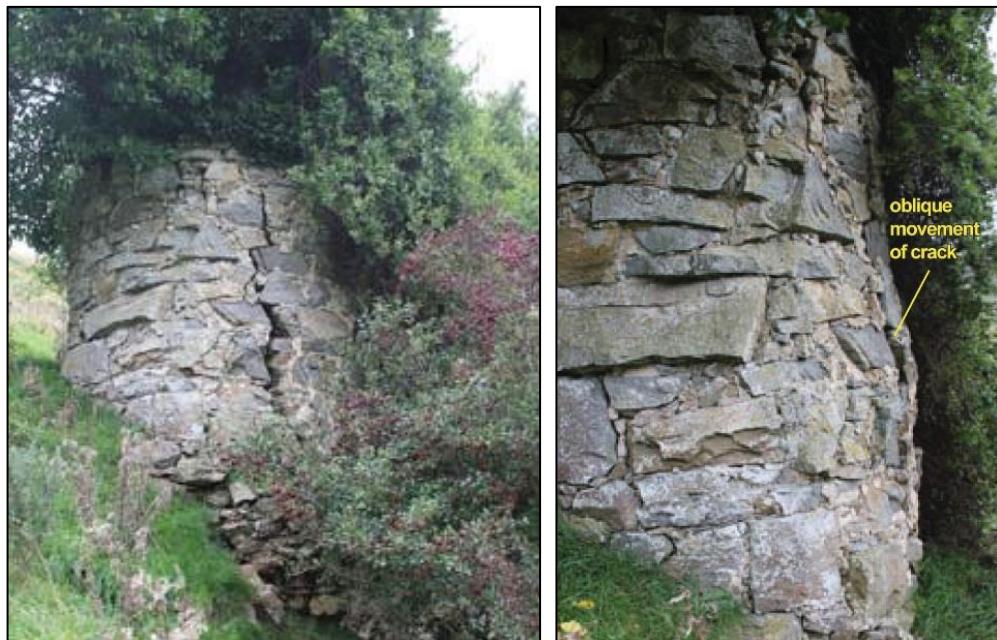
Figure 14. Large crack in the south eastern face of the charging bowl, looking north west (left); a view from the south of the drum exhibiting oblique movement of the crack (right).

The eastern elevation is largely obscured by vegetation. Illustrations of this elevation cannot be completed until the vegetation is cleared. The eastern face of the charging bowl has a large oblique crack running from the top down to below the surface. This crack has been discussed above and can be viewed in the southern elevation of the structure (see Figure 12) as well as the photographs in Figure 14. The stone masonry work in the eastern face of the charging bowl is well preserved (apart from the crack) with only some minor repointing needed. The base of the eastern face of the charging

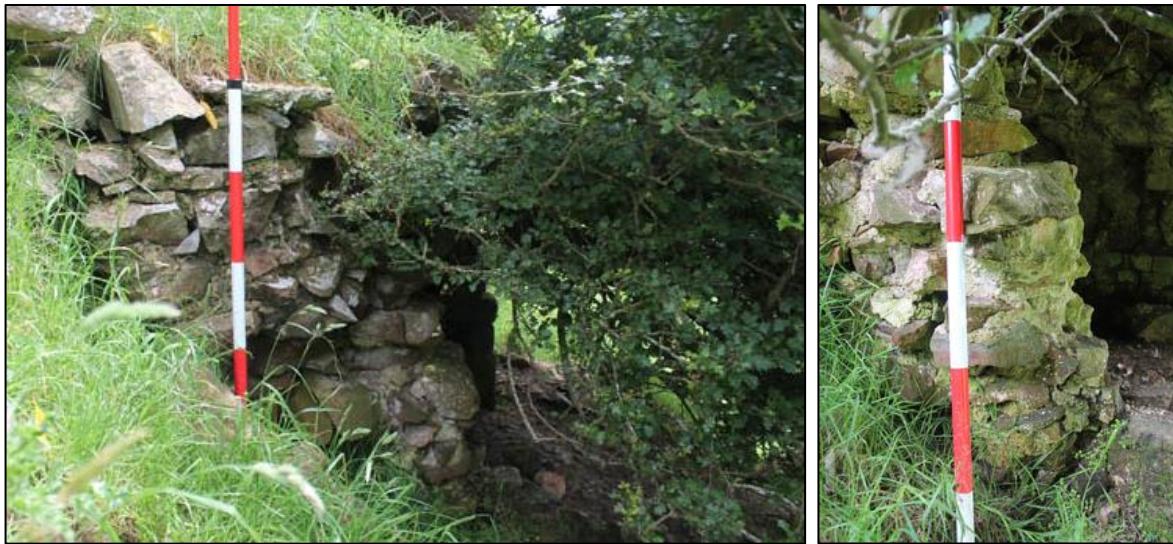
Figure 15. Outer southern wall of firebox: looking north (left); firebox southern wall end, looking north-west (right).

The southern wall of the firebox will need to be restored as it is danger of collapsing. The stone masons can replicate the masonry work from the northern wall of the firebox, which is still in a relatively good condition. A temporary fence should be put around areas of the lime kiln which are vulnerable to damage from cattle.

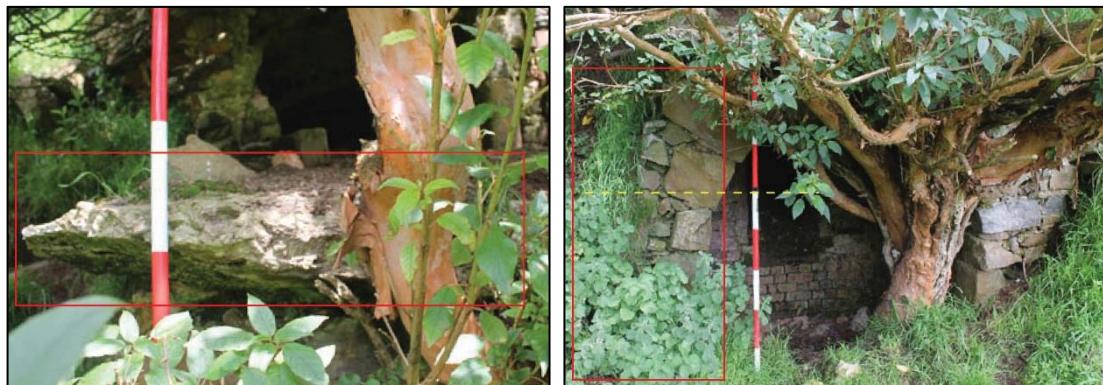
The southern outer stone wall of the drawing eye compartment was obscured by vegetation. The ground is around this wall has been filled in about a metre high against the wall which is part of the entryway to the drawing eye compartment (see Figure 16: right). The floor level inside the drawing compartment was noted to drop another 80mm below ground level.

Figure 16. Large concrete slab (outlined in red) which is the platform to the firebox entryway (left); the ground level drops one metre at the junction of the drawing eye entryway stonework (right).

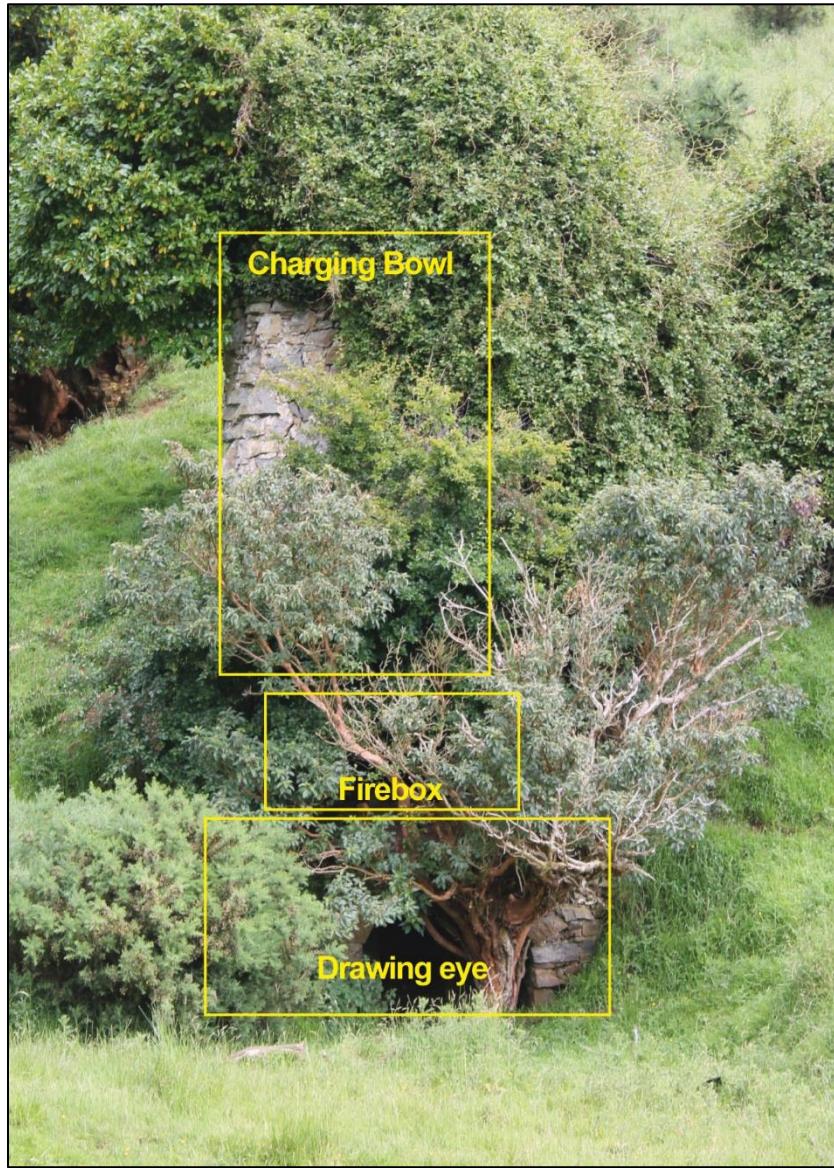
Figure 17. Vegetation covering almost the entire eastern face of the lime kiln, looking west.

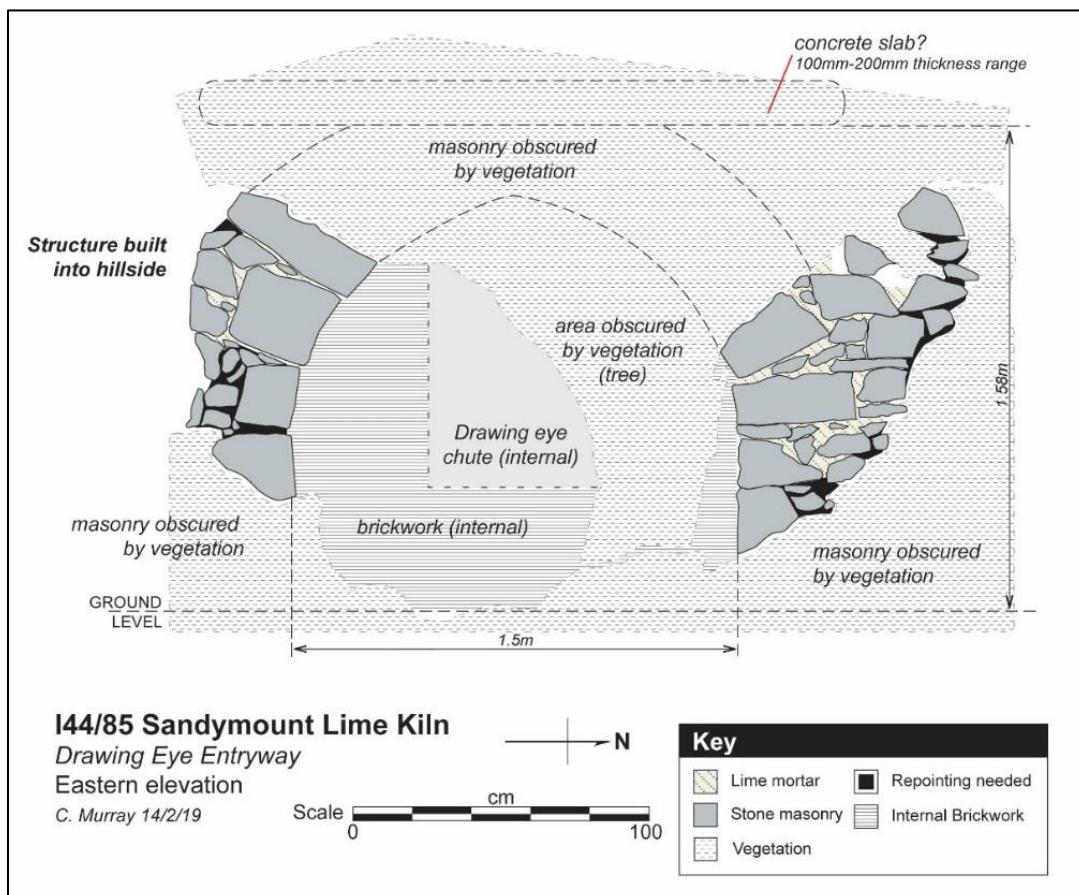
The stonework for the drawing eye compartment entryway is approximately 1.58m high and the entryway is 1.5m wide. The external stonework sides and base masonry are laid using the random rubble technique (Salmond, 1994:49; see Figure 18). Cut limestone blockwork with roughly hewn faces forms the archway over this entrance and is largely complete. The stone masonry work that has not been damaged by tree growth

has remnant lime mortar still binding it together, however, repointing will be needed in the blackened areas exhibited in Figure 18. The base of the entryway was obscured by vegetation and soil. Erosion of the surface around the entryway caused by cattle trampling was observed and could be a contributing factor to slumping.

Figure 18. Eastern elevation of the entryway to the Drawing Eye chamber.

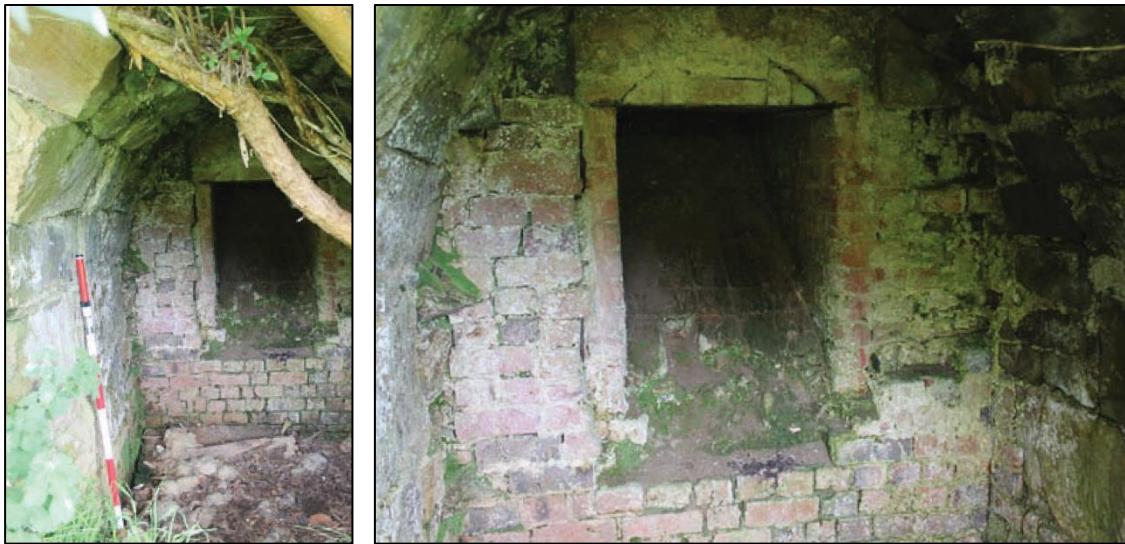
The inner floor of the drawing eye compartment was noted to drop below the outer ground level by approximately 80mm. The floor is covered in vegetation and the remains of a dead sheep. The drawing eye chamber displays an arched ceiling made from large limestone blocks which make up the inner northern and southern walls (see Figure 19: left). This stonework is in good condition but will need some minor repointing done. The northern inner wall and some of the ceiling was noted to have a green mold growing on it. The inner western wall of the drawing eye compartment, as well as the drawing eye chute, are made from bricks (Figure 19: right). The brickwork is in good condition with only minor repointing needed.

Figure 19. Inner drawing eye compartment: large dressed limestone blocks exhibited in the southern inner wall and the arched roof (left); the drawing eye chute and brick surround (right).

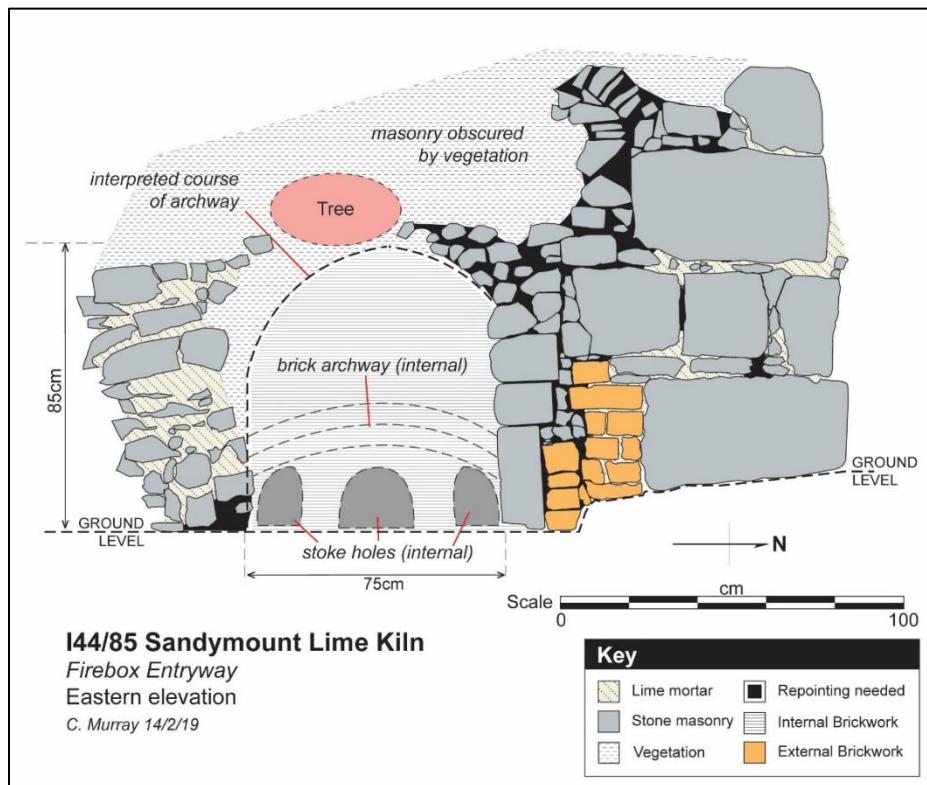
The stonework for the firebox entryway has largely been destroyed by a tree growing out of the roof (see Figure 20). This tree has been discussed above and can be viewed in Figure 13 (left). The southern wall of this section of the lime kiln has been pushed out by the growing tree and is leaning approximately 22° to the south (see Figure 13: left and Figure 18). The larger stone quoins which would have secured the northern wall end have fallen away and could be the blocks that are lying directly south of the compartment. Large pieces of lime mortar still hold the remaining section of the southern wall together, however the wall will need to be stabilized. The area directly to the south of the leaning south wall exhibits heavy cattle trampling which has eroded the bank. The cattle damage in this area is contributing to the erosion of the slope and could be causing minor slumping which is affecting the structure. The northern exterior wall of the firebox has incorporated bricks into the lower course work (Figure 20) with some minor repointing needed in the lower courses. A lot of the stone work in the upper courses of this section of wall have become dislodged from tree growth and will need to be stabilized. The stone arch entryway has been destroyed by tree growth, however, the interpreted line of the archway can be observed in Figure 20. The firebox roof was obscured by vegetation so the condition could not be attained.

Figure 20. Eastern elevation of the firebox.

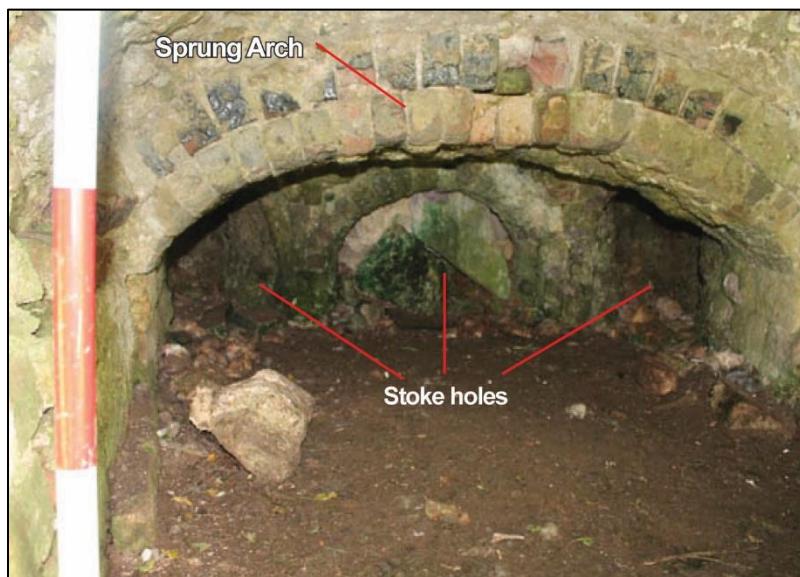
The interior of the firebox exhibits a mixture of stone and brick masonry. The lower courses of the northern and southern walls (which remain) are brick with the higher courses using larger dressed limestone blocks. A sprung arch made from firebricks is observable in this chamber (Figure 21), some of the central bricks are damaged and may need to be restored. Along the western inner wall of this chamber are three stoke

holes with brick arch surrounds. The centre stoke hole is open and the two holes either side look to have been sealed. The floor of the interior of the firebox is dirt with a few scattered pieces of limestone (Figure 21).

Figure 21. Firebox interior exhibiting the sprung arch and stoke holes.

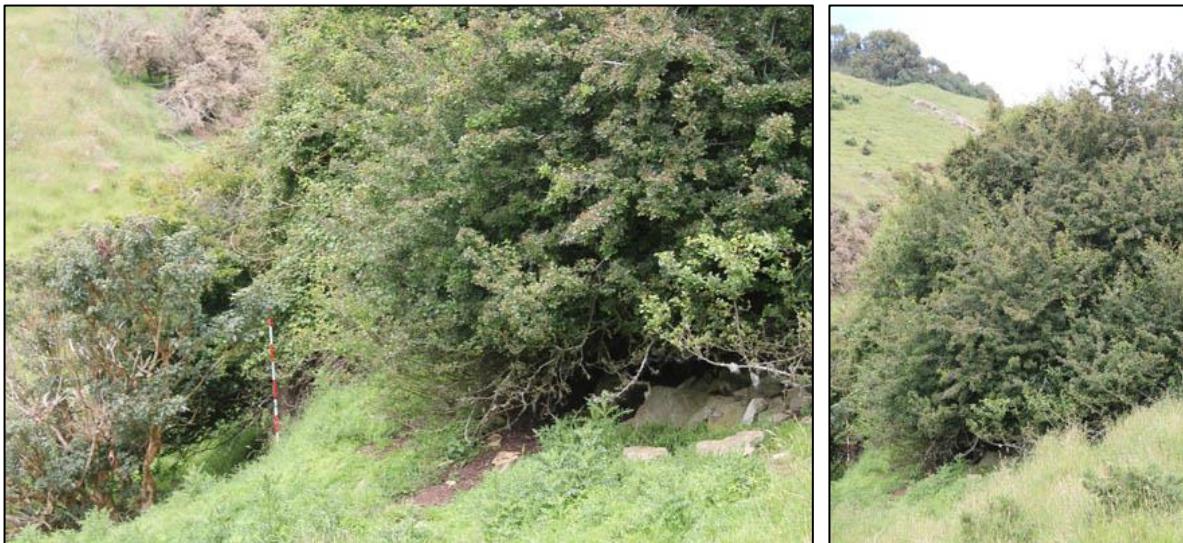
The northern elevation of the structure is entirely obscured by vegetation (see Figure 22), so elevations were not able to be drawn. The northern face of the charging bowl is covered in a vine as well as the foliage from the tree growing out through the top. The vine has spread down over the tree which is growing out of the roof of the firebox. The vine and higher ground level is also obscuring the outer northern wall stonework of the drawing eye and firebox compartments.

Figure 22. Looking directly south toward the lime kiln: the stadia pole is at the entryway to the firebox (left); the vegetation covers the entire charging bowl and working discard area (feature 3) – note the stadia pole in the bottom left of the image (right).
