Condition Report: Rutherford's Farm (I44/426)

By Carl Murray and Stuart Griffiths (March 2019)

**Report for Hereweka/Harbour Cone
Management Trust**

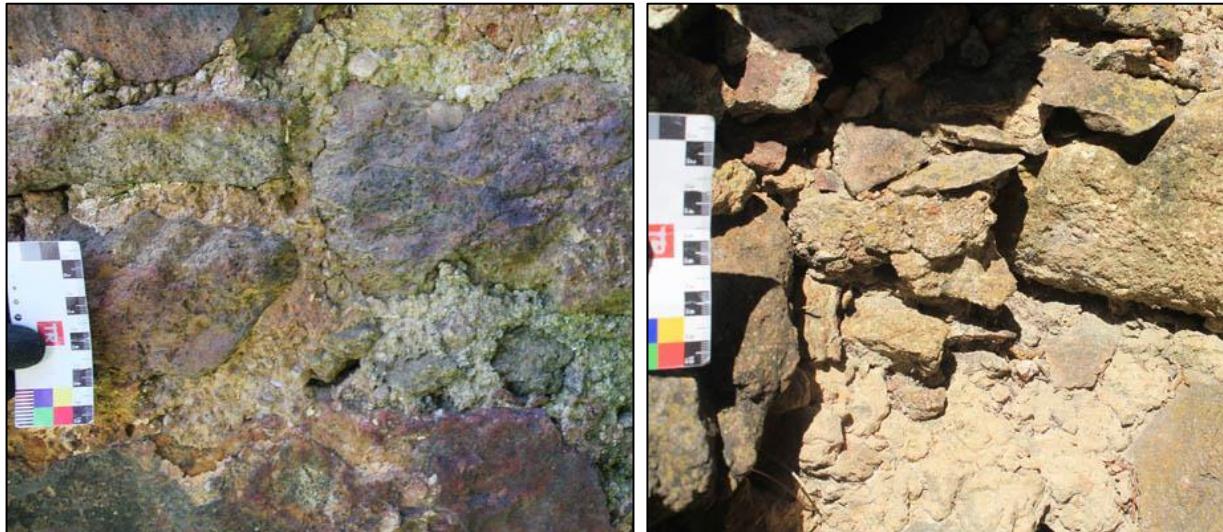
The inner wall mortar used in the homestead masonry is a mixture of lime and clay with volcanic tuff fragments also been used in the wall filling. A lime mortar is used for the external pointing and is drawn out flush with the stone. A volcanic tuff aggregate was noted to be mixed with the lime mortar which may explain its resistance to weathering. The mixing of volcanic tuff with lime mortar causes a chemical reaction (between alumino-silicates and calcium oxide) which increases its adhesion, durability and bonding strength (Al-Zou and Kamel, 2014: 279-280). This may suggest the tuff was used in the production of mortar with knowledge of its increased strengthening and bonding attributes.

Figure 5. Course lime and tuff aggregate mortar used for the external pointing (left); inner wall core mixture of tuff rubble, clay and lime (right).

These walls and presumably the walls that are obscured by vegetation, will need a capping treatment to aid in securing them as well as protecting the interior of the wall from water entering.

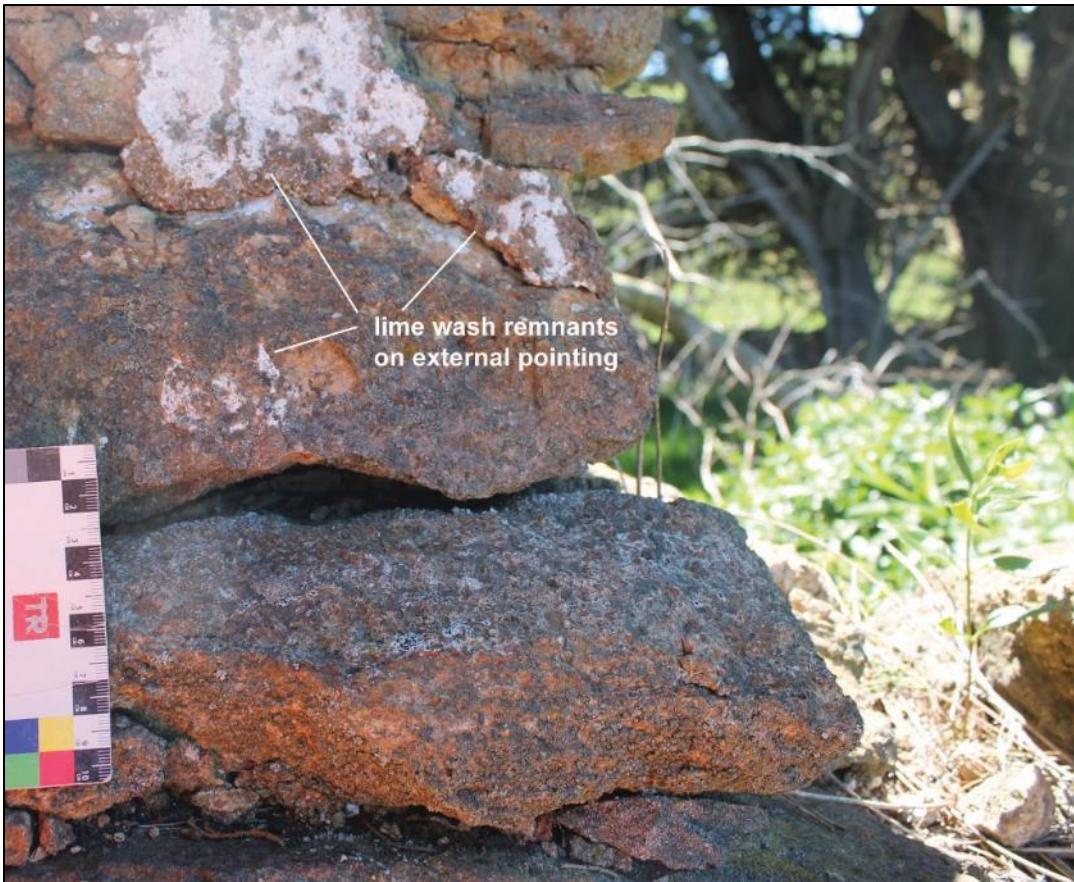
The homestead has been built in a random stone course manner (Salmond, 1994 :89), using the local volcanic tuff, which is discussed in the geology and quarrying section above. The stone edges and faces have been hewn to bring them into line, but the quoins were noted to have been worked into more robust forms. Course lime mortar mixed with volcanic tuff aggregate has been used for the external pointing and drawn flush to the stone surface (Figure 5; left). The wall core is a mixture of volcanic tuff rubble, lime and clay, and has been largely washed away where exposed to erosion (Figure 5; right). A lime wash render was likely used as a protective finish as small fragments were observed on the surface of the external mortar (Figure 6).

Figure 6. Remnants of a fine coat of lime wash over the external pointing

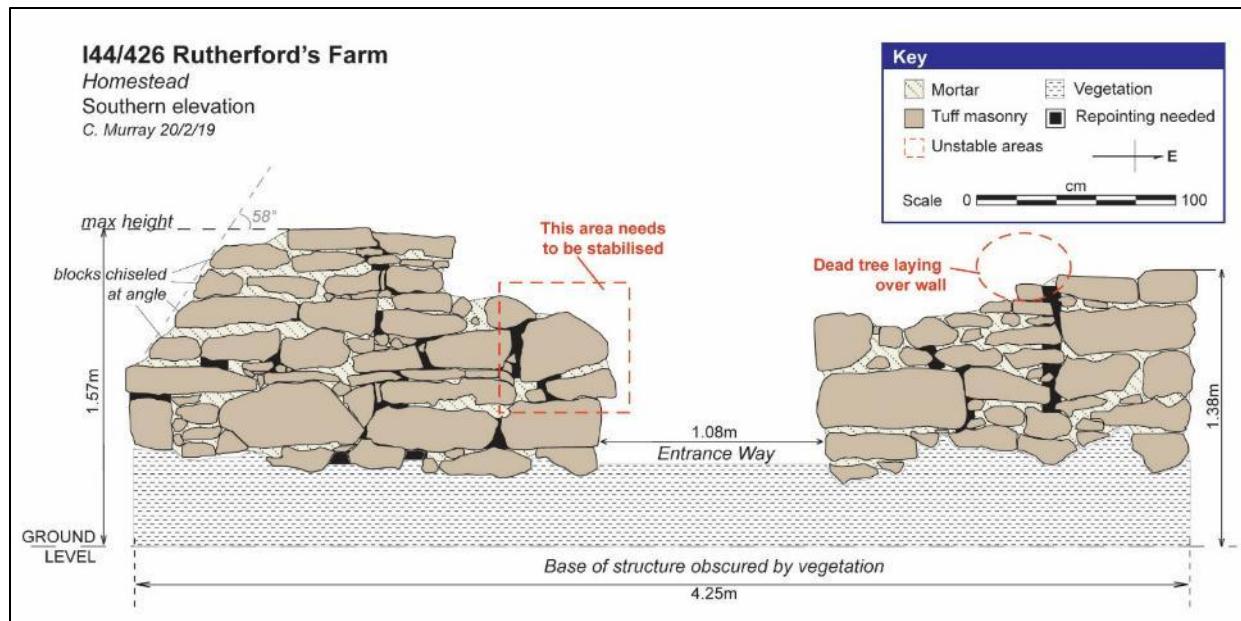
The southern elevation of the homestead (Figure 7) is approximately 4.25 metres wide by 1.57 metres high. The two masonry sections are still largely intact, however, vegetation is obscuring the base of the structure. The blackened areas in Figure 7 are crevices where mortar and wall core has been washed out. The south-eastern corner of the entrance way is sitting loosely on top of the lower course and has been pushed out (eastward) approximately 15 cm. This area is outlined with a red dashed line in Figure 7 and is also exhibited in Figure 8. Stone blocks at the south-western end of the southern wall are noted to be chiseled and laid at an angle of approximately 58°, most likely to support a roof truss (see Figure 7).

A dead tree is laying over the north-eastern section of the homestead and is likely bearing weight upon this part of the structure (see Figure 7 and Figure 9). The south-eastern section of masonry offers a good example of the mortar's weather resistance with most of the wall still intact (Figure 9).

Figure 7. Southern elevation of Rutherford's homestead.

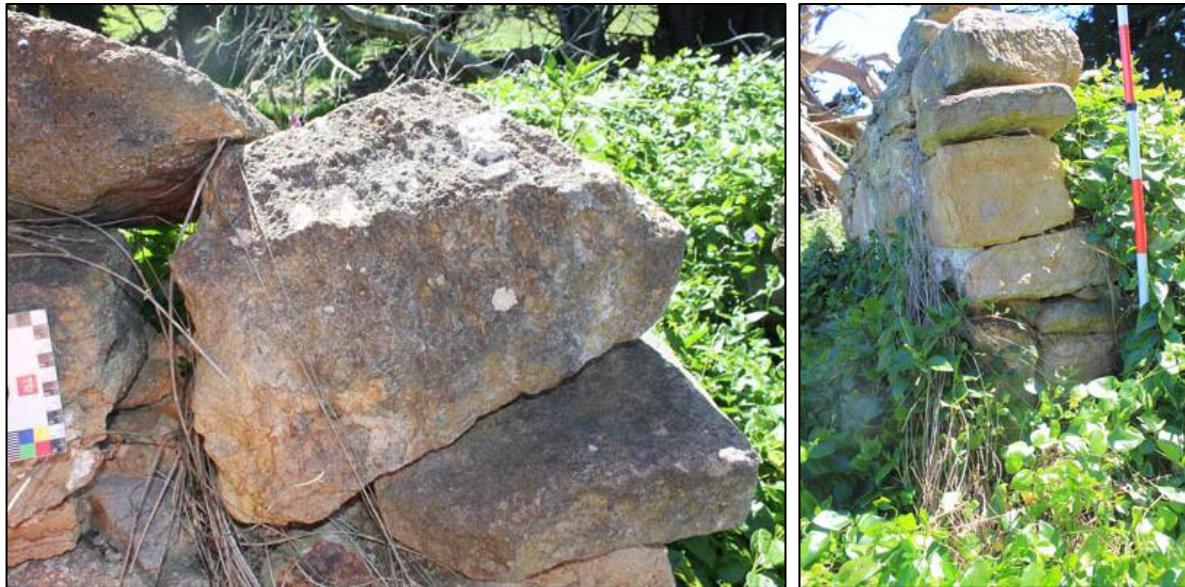
Figure 8. South-western corner of the entranceway to the homestead which needs to be stabilized: looking north-down (left); looking west at the inner section of wall (right).

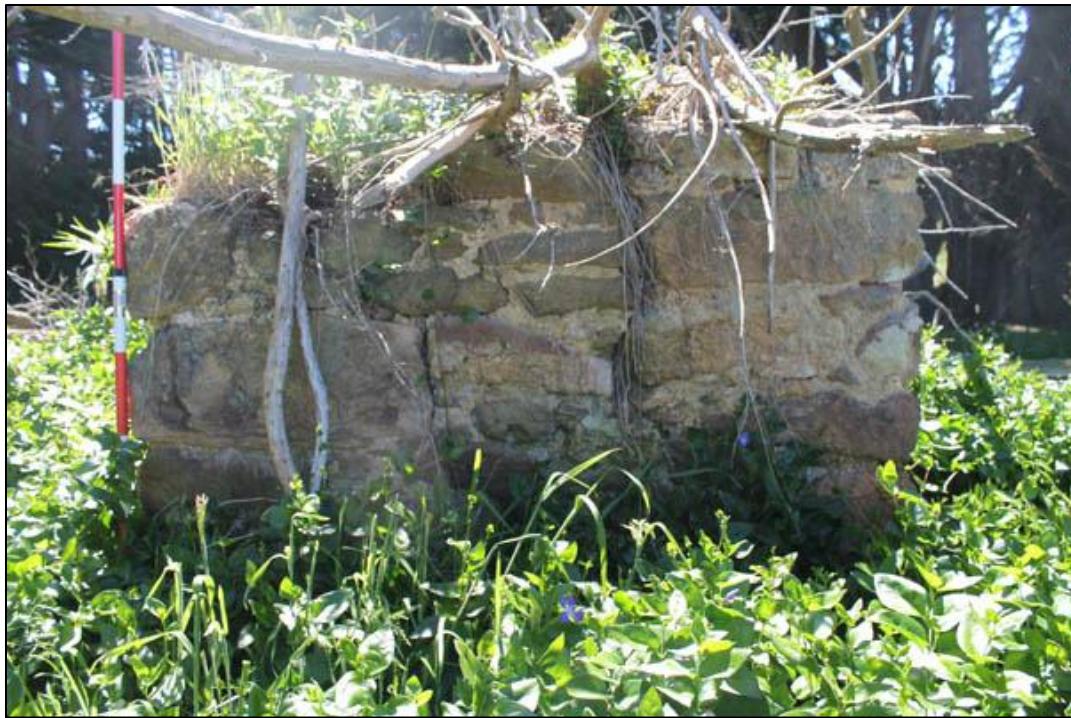
Figure 9. The south-eastern section of the southern wall (looking north) with the dead tree laying over it; note the lime mortar here has resisted weathering.

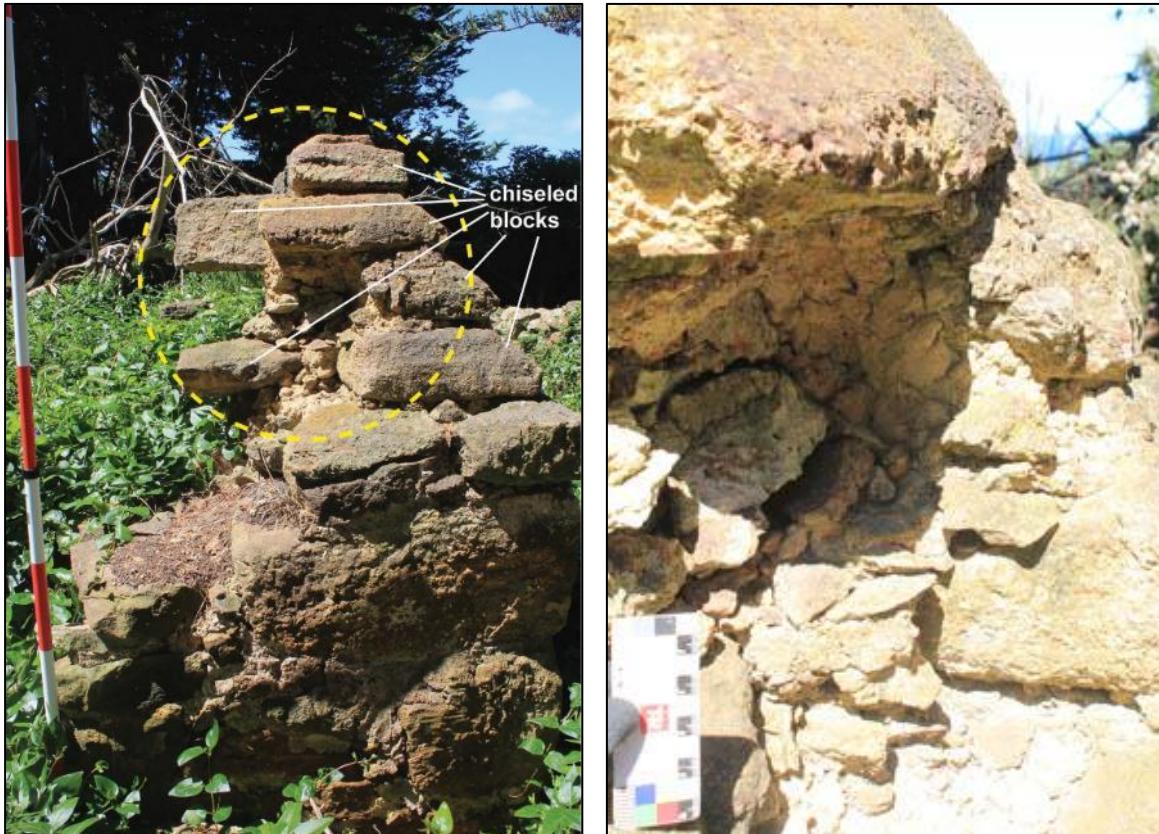
The southern corner section of masonry is all that remains of the western wall. The top of the inner southern wall can be observed from this position to be very unstable. The yellow dashed circle in Figure 10 (left) highlights the area of the inner southern wall which will need to be stabilized. Large stone blocks (protruding northward) which likely supported a roof truss are being held in place by the weight of surrounding blocks. The mortar and a lot of the wall core in this area has been washed out (see Figure 10; right), making the top of the wall vulnerable to collapse.

Figure 10. The area within the yellow dashed circle needs to be stabilized, looking east (left); A close-up of the lime/clay mortar used in the wall core, looking south (right).

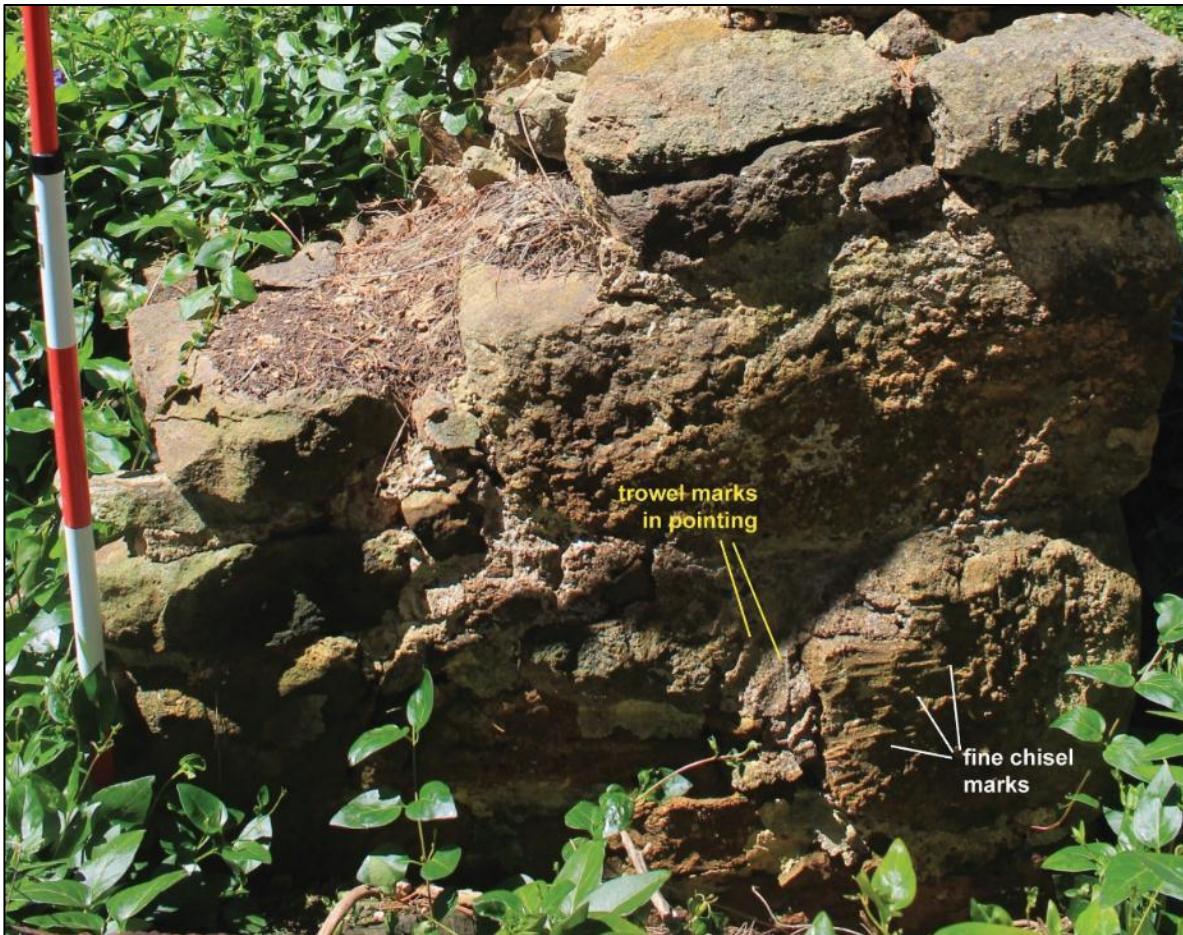
The remaining section of the western wall is approximately 1.2m high, 1.5m long and 60cm wide. This small remaining section of wall is in good condition, with most of the mortar still intact and holding the stone blocks in place. Figure 11 shows this section of wall with tool marks (trowel point?) observable in a lime mortar which is mixed with a finer aggregate than the mortar observed elsewhere on the structure. This part of the wall has likely been repointed at a later stage, but still during the occupancy of the homestead.

Some of the larger blocks in this section of wall are weathered, likely a result of increased water and wind exposure without the protection of a roof. Very fine chisel marks can be observed on some of these blocks (see Figure 11), emphasizing the skill

Figure 11. Outer western wall, looking east: trowel marks observed in lime mortar (yellow); fine chisel marks exhibited in the volcanic tuff (white).

of the stone mason as well as informing us the exceptionally sharp tool set. These tool marks offer evidence of tool types and methods used to dress the stone and should be acknowledged if restorative work is undertaken on sections of wall where these are exhibited.

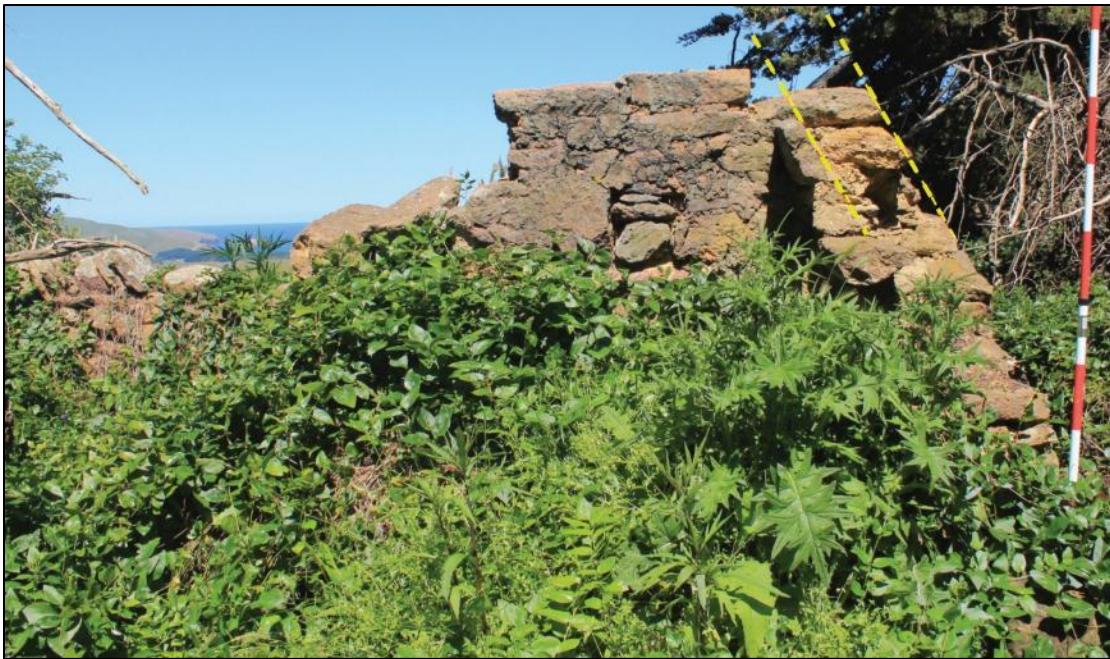
Figure 12. Looking south toward the homestead. The yellow dashed lines in the top right of the image follow the angle (58°) cut into the stone which likely supported a truss.

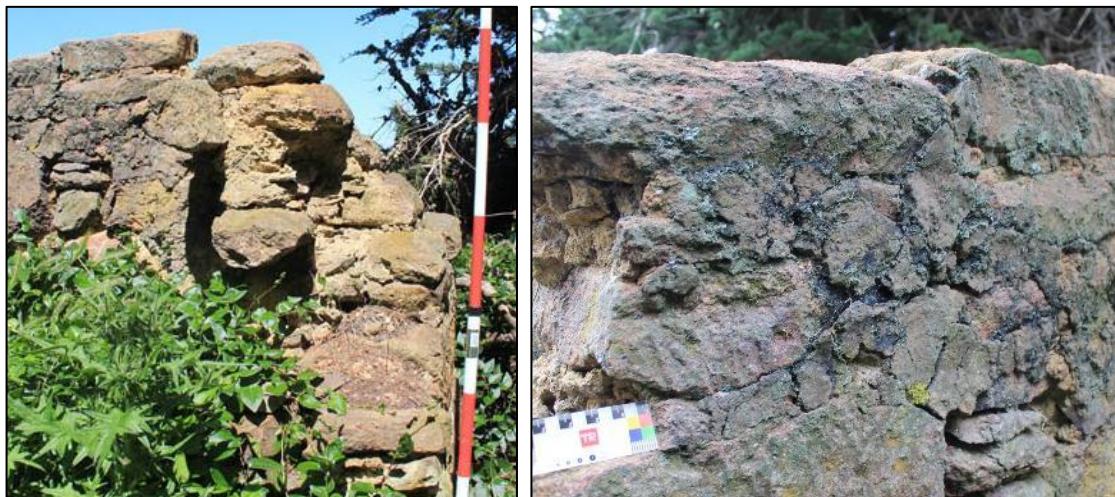
The northern wall of the structure has been removed, with the materials likely being used in the drywalls around the site. The inner southern wall can be seen from this position, revealing the large blocks protruding from the top of the western section of the southern wall. Figure 12 is a photograph taken looking south toward the homestead structure and exhibits the interior of the structure which is obscured by vegetation. In the top right of the image, two yellow dashed lines highlight the angle cut into the blocks which likely functioned as support for a roof truss. A close-up of these blocks looking south at the inner wall is shown in Figure 13 (left). A viscous black pitch/tar was observed on the inner southern wall (western section; see Figure 13; right) which could be associated with asphalt damp-proofing between the courses. No aggregate was observed to be mixed with this binding agent and it has likely been applied as a restorative measure rather than being part of the original fabric.

Figure 13. The inner southern wall with large cut blocks protruding northward (left); black pitch/tar used to repoint a section of the inner southern wall (right).

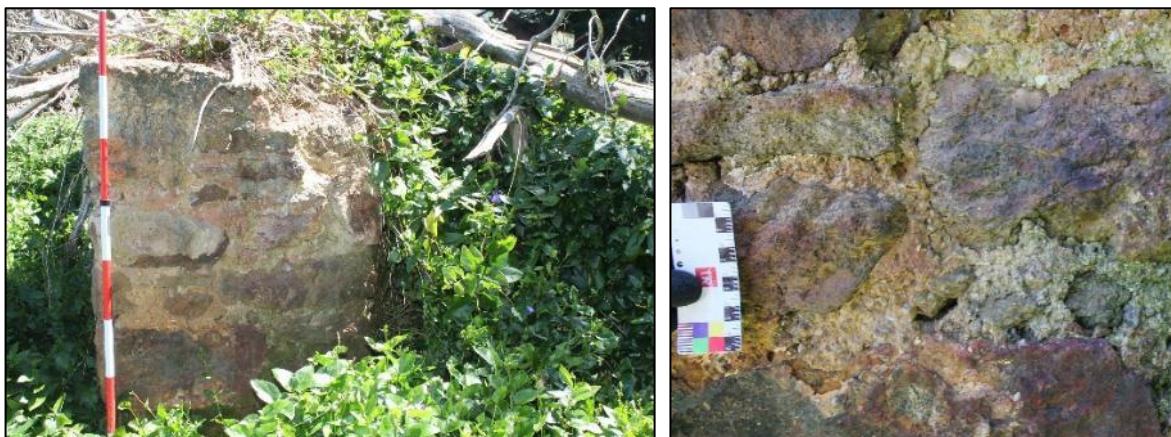
The eastern elevation of the homestead consists of a small section of wall which measures approximately 1.4m high, 1m long and 60cm thick. The northern part of the wall is missing, the materials likely having been removed and used elsewhere on the site. It is also possible that the missing section of wall was made from wood and has deteriorated. Vegetation is obscuring the area where the wall continued so no foundations for the wall were observed. A dead tree is lying across part of the eastern wall and hanging over the edge of the southern wall and can be viewed in the top right corner of Figure 14 (left).

The small section of masonry which remains offers an example of the original lime mortar used in the structure, with the stone in this section still very strongly set (Figure 14; right). The stone in this section of the structure is in relatively good condition, with erosion being only minimal.

Figure 14. Outer eastern wall, looking west (left); close-up of the masonry in the outer western wall. Note the volcanic tuff used as aggregate in the lime mortar (right).

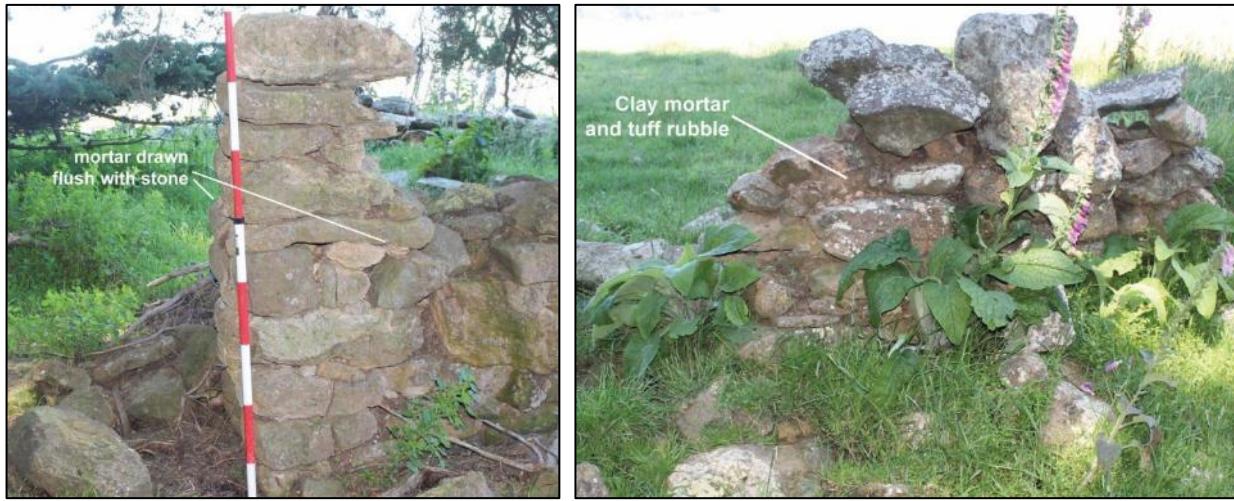
Figure 15. Northern wall end of the cow byre exhibiting remnants lime mortar drawn flush with the stone (left); clay mortar and tuff rubble used in the inner wall.

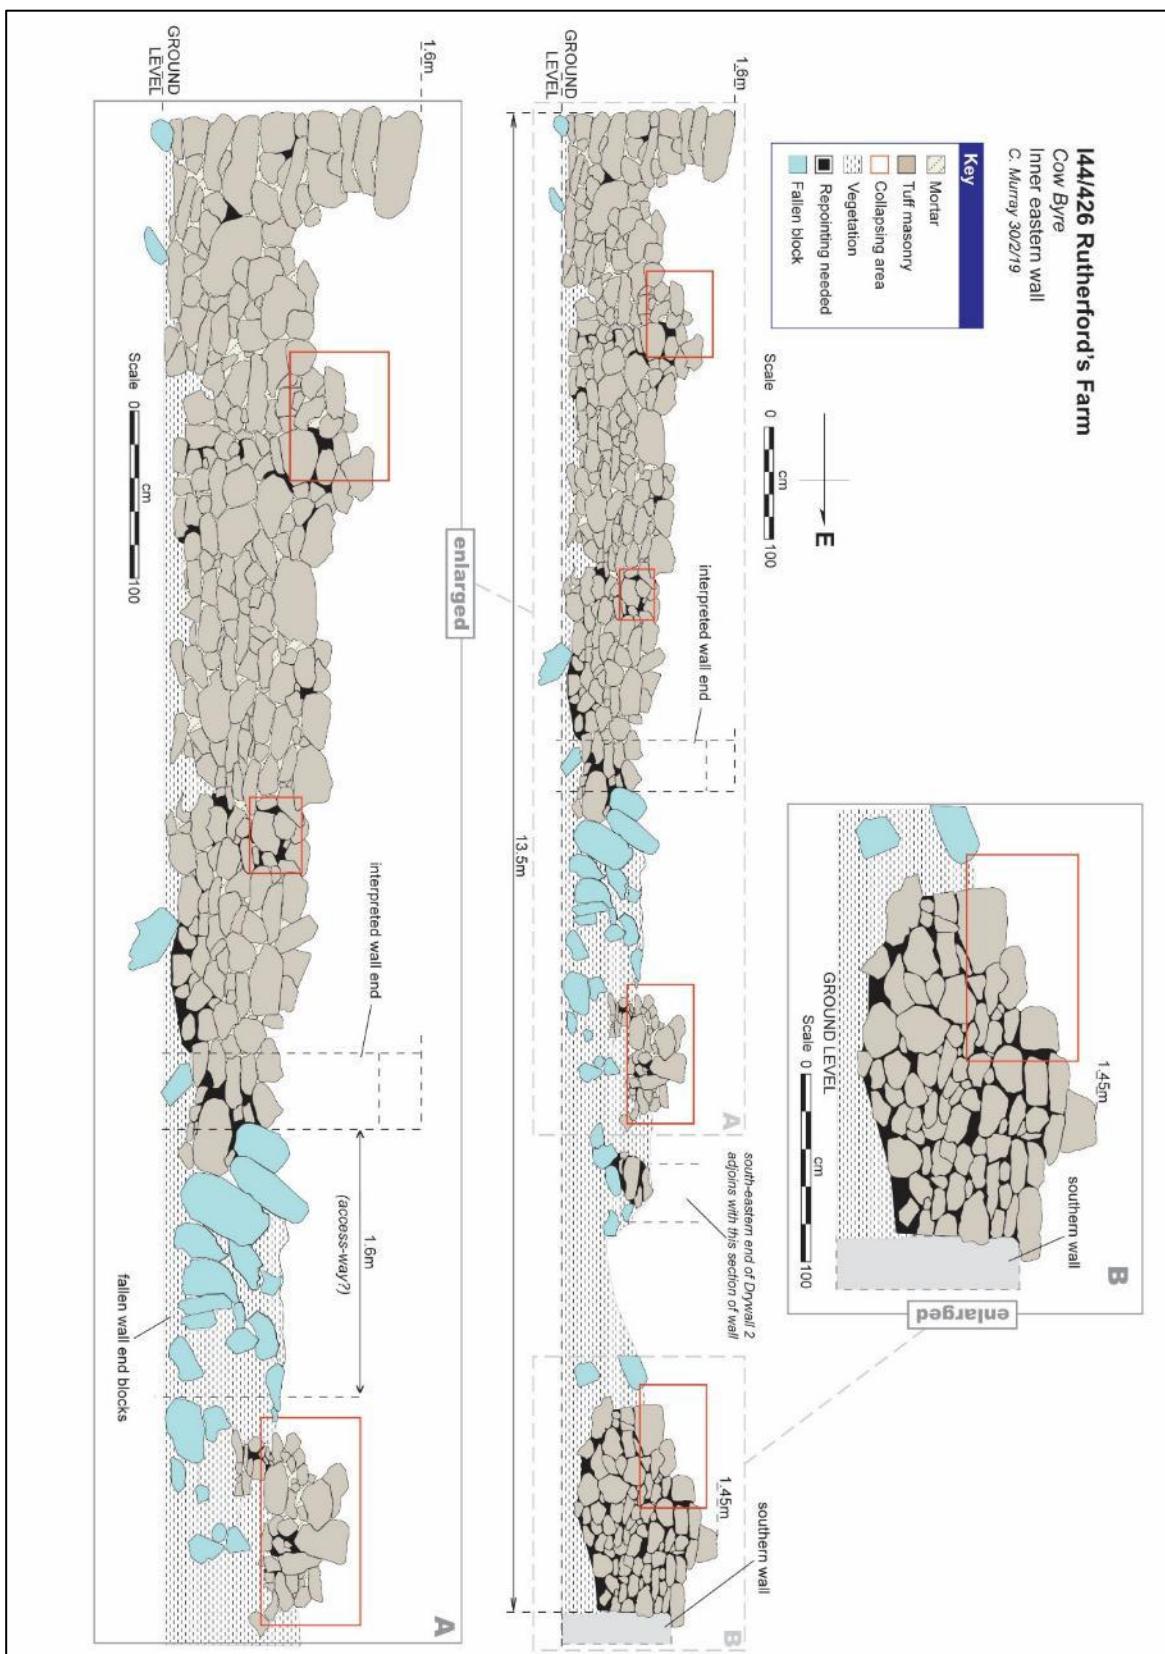
The eastern wall of the cow byre is approximately 13.5 metres long, 1.6 metres high at its highest point, and 60cm wide. The stone used is mainly sub-rounded field stone with evidence of coarse dressing to shape some of the larger blocks. All of the external pointing has been washed out. These areas are exhibited in the illustration of the inner eastern wall (Figure 16) as blackened areas between the masonry. The enlarged southern section of wall (see Figure 16B: enlarged) is the area which has been most affected by weathering, with most of the mortar and wall core being washed out. About half way along the inner eastern wall, large stone blocks belonging to another wall end are strewn about the base of the wall (see Figure 16A: enlarged). Vegetation is obscuring the footings of the wall, and grasses are covering large areas of the southern part of the wall. The northern section of the outer eastern wall was inaccessible due to tree growth. This area will be updated after vegetation is removed. The southern section of the outer eastern wall (see Figure 17) has no observable mortar or wall core present and will need to be stabilized.

Figure 16. Cow Bye: section drawing of inner eastern wall.

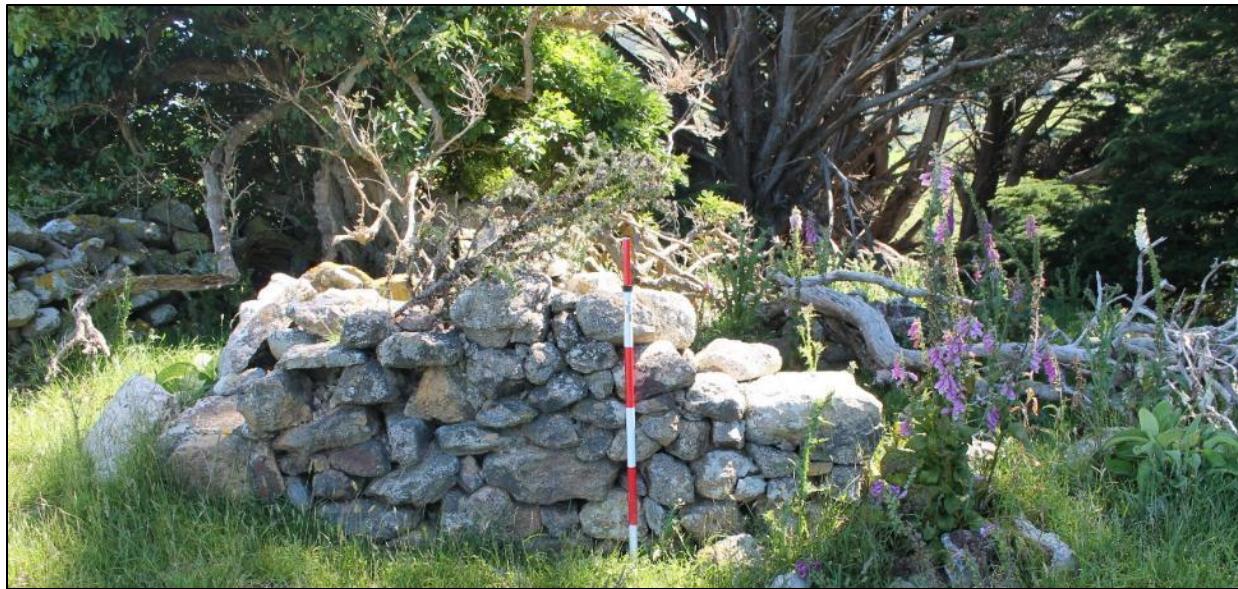
Figure 17. The southern section of the cow byre's outer eastern wall, looking west.

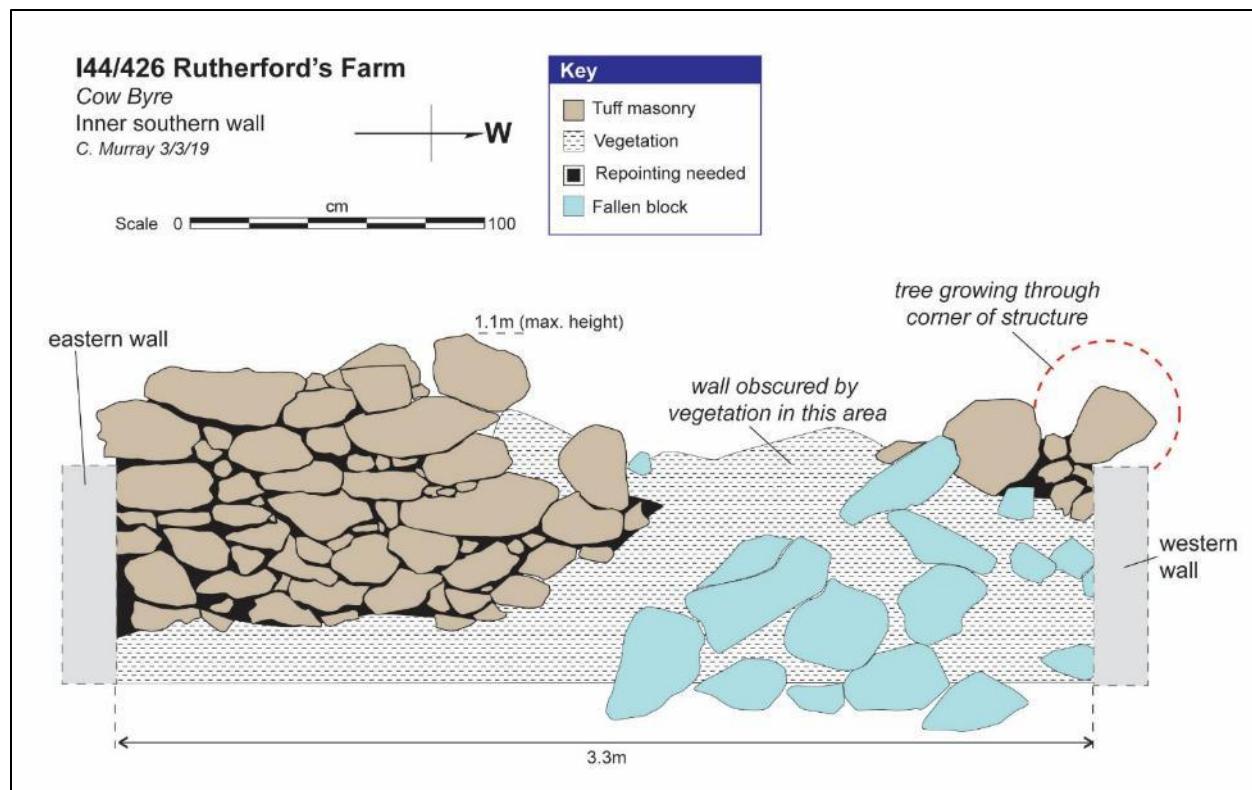
The southern wall is the back of the cow byre and adjoins with the eastern and western walls (see Figure 18). This section of wall measures approximately 3.3m long, 1.1m maximum height and 60cm wide. The base and the central sections of the inner southern wall were obscured by vegetation. A tree is growing through the western corner of the wall and has damaged the masonry in this area by dislodging the stone blocks which are scattered around the base of the wall (Figure 20). The external mortar has eroded away from the inner southern wall and is shown as the blackened areas between the stone work in Figure 18.

Figure 18. Cow byre: section drawing of inner southern wall.

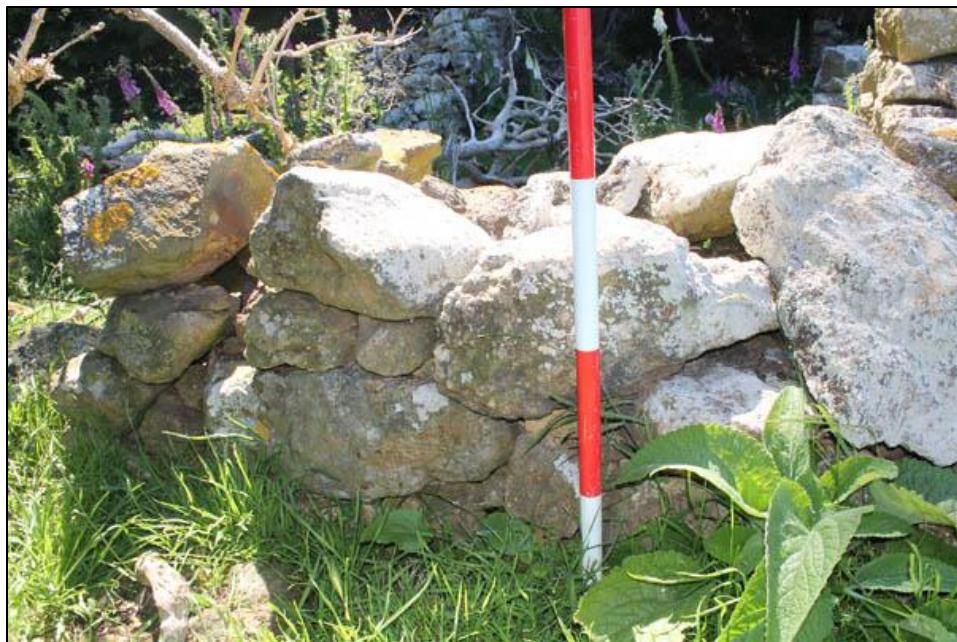
Only three courses of stone are observable in the cow byre's outer southern wall (Figure 19) with most of the mortar washed out. The ground surface is higher at the base of the outer wall compared to inside the byre by approximately 40cm. Vegetation and the tree growing in the south-western corner of the structure made recording of that area difficult. The vegetation will need to be removed where it is covering the wall to observe its condition. The tree growing through the south-western corner is causing damage to both the cow byre and Dry wall 3.

Figure 19. The small remaining section of the outer southern wall of the cow byre, looking north-west.

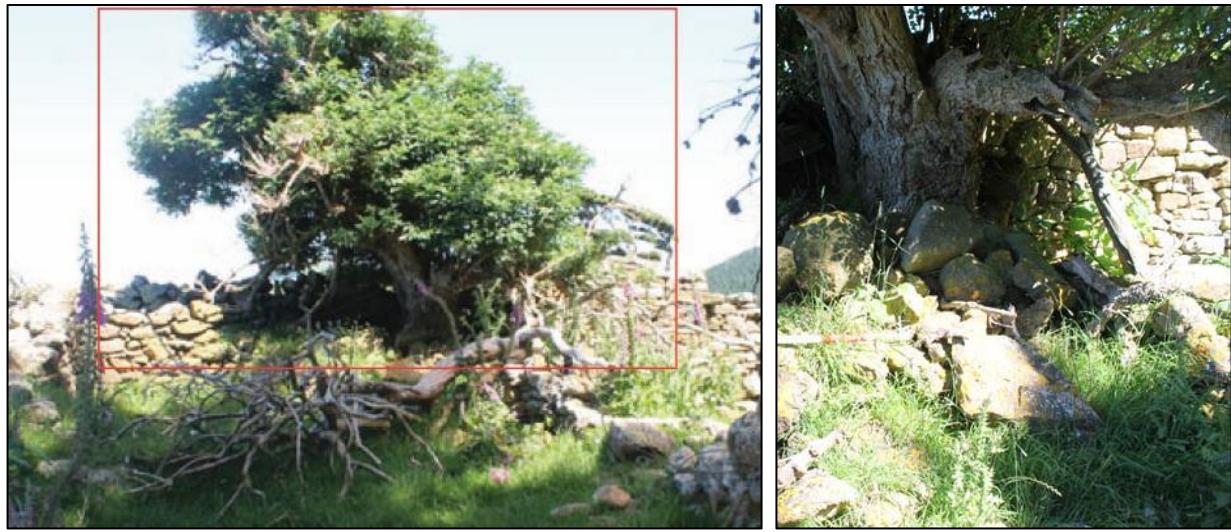
south-western end of Drywall 2 adjoins the eastern wall of the cow byre (see Figure 3). A tree is growing up through the south-west corner of the cow byre and is also damaging Drywall 3. An area directly east of the cow byre was recorded by Webb (2009) as being the footprint of a structure and is shown in the site plan (Figure 3). This area was obscured by vegetation and a fallen tree during the recent field surveys but should be acknowledged to ensure no damage is done to the area if physical conservation work is conducted.

Figure 20. The large tree growing through the south-west corner of the cow byre and Drywall 3, looking south (left); a close-up of the tree, looking south (right).

The vegetation at Rutherford's Farm is the biggest cause of damage to the site, with large macrocarpas growing into each other and dropping large broken branches. The tree growing within the south-east corner of the cow byre will need to be carefully removed. There are several dead trees lying over structures within the site, that will also need to be removed. Grasses, fallen leaves and other ground-based vegetation is obscuring large sections of the stone features making recording of the condition difficult. The large stand of macrocarpas that were planted within the wall boundaries, have now pushed large parts of the wall over. It is suggested that the areas below the macrocarpas should be closed to public access until the trees have been cut back or removed. If any vegetation is removed from a structure, a plan needs to be put into place which will ensure the removal of vegetation will not cause further damage to the structure.

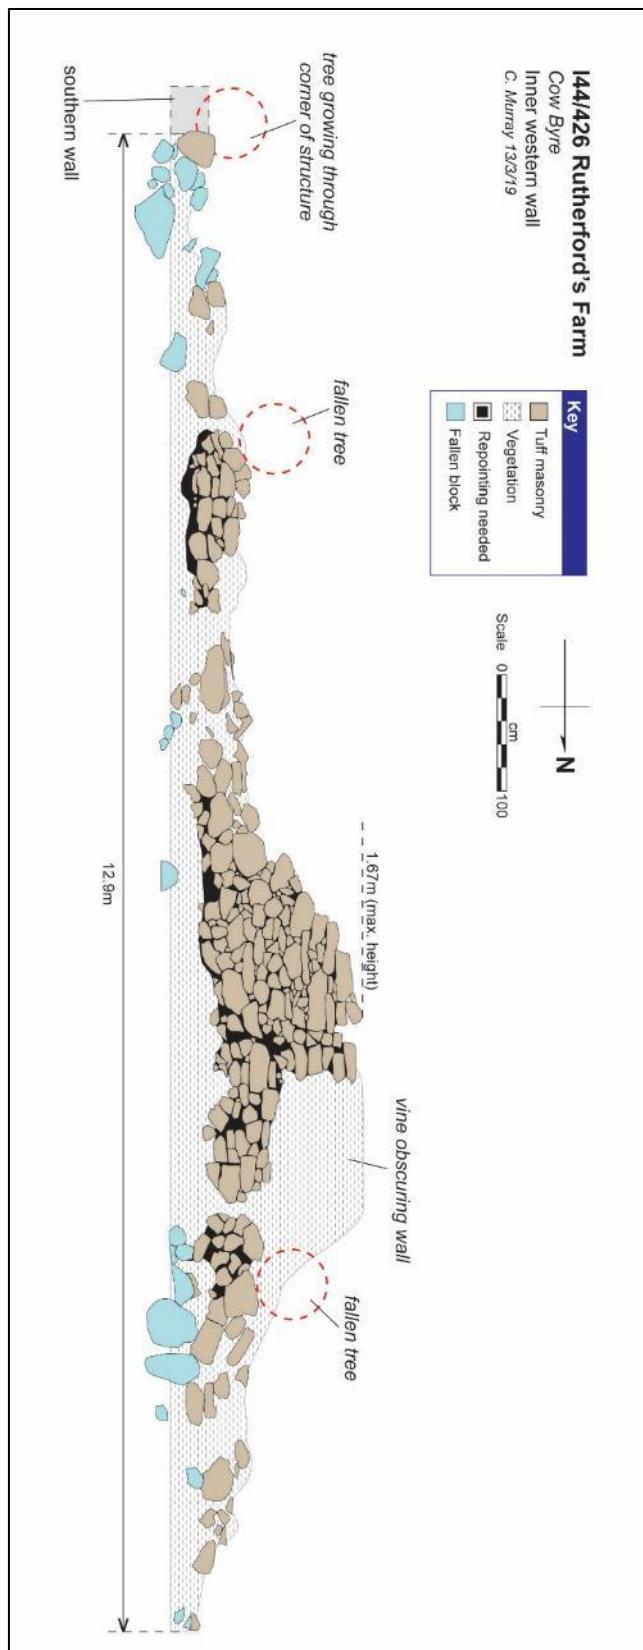
The western wall of the cow byre is approximately 12.9m long, 1.67m high at its highest point, and 60cm wide. An illustration of the inner western wall is offered in Figure 21 and shows the extent of vegetation over this part of the structure. The tree growing in the southern section of wall is discussed above (see Figure 20) and causing the most damage. Two dead trees have fallen over the structure (outlined in red: Figure 21) and will need to be removed. The observable stone work is in relatively good condition, however, the external mortar has been washed out. The blackened areas between the masonry (Figure 21) indicate where mortar has been washed out, also showing blocks which have fallen at the base of the wall (in blue). The central part of the wall offers a good example of the original height of the structure (approximately 1.67m), however, a vine covering the wall is obscuring the stone work.

Figure 21. Inner western wall of the cow byre.

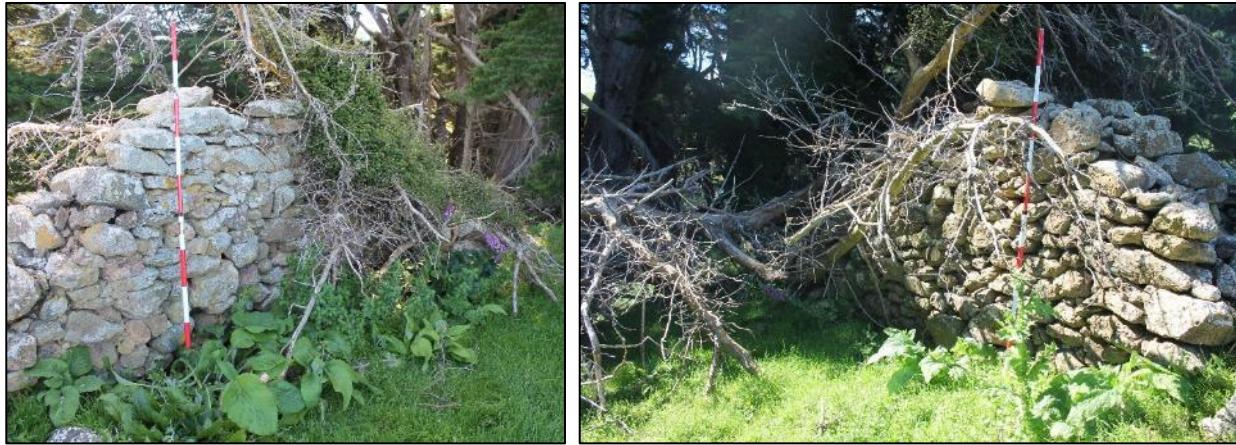
The northern section of the outer western wall was inaccessible due to vegetation and a fallen trees. Figure 22 shows the vegetation coverage of the inner and outer sections of the western wall also exhibiting the large area of this wall which is still intact. Figure 23 shows the thick vegetation obscuring the southern section of the outer western wall.

Figure 22. Northern section of cow byre's western wall with vegetation making some areas inaccessible: inner wall, looking north-west (left); outer wall, looking north-east (right).

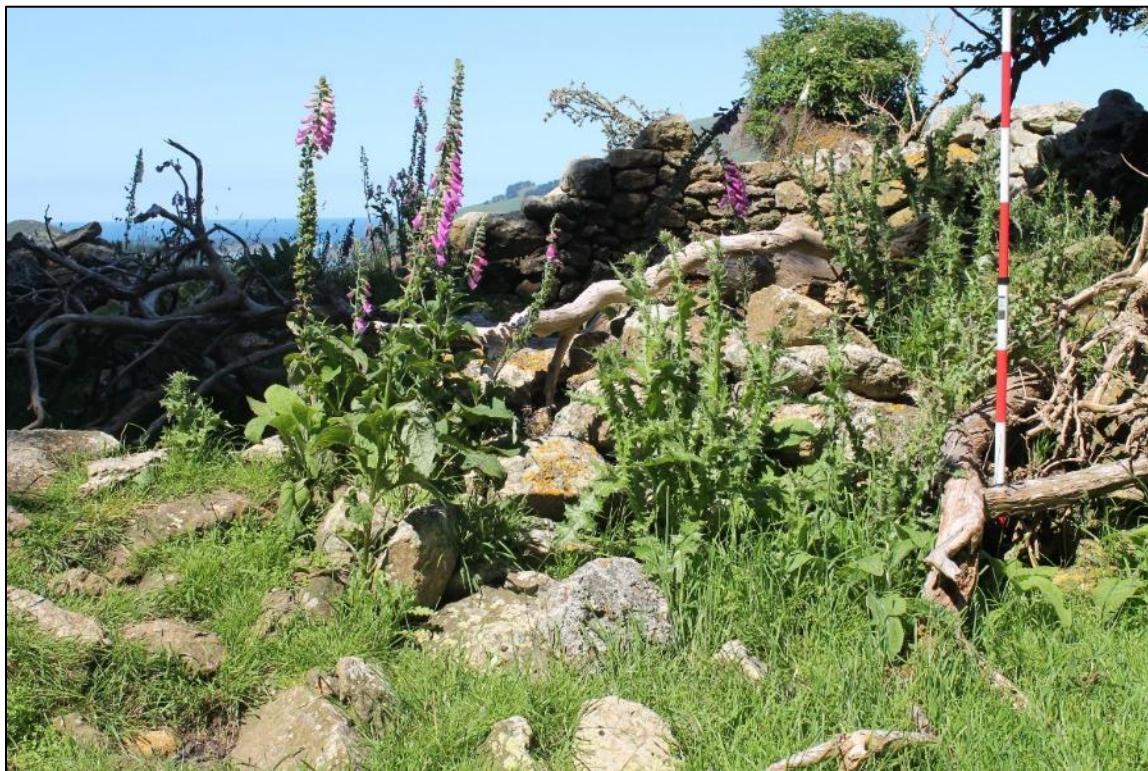
Figure 23. Southern section of the cow byre's outer western wall exhibiting the thick vegetation obscuring this area of the structure, looking south-east.

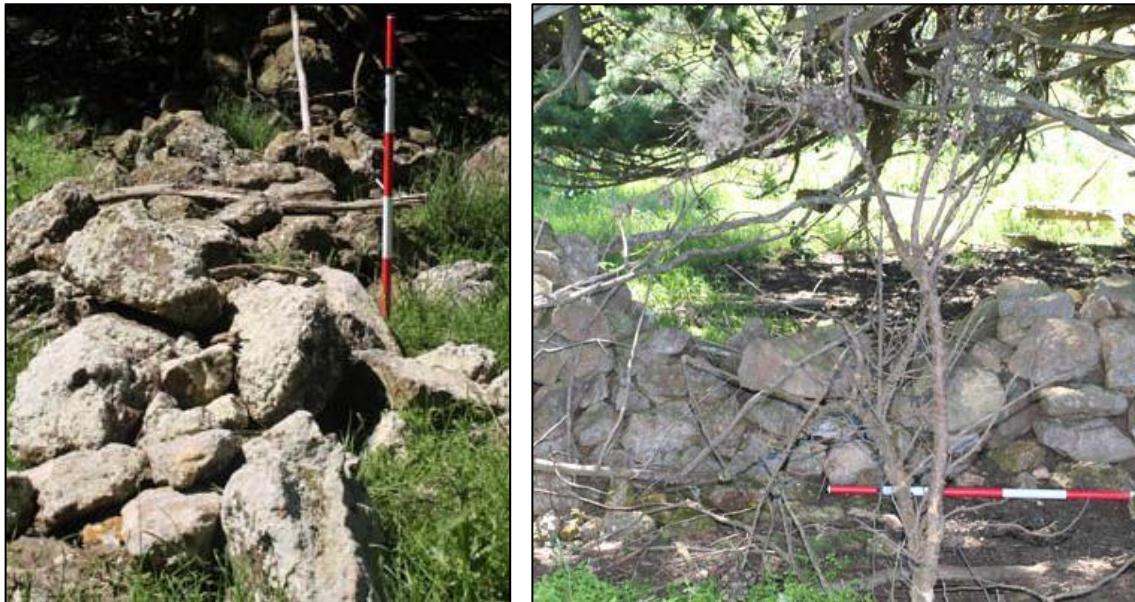
The north-western section of Drywall 1 is approximately 22m long and is oriented north-east to south-west. This part of the wall adjoins to the north-eastern section of Drywall 1 (see Figure 3). This section of wall has a height range of 10cm to 1.2m. A lot of this structure is still intact, with fallen blocks strewn about in the immediate vicinity of the wall (see Figure 24: left). Fallen branches are shown in Figure 24 (right) to be damaging part of the wall. The macrocarpas planted within the wall boundary have pushed a large section of this wall over (see Figure 25).

Figure 24. North-western section of Drywall 1: looking north-east (left); looking north-west (right).

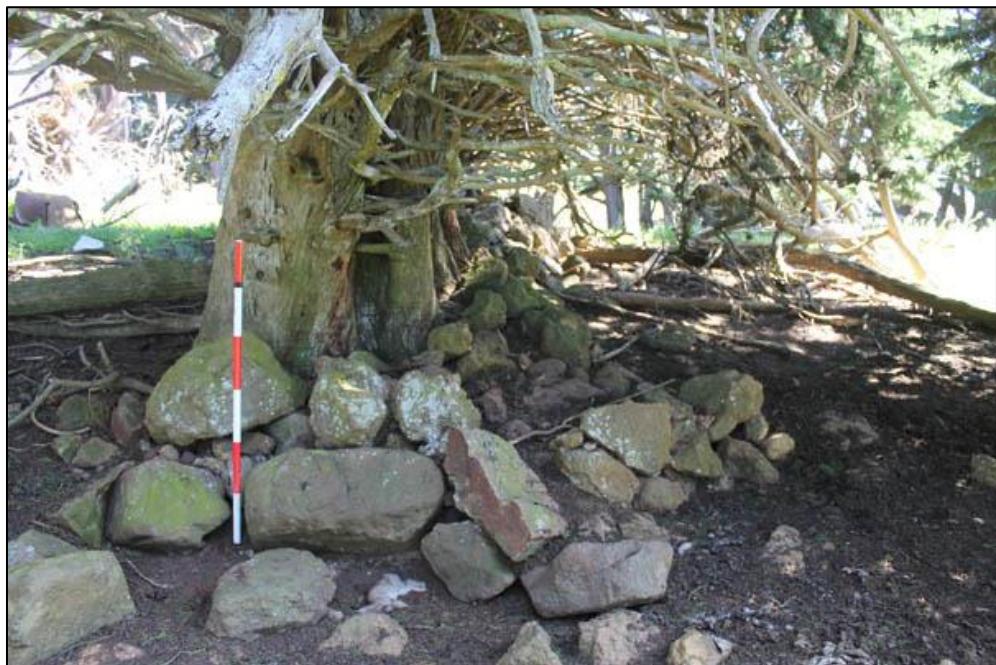
Figure 25. North-western section of Drywall 1 showing the damage caused by macrocarpa growth, looking south-west.

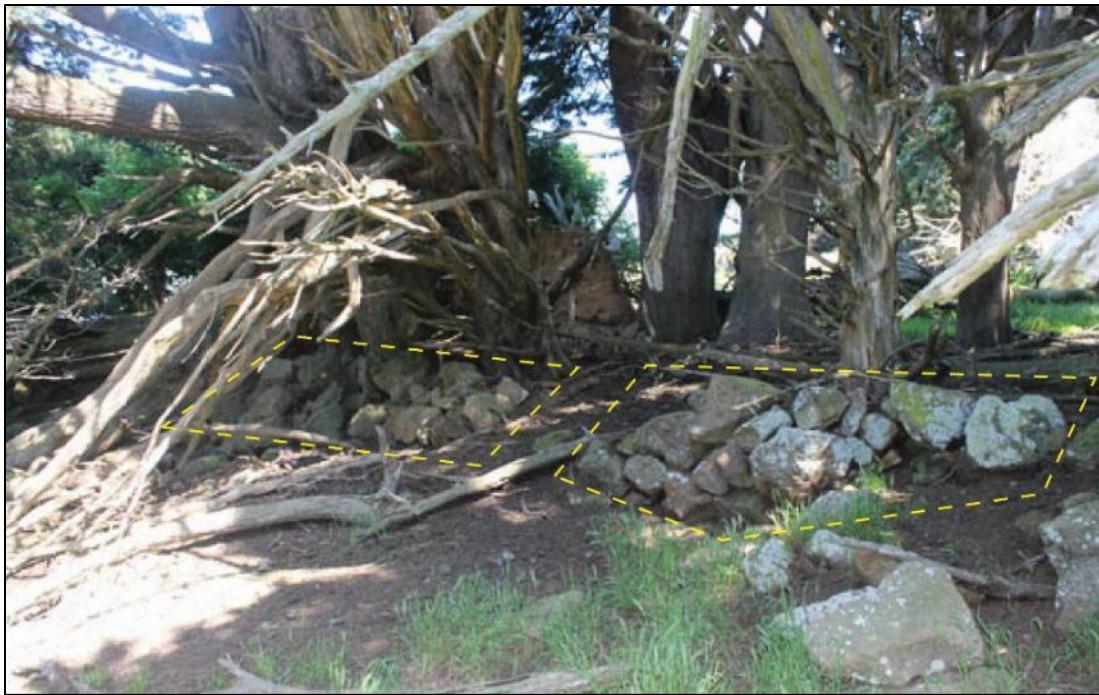
The north-eastern section of Drywall 1 is approximately 15m long and is oriented north-west to south-east. This part of the wall adjoins to the north-eastern and south-eastern sections of Drywall 1. This section of wall has a height range of 20cm to 80cm. Figure 26 displays the remaining parts of the section of wall outlined in the yellow dashed line. Fallen blocks from the wall can be seen in the foreground. There was possibly a gate in the gap between the two remaining sections of this wall.

Figure 26. North-east section of Drywall1 (looking south).
