Condition Report: Rutherford's Farm (I44/426)

By Carl Murray and Stuart Griffiths (March 2019)

**Report for Hereweka/Harbour Cone
Management Trust**

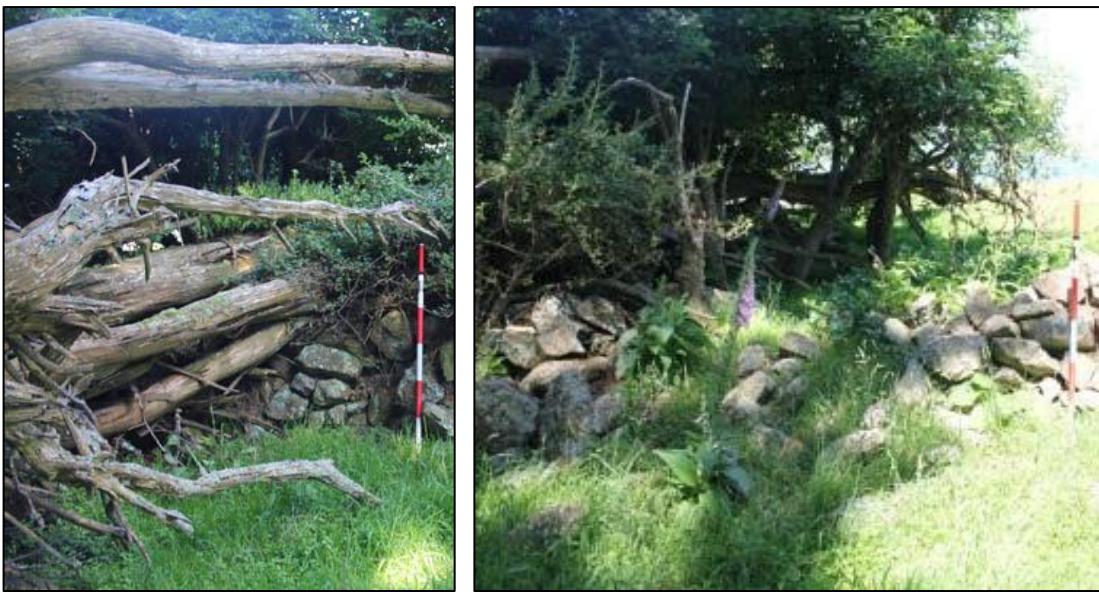
The south-eastern section of Drywall 1 is approximately 16m long and is oriented north-east to south-west. This part of the wall adjoins to the north-eastern section of Drywall 1 and has a height range of 15cm to 1.35m. Figure 27 (left) exhibits a fallen tree on the north-eastern end of the wall as well as a small shrub (behind the stadia pole) which is growing out of the wall. A gap in the wall approximately 1.5m wide Figure 27 (right) may have been another access way to the section. A large section of this wall is in excellent condition with tilted coping stones still capping the structure (Figure 28). A vine is covering part of the wall and is likely aiding in protecting it from weathering and livestock damage. However, due to the wall having no mortar adhering the stone, the vine is

Figure 27. South-eastern section of Drywall1, looking south-east (left); a gap in the wall which may have been an access way (right).

likely to grow within the structure dislodging the stonework over time and should therefore be removed.

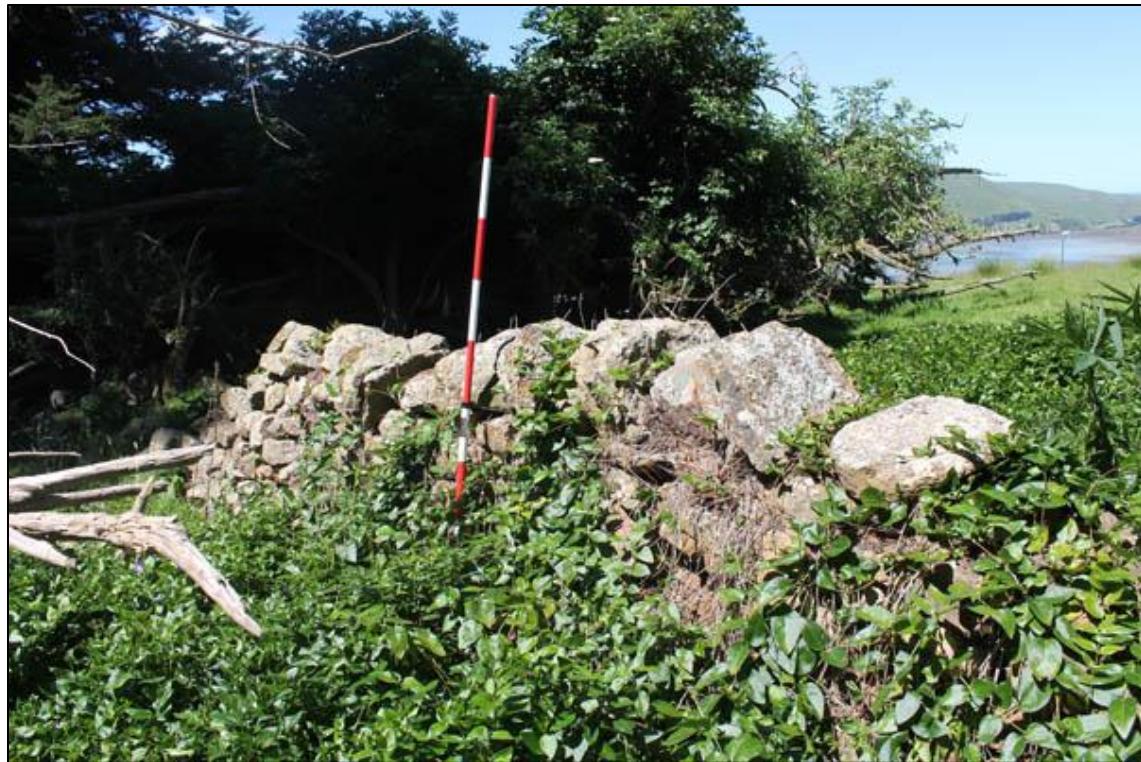
Figure 28. South-eastern section of Drywall1, looking east. Note the coping stones are still capping a large section of this wall.

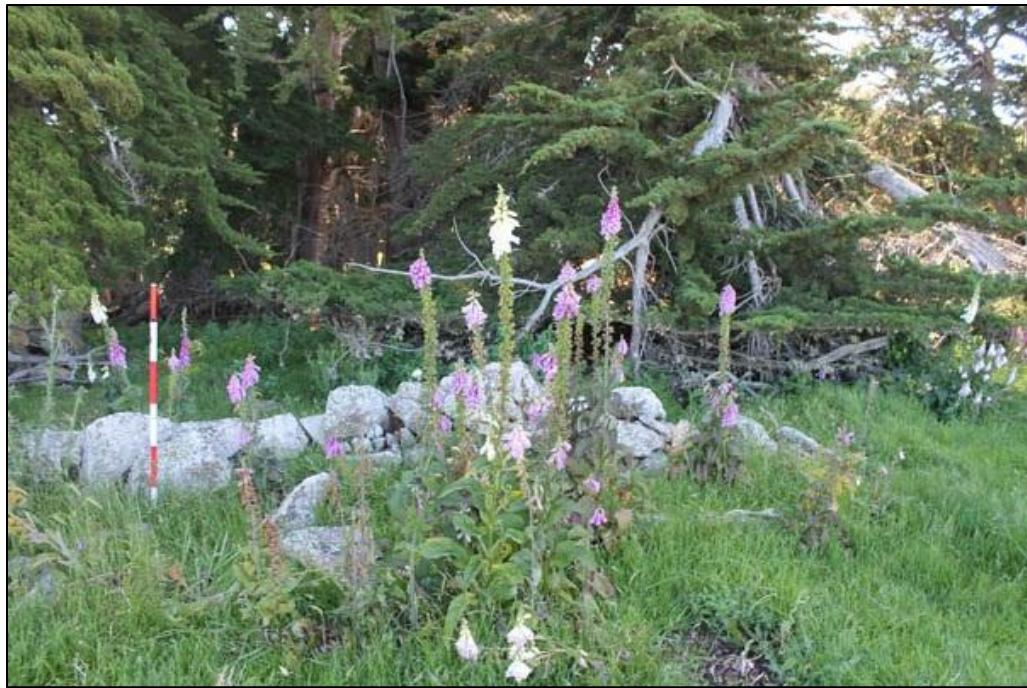
Drywall 2 (see Figure 29 to 31) is oriented north-east to south-west and is approximately 20 metres long. The south-western end of this wall is adjoined with the eastern wall of the cow byre (see Figure 3 and Figure 31). The large blocks observed at the intersection of the two structures suggest a gate support may have been built into the wall. The maximum height of Drywall 2 was approximately 63cm and the minimum was 10cm where only one course of the wall could be observed. A lot of the damaged areas of the wall exhibit fallen blocks within the vicinity. Damage to this structure has likely been caused by falling branches from the nearby macrocarpas.

Figure 29. North-eastern section of Drywall 2, looking north-west.

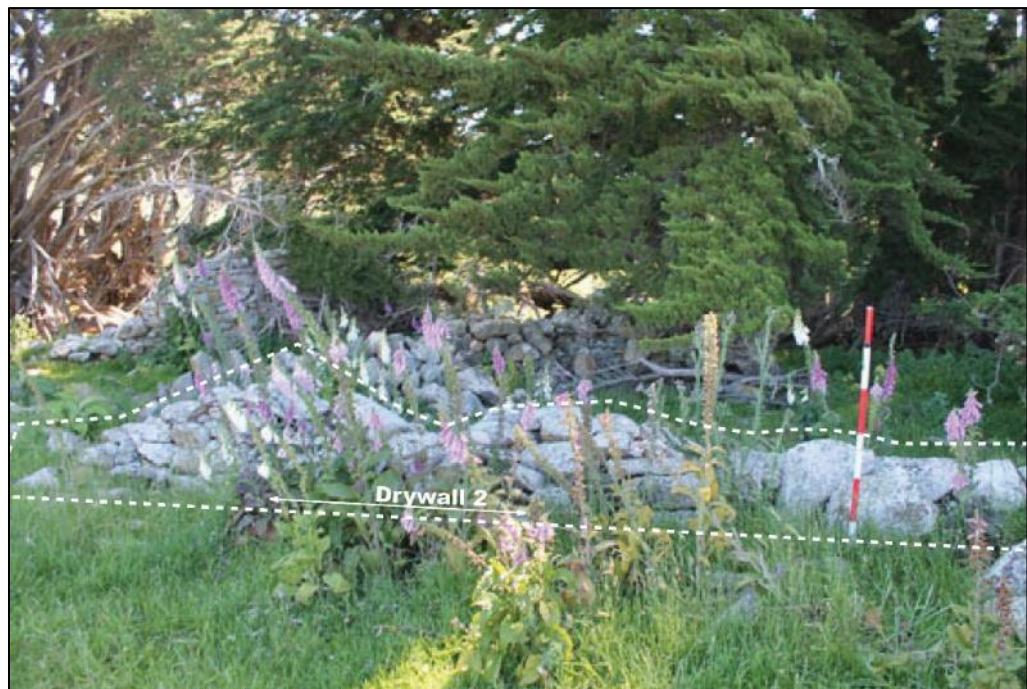
Figure 30. Drywall 2: looking south-west. Note the cow byre in the background.

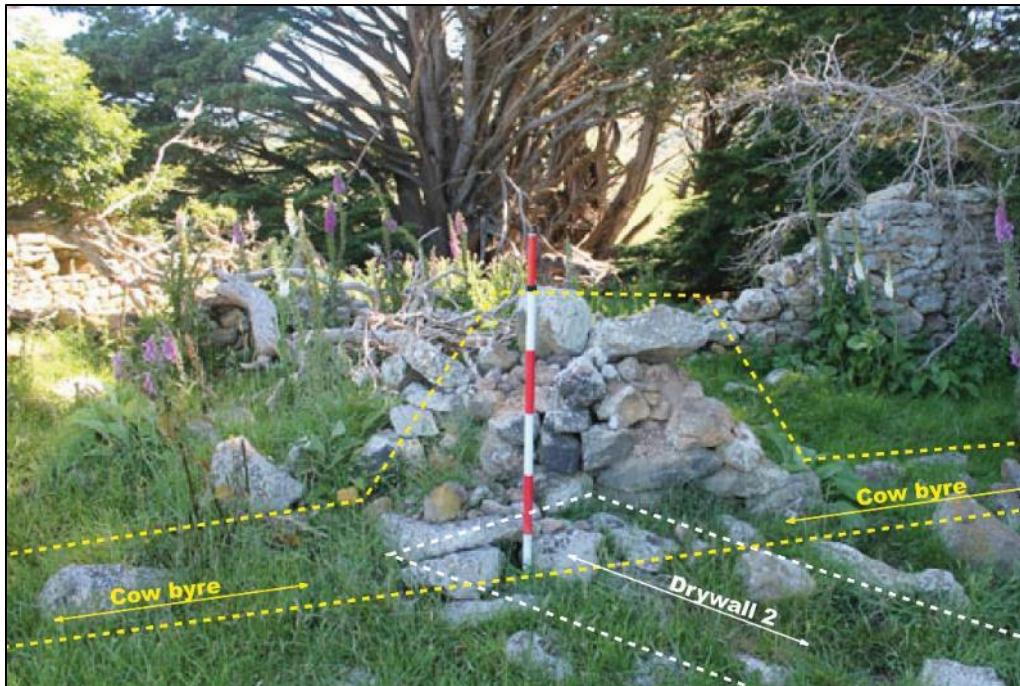
Figure 31. The south-western end of Drywall 2 that adjoins with the eastern wall of the cow byre.

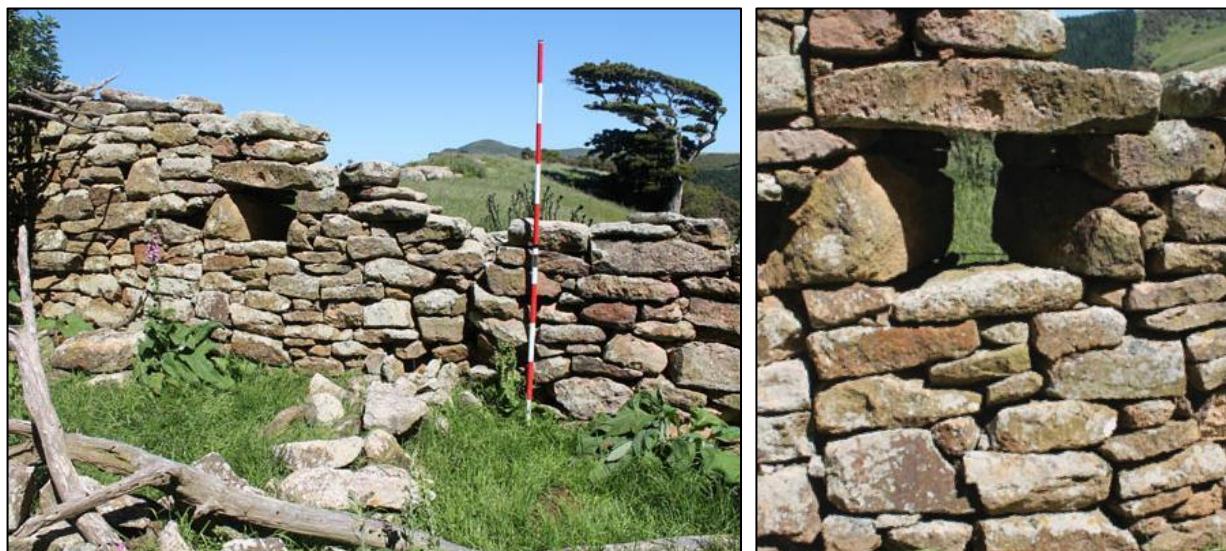
Figure 32. Inner section of Drywall 3, looking south. The small window built into the wall (right).

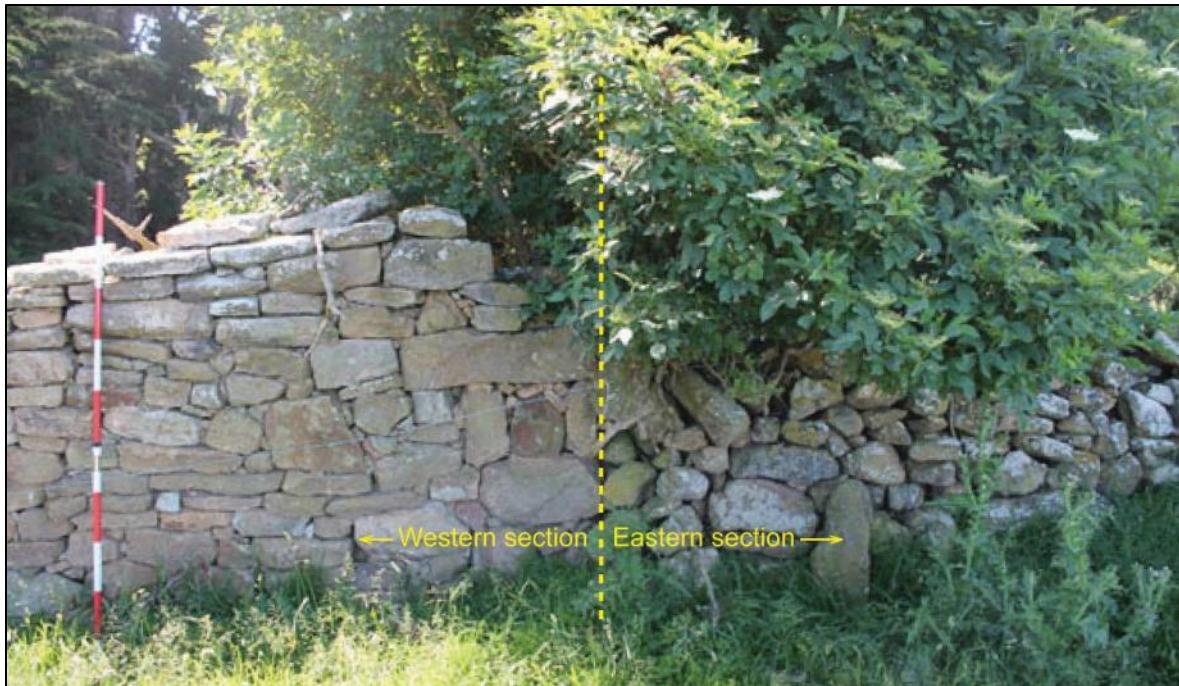
Figure 33. Drywall 3: two separate methods of construction are exhibited either side of the yellow dashed line, looking north.

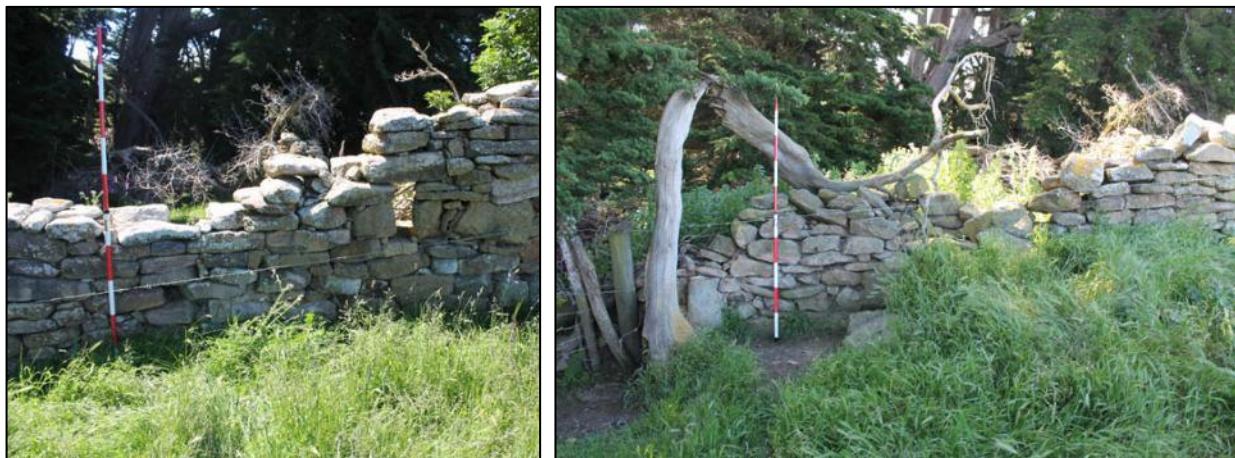
Figure 34. The western section of Drywall 3, looking north; a tree has fallen on the western end of the wall (right).

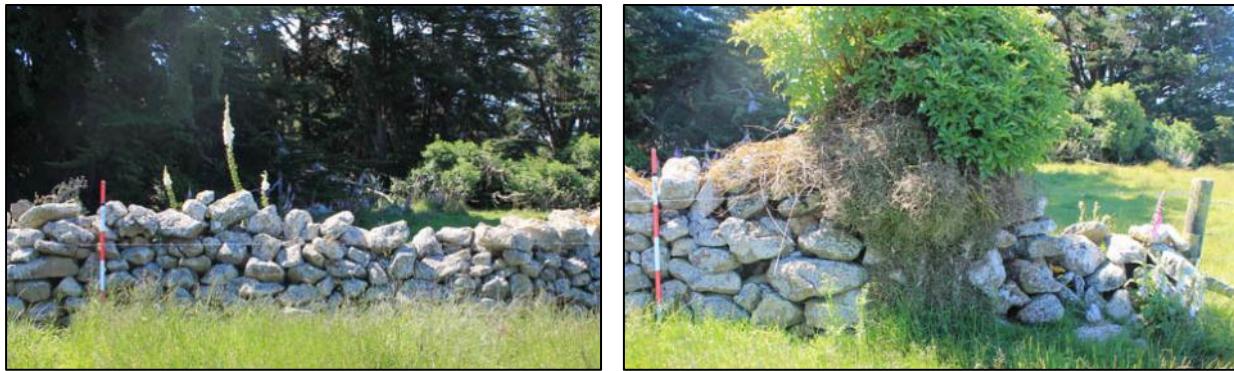
material used to build this wall has possibly been taken from the house site or the byre due to the quality of the hewn stone used, with some specimens exhibiting the fine chisel marks observed on some of the blocks still extant in the homestead. Figure 34 shows the western section of wall looking north. A tree has fallen on the western end of the wall (see Figure 34: right) and will need to be removed. The eastern section of Drywall 3 is approximately 17 metres long and has a maximum height of 1.2 metres. This section of wall is still largely intact with fallen stones still within the vicinity of the structure. A small tree is growing out of the eastern end of the wall (see Figure 35: right) and will need to be removed.

Figure 35. The eastern section of Drywall 3, looking north (left); a small tree growing out of the eastern end of the wall (right).

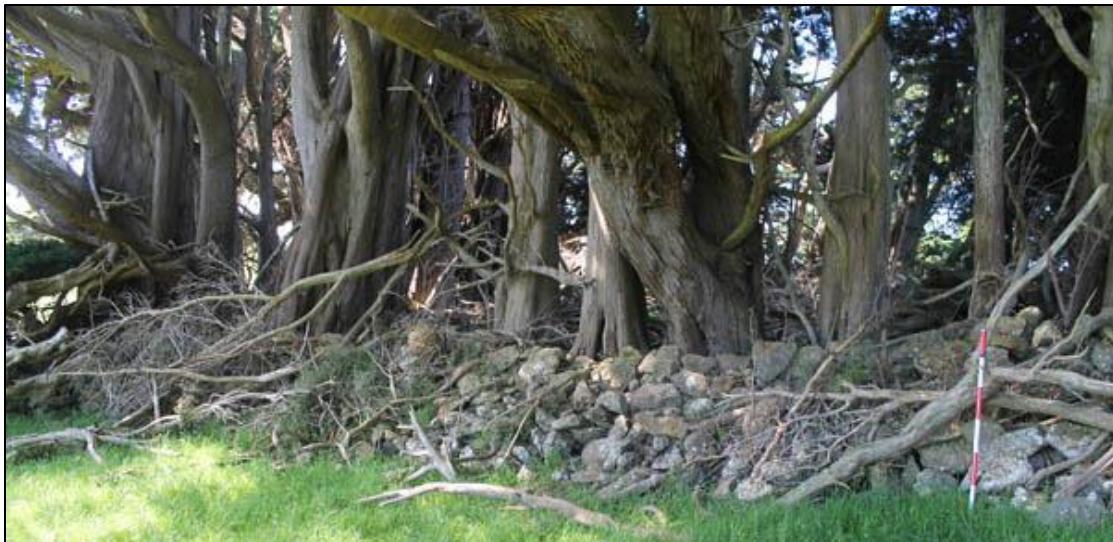
This wall has been badly damaged by macrocarpa trees which are dropping large branches onto the feature, causing sections of the wall to collapse (see Figure 36). The macrocarpas, which were planted inside the wall, have overgrown areas of the structure causing it to bulge outward (Figure 37). For this reason, a lot of the stones dislodged from the wall are strewn about the western base of the wall.

Figure 36. Drywall 4: northern section of the wall with macrocarpa tree branches fallen onto the structure causing massive damage.

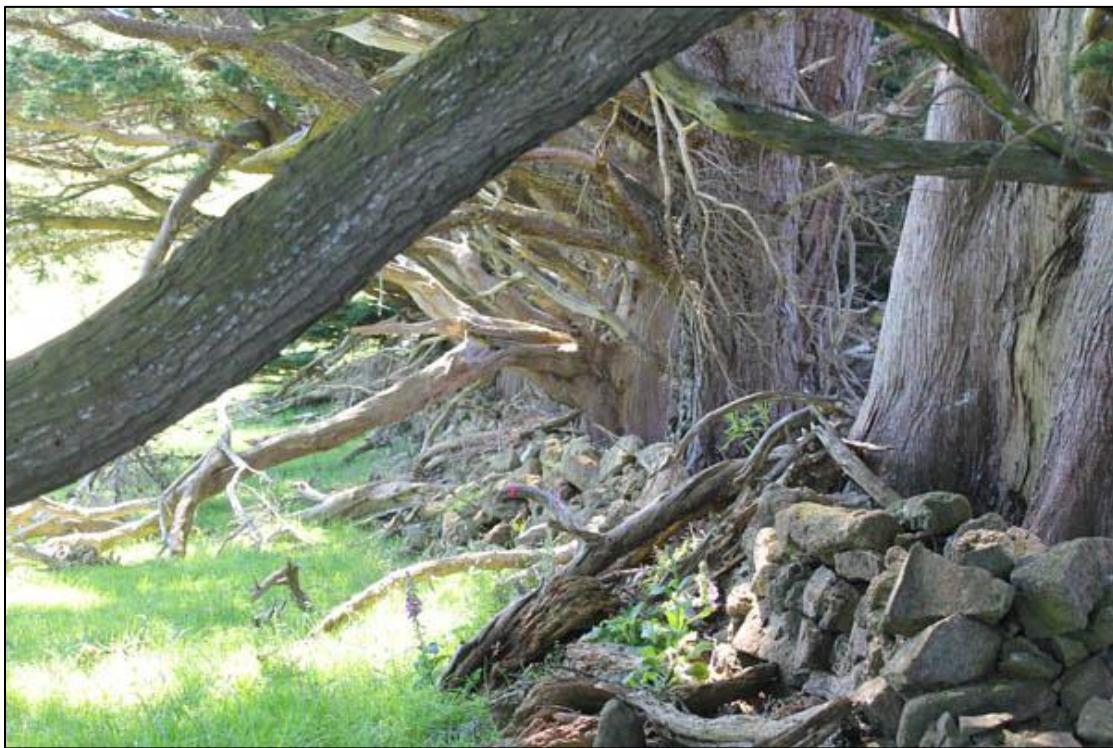
Figure 37. Drywall 3: macrocarpa growth pushing the wall outward.
