LARNACH'S FARMSTEAD
OTAGO PENINSULA
DUNEDIN
SITE I44/412

ARCHAEOLOGICAL REPORT ON
WOOLSHED BUILDING
FOR
HEREWEKA/HARBOUR CONE TRUST
ARCHAEOLOGICAL AUTHORITY 2017/521
REVISION 1

P.G. PETCHEY
SOUTHERN ARCHÆOLOGY LTD.
2018

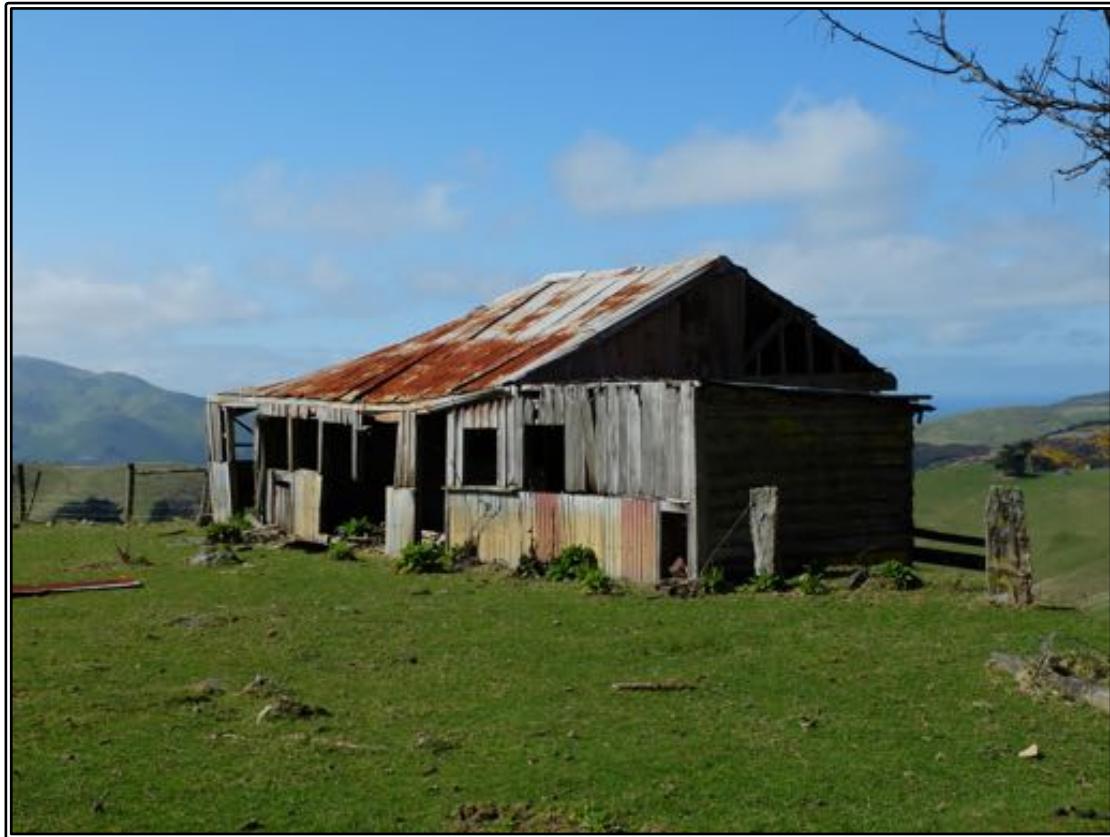
Figure 2
The small woolshed at the Larnach farmyard in September 2016.

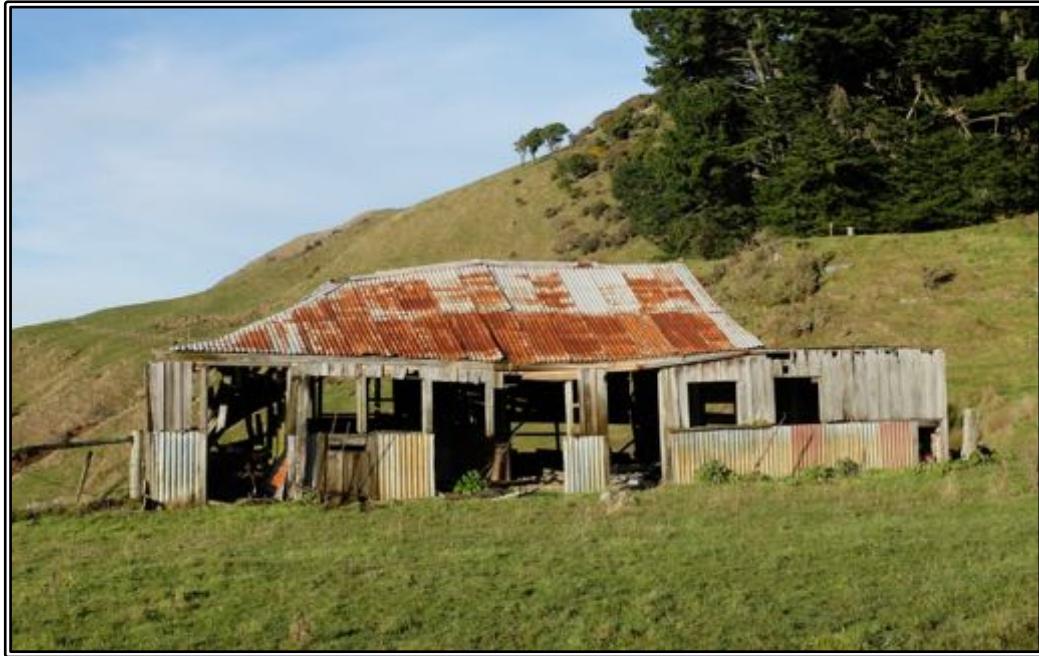
Figure 12
The front of the building in 2017.

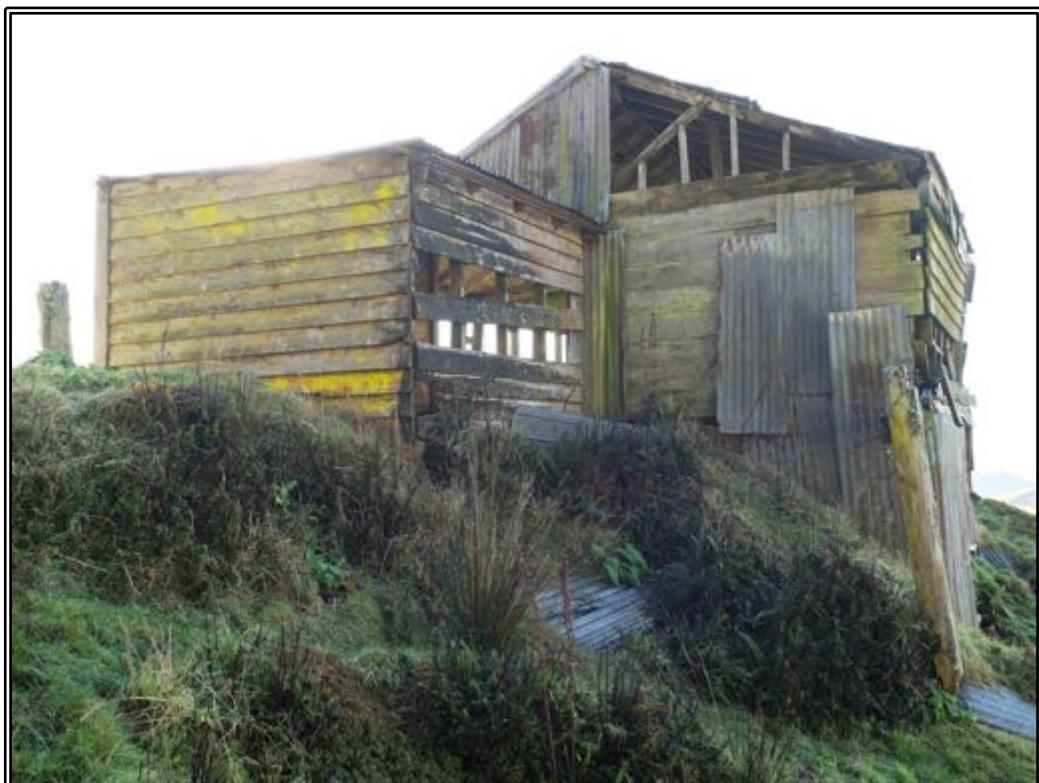
Figure 13
The western end wall in 2017.

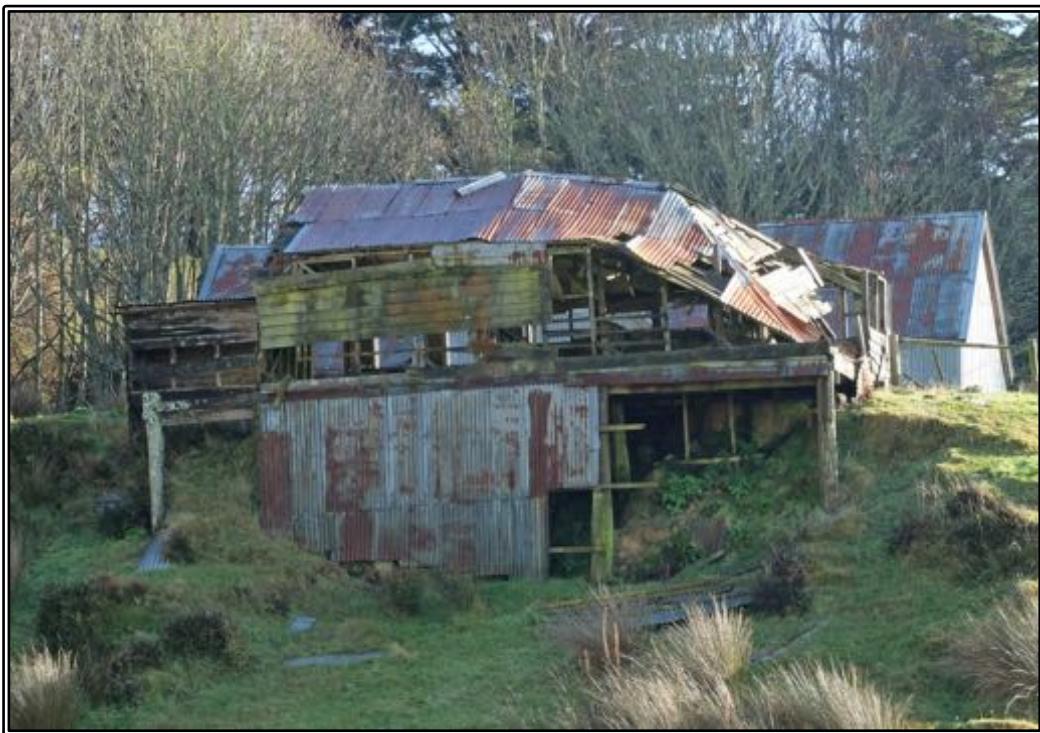
Figure 14
The rear wall in 2017.

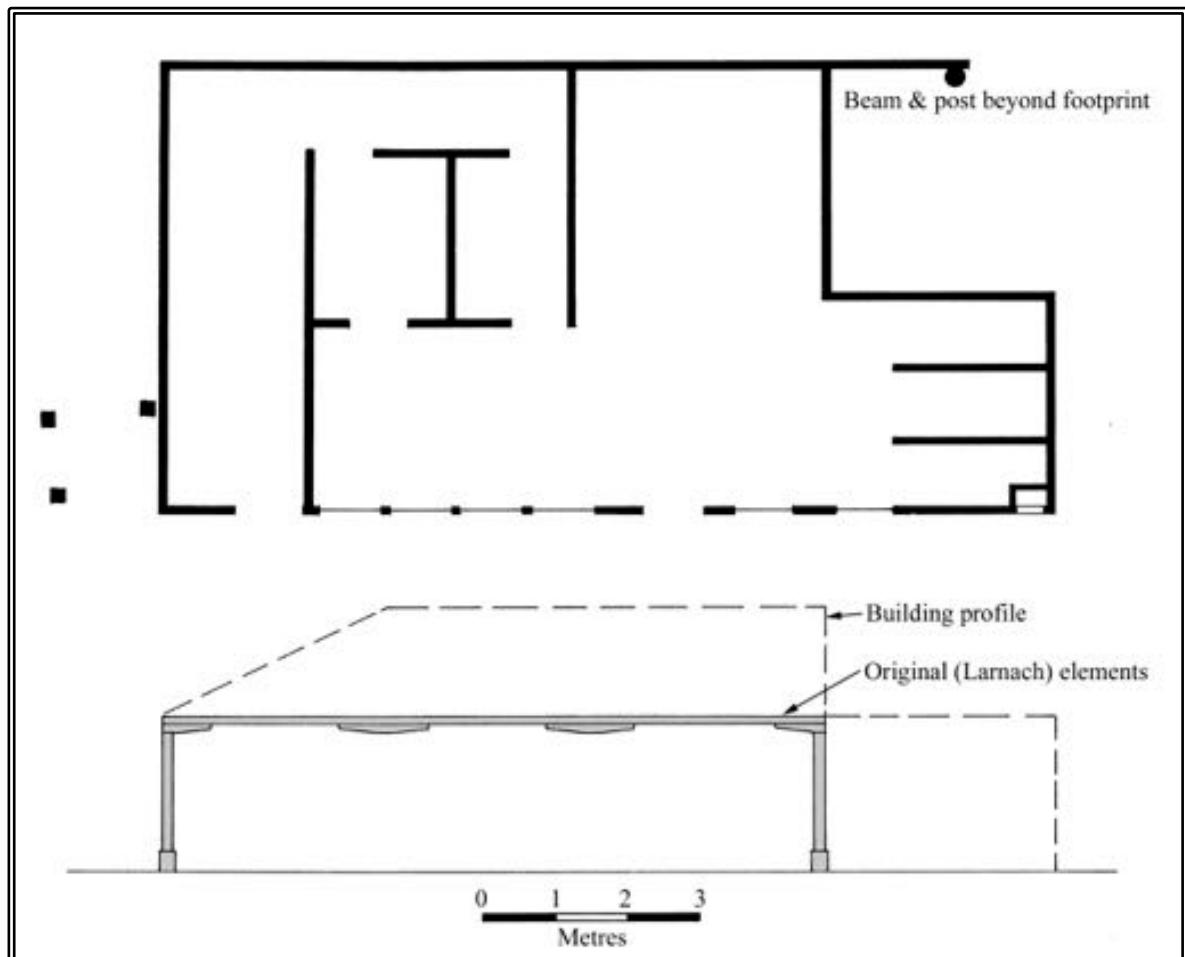
Figure 16

Floor plan (top) of the building as it stood in 2018. The three piles to the left are those that were investigated by archaeological excavation in 2018 (see discussion below). The elevation (bottom) shows the building profile (dashed lines) as it was prior to the roof collapse, and the only surviving original (Larnach-era) elements that were identified during the analysis work.

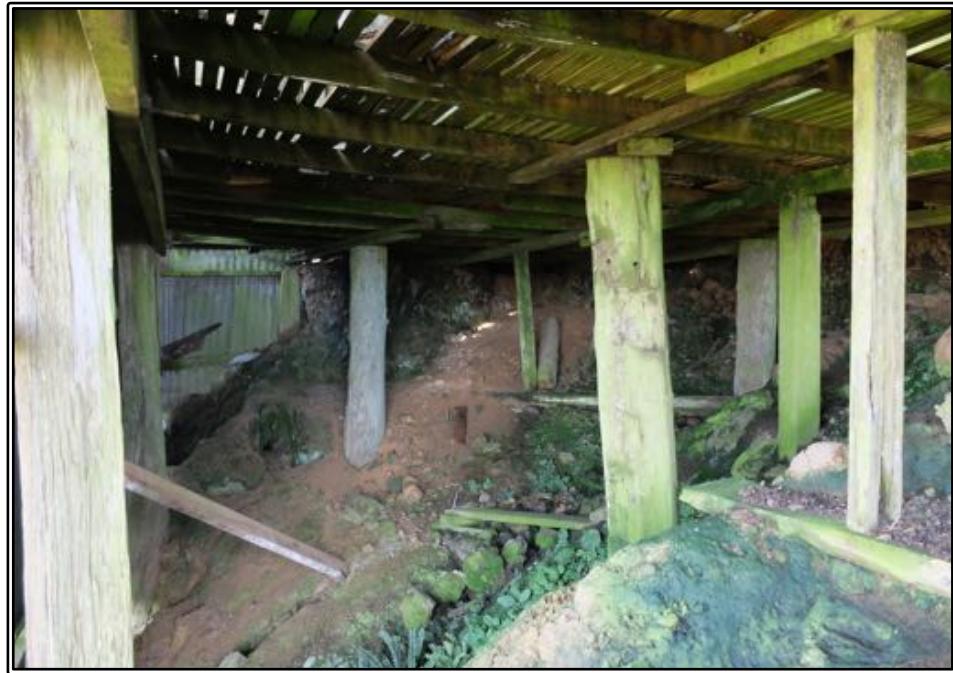
**Figure 19**

Underfloor view, showing the posts of various sizes that supported the building, the lightweight floor framing, and the steep ground surface.

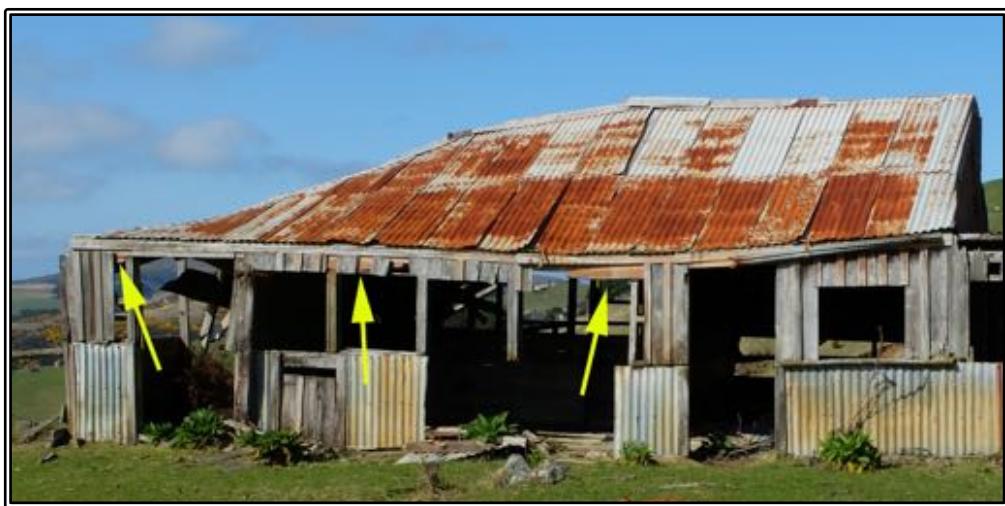
Figure 25

The front of the building had a different construction, and consisted of a substantial beam (5.75 inches by 4 inches) that had originally been supported by posts (6 inches x 5.5 inches, set into timber piles) and corbels (4 feet long) (arrowed in Figure 25). However, only the outer two posts remained in place, and the corbels associated with these two posts had both been cut off short. The shortened corbels suggest that the building once extended further to both the east and west (the west extension was shown in the 1942 aerial photo). The eastward extension was investigated archaeologically (see discussion below). In addition, another corbel was found repurposed as a post below the building (see Figure 20 above), suggesting that more of the structure had been dismantled in the past. Another conundrum was that three of the surviving in situ corbels had mortices to match the tenons on the tops of the posts (see Figure 28), but one corbel was blank with no such detail, suggesting that its associated post was just butted beneath it. The repurposed corbel (Figure 20) also had no mortice. The corbels that did have mortices matched mortices in the beam, indicating that the relative locations of the surviving in situ elements were original to those elements. Other lightweight studs had been added into the structure to support the sagging top plate (due to the removal of the original posts) and to provide framing for the corrugated iron and board & batten cladding.

The three visible original timber corbels in the front wall of the building (arrowed) prior to stripping of the remaining cladding.

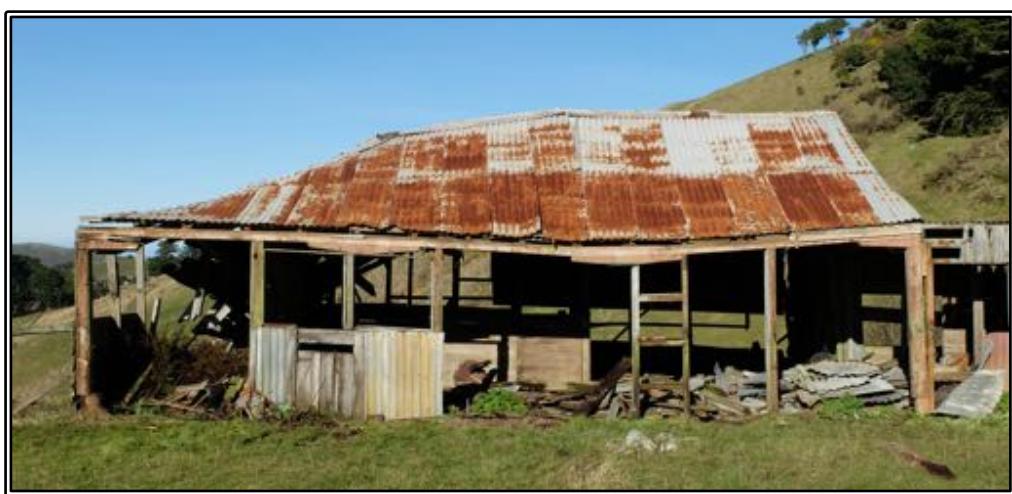
Figure 26

The front of the building after much of the cladding was stripped, exposing the two remaining posts (at either end of the main structure) and four corbels.

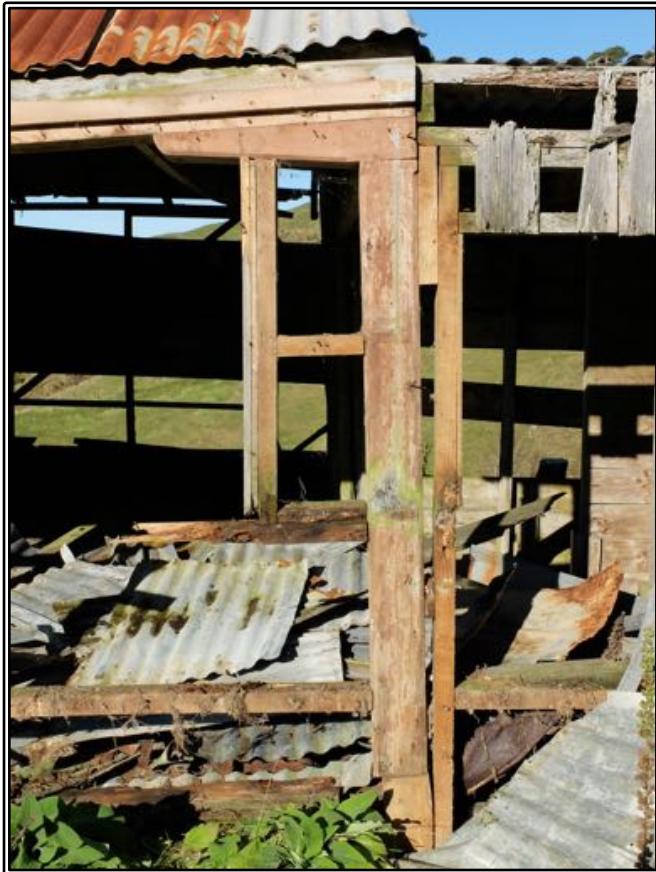
Figure 29

The westernmost intact post and the cut corbel that it supported. Note the base of the post is set into a timber pile.

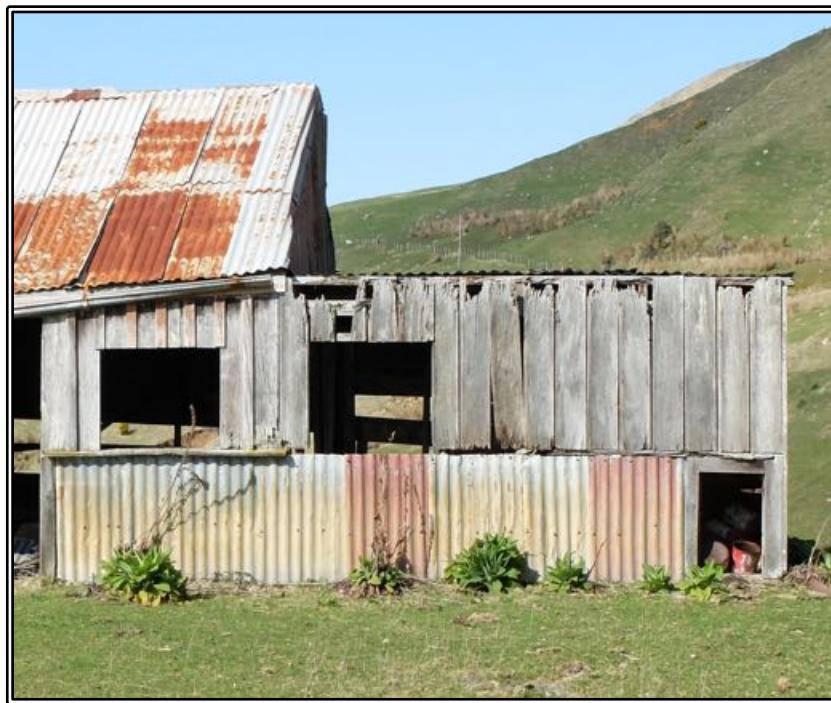
Figure 31

A detail of the board and batten and corrugated iron cladding on the western end of the main building, and the vertical boards on the western extension, in 2016.

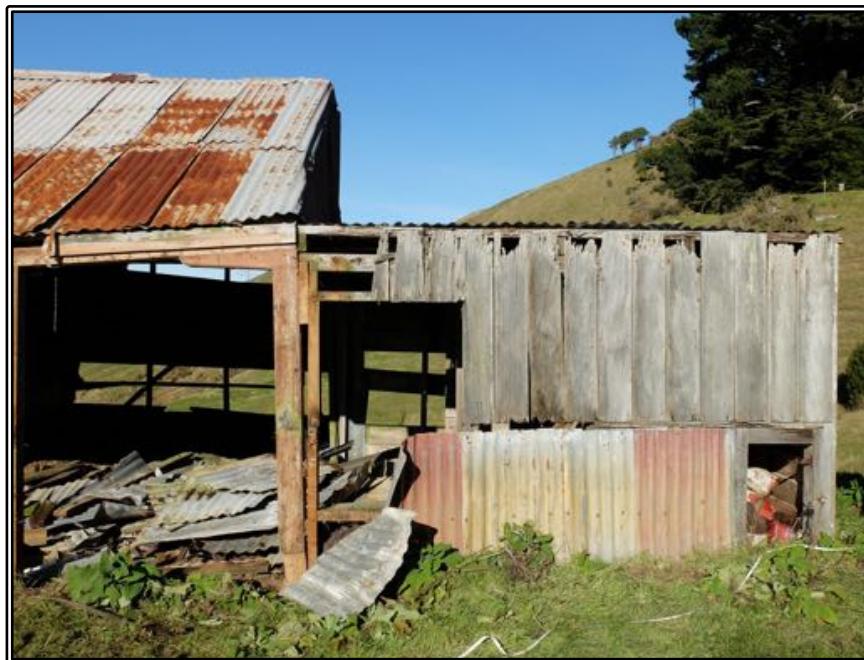
Figure 32

The same area of the building after the cladding had been stripped off the main building, showing how the extension was added to the main structure.

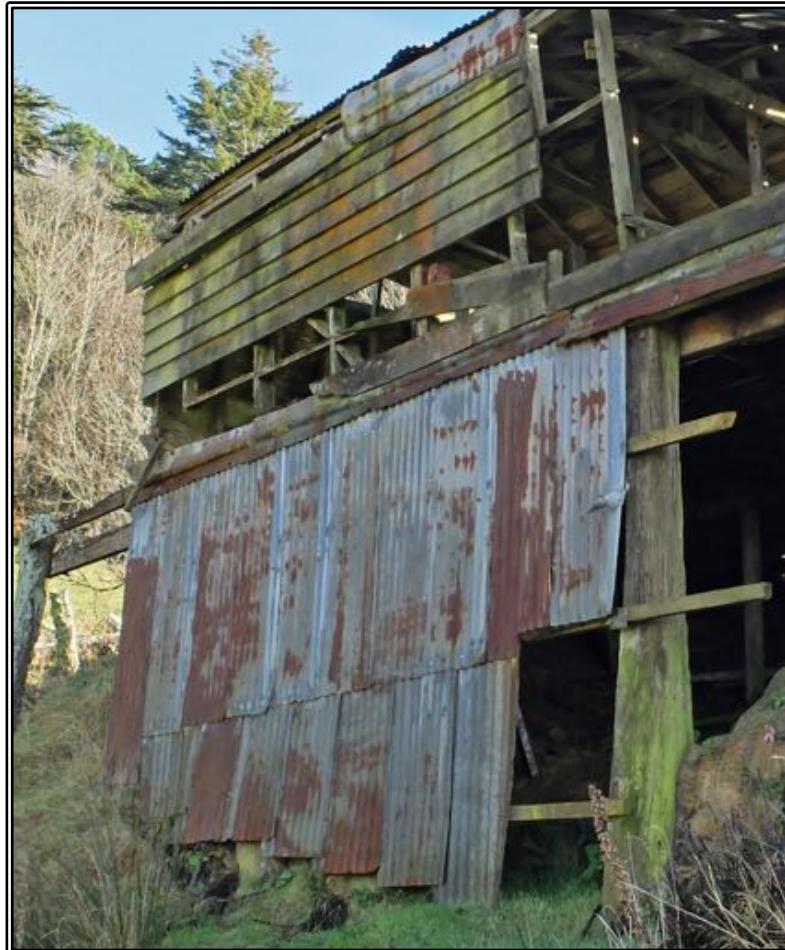
The large area beneath the building was enclosed using corrugated iron attached to a light timber frame attached to the main rear posts of the foundation structure (Figure). Over a third of this cladding had come away from the building and was lying on the ground.

Figure 33
A view of the rear of the building, showing the corrugated iron cladding covering the sub-floor area, and the weatherboards on the wall of the building.

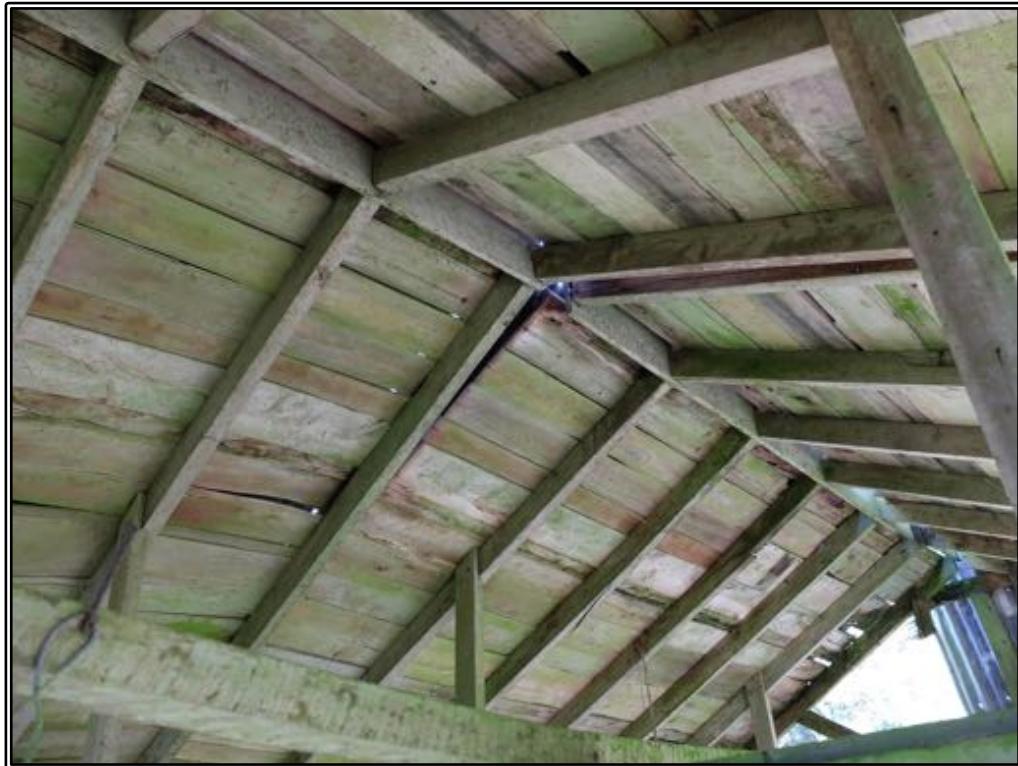
Figure 34
The roof framing, showing the rafters and sarking.

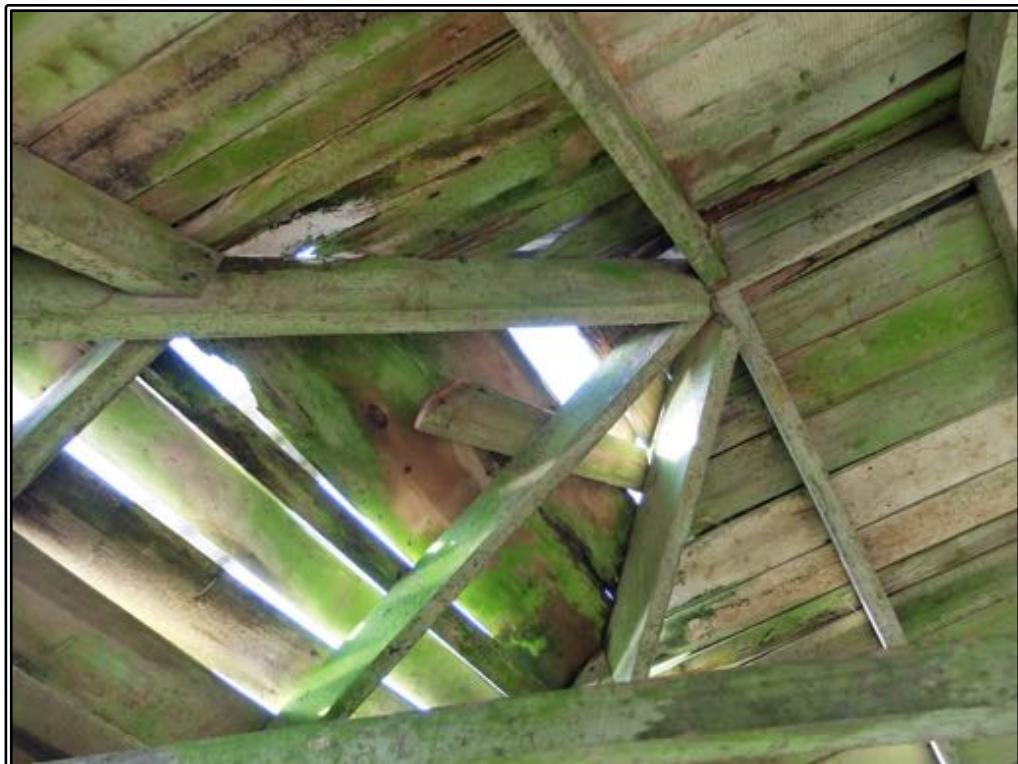
Figure 35
Detail of the ridge structure at the hipped end of the roof.

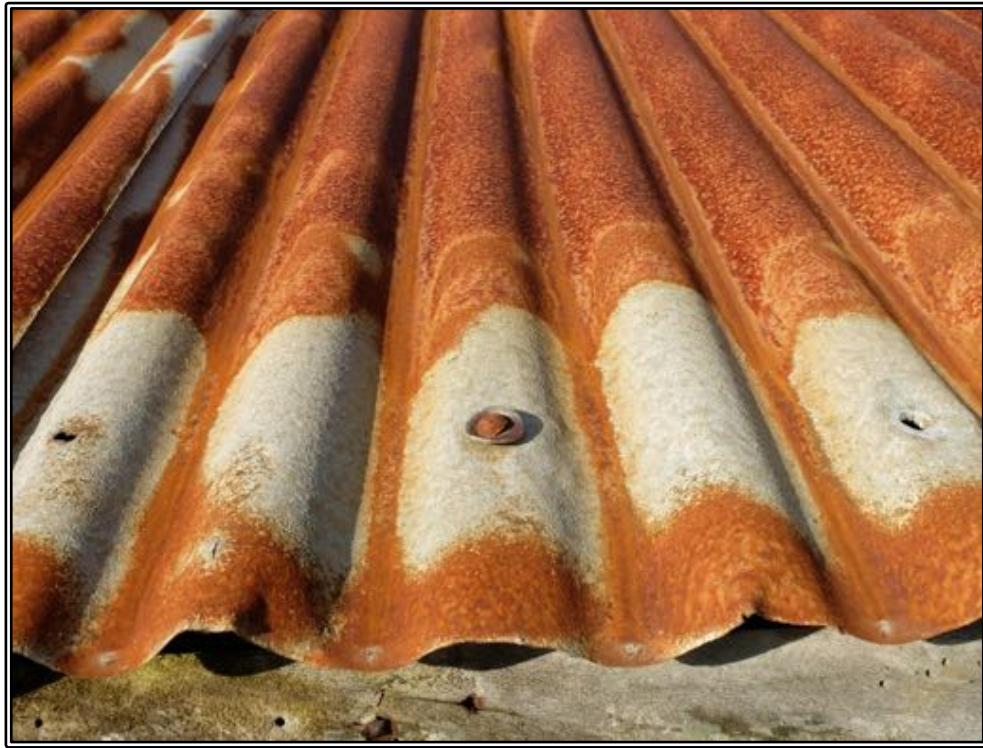
Figure 36

Detail of the corrugated iron roof cladding, showing the lead-washer roofing nails that were used to fix the iron.

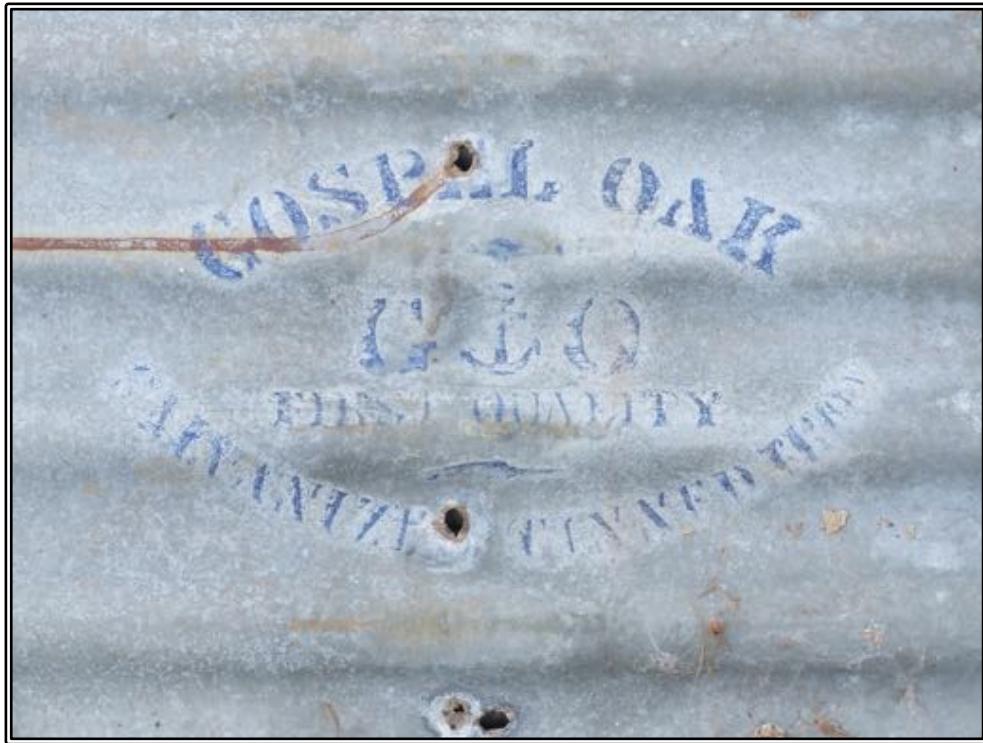
Figure 37

Detail of the maker's mark on one sheet of iron (all sheets inspected were from the same maker); 'Gospel Oak, Best Quality, Galvanized Tinned Iron.'

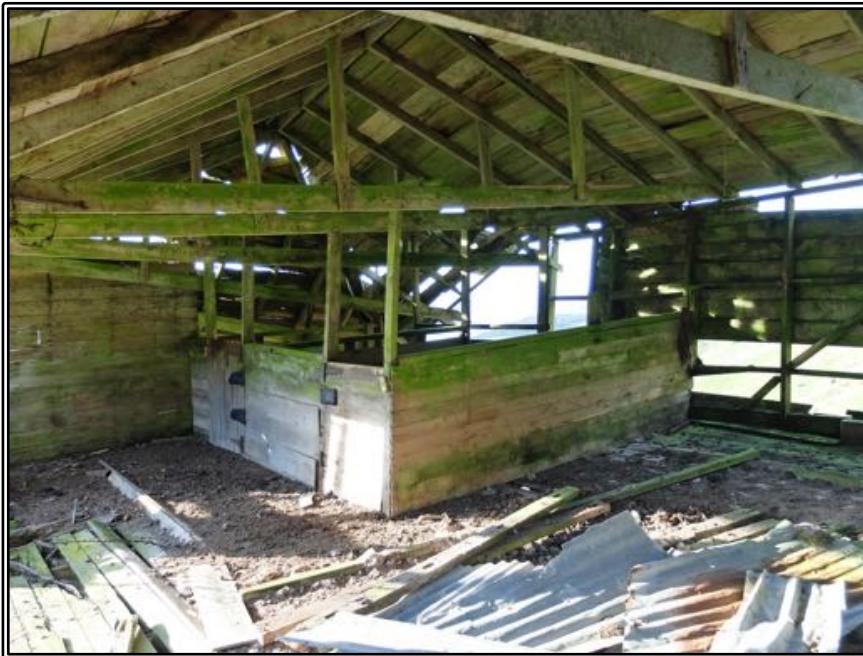
Figure 40
The interior of the building, showing the pens at the eastern end.

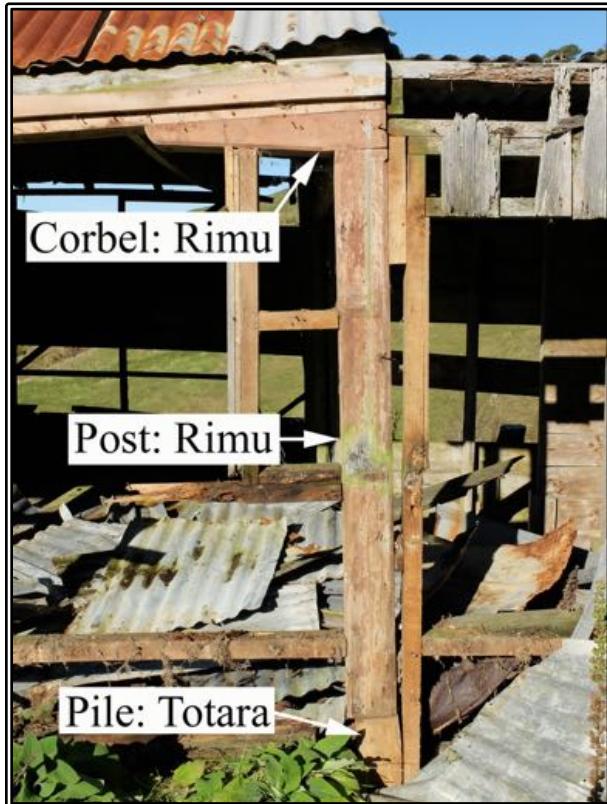
Figure 41

The mixture of timbers is notable. The front piles, posts and corbels are interpreted as original elements of the building (see discussion below), and are consistent with contemporary structural uses of timber: totara for the ground-contact piles and rimu for the framing (Figure 41).

Annotated detail of post and corbel at the front of the building, showing the timbers utilised.

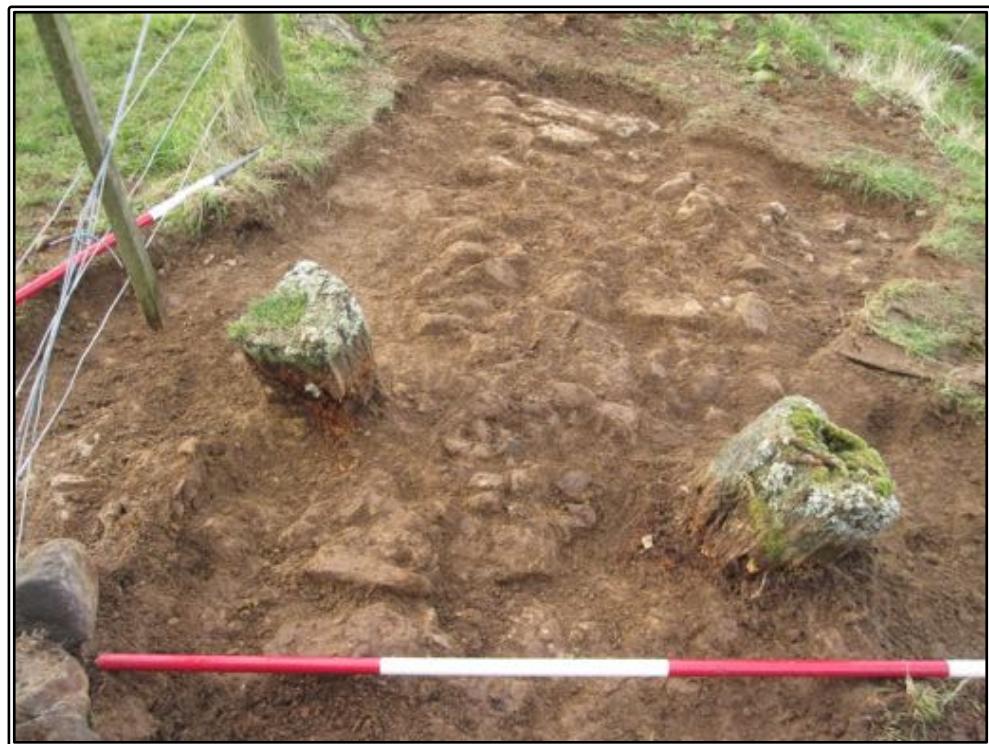
Figure 44

This excavation revealed a rough rubble surface with three timber piles set into the ground (Figures 43 and 44), suggesting that the building once extended 5 feet (1.5m) further in this direction (see Figure 16 above). The excavation also found a small amount of artefactual material, including a bottle and a file (discussed in more detail below).

Another view of the timber piles and rock rubble surface.

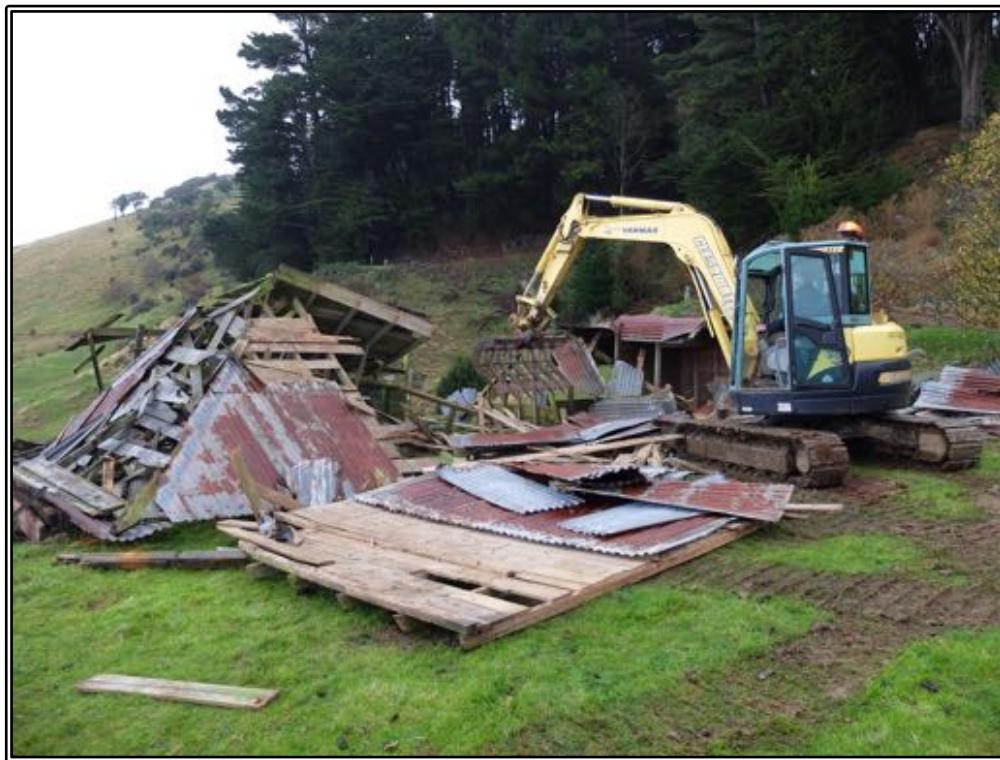
Figure 46
The building superstructure during demolition.

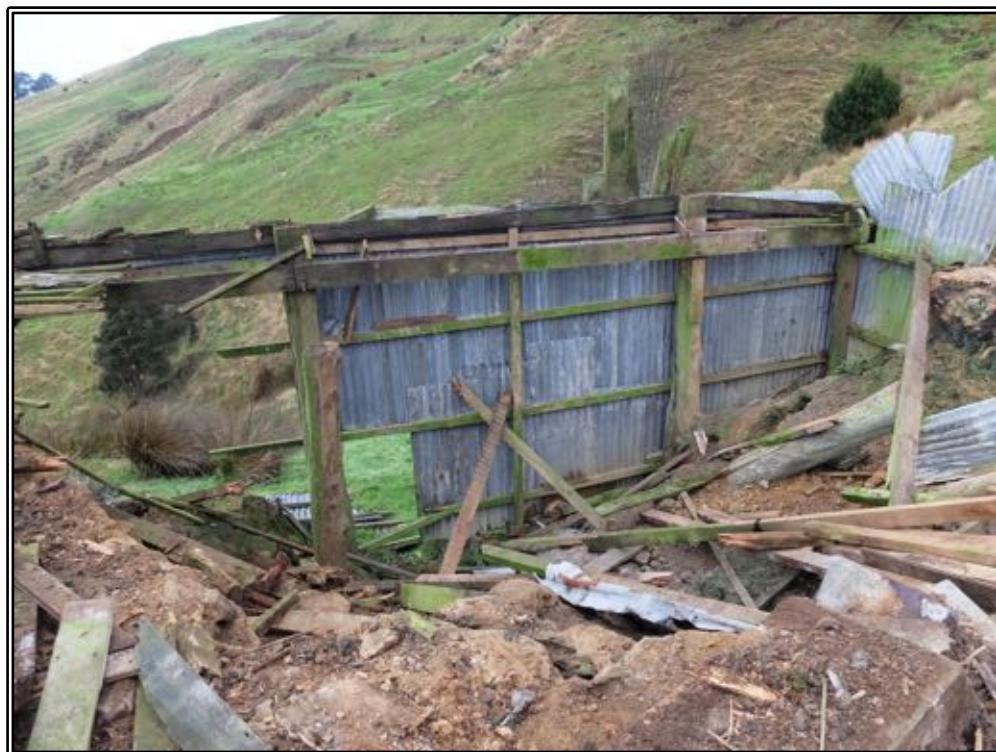
Figure 47
The rear support structure exposed after the removal of the floor.

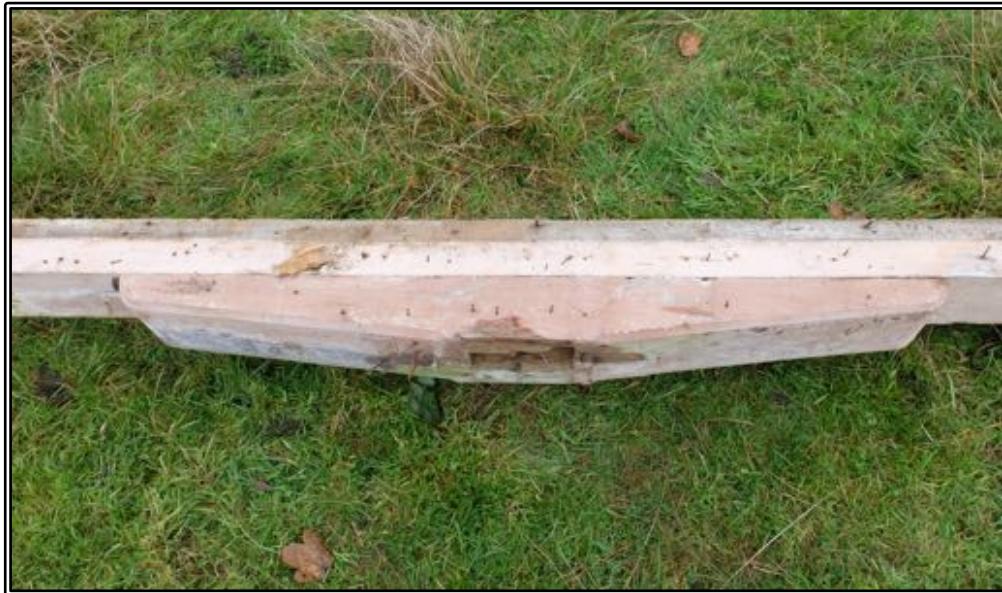
Figure 48
One of the corbels from the front wall after removal.

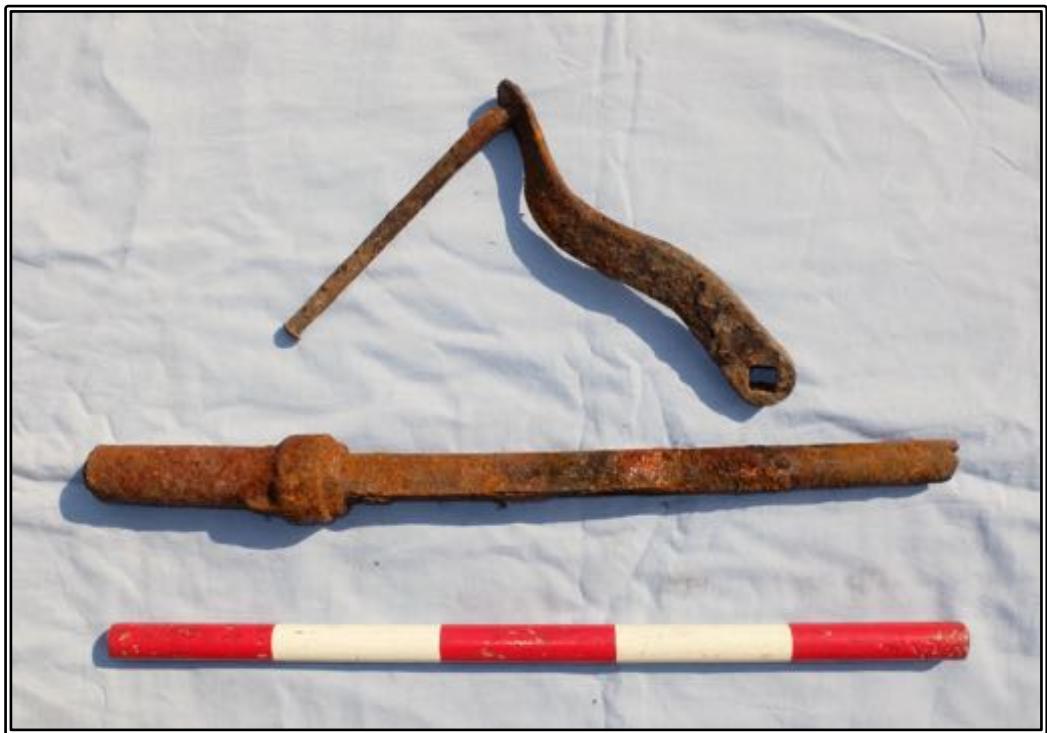
**Figure 58**

The rock drill (Figure 58) had been used as a spike to fasten a beam to one of the main rear posts of the building. It is unlikely to have been used for its original purpose at the farmstead, but the nearby limeworks is one possible place where such tools would have been in regular use.

Handle (top) and rock drill recovered during the deconstruction of the building. The rock drill had been used as a spike driven into one of the rear main posts. The scale is 0.5m long.

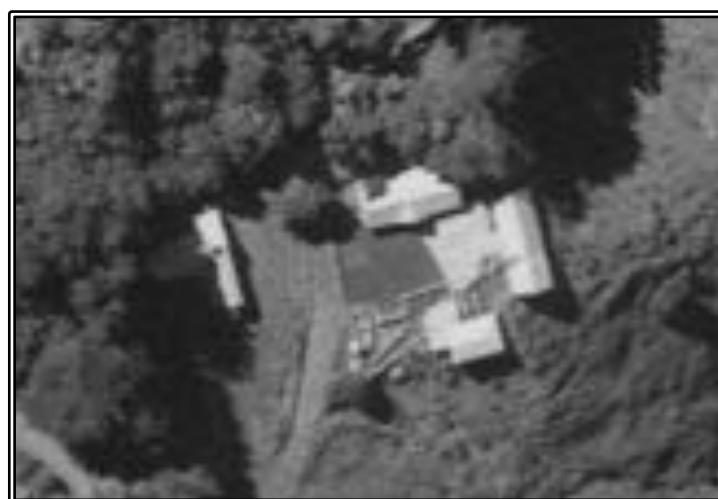
Figure 62

A 1958 aerial photograph of Larnach's farmstead, to the same orientation as the above image. By this date the woolshed had been truncated, with the western half removed.

6. The land instability continued, and the western end of the reconstructed building was damaged some time between 1942 and 1958, leading to the building being truncated, with only the eastern half left in place. A small extension was later added over part of the earlier western footprint, where solid ground remained. The building was certainly in use as a woolshed at this time.
7. Maintenance probably ceased completely from 1973, after a new woolshed was built adjacent to the byre.
8. The building was demolished in 2018.

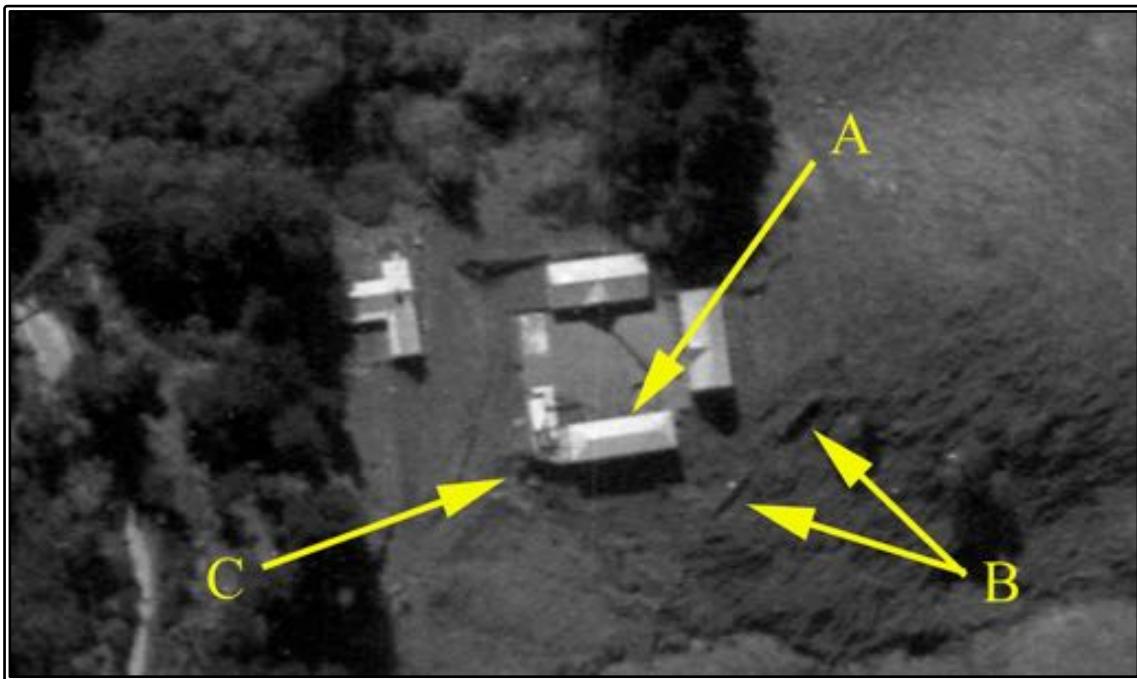
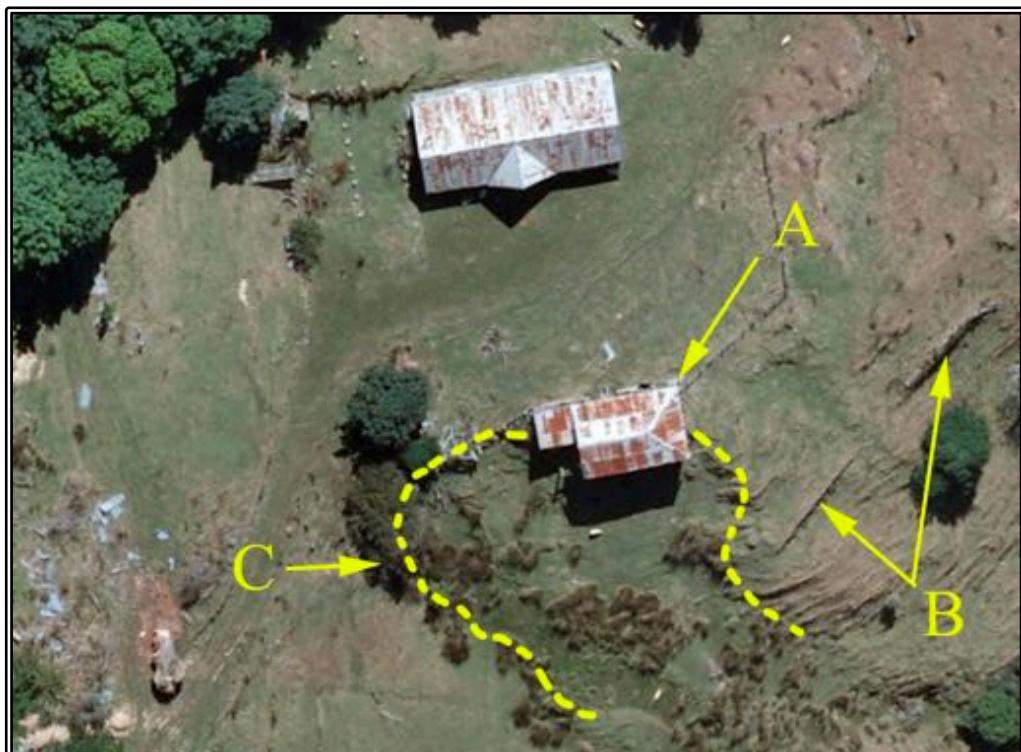
Figures 63 (above) and 64 (below)

As stated in point 7 above, there is evidence that a slip has carried away part of the farmyard terrace, and almost certainly damaged the original building. The farmyard terrace itself is the result of cut and fill work on a spur to create a level area large enough for Larnach's intended fully-enclosed farmyard; from the lie of the land it appears most likely that the main line of the spur originally ran through the middle of the farmyard area. The cutting and filling carried out by Larnach's workmen created a large space, but there were probably stability issues that soon appeared. In particular there are two areas of revetment on the SE slope below the farmyard (B in Figure 63, and Figure 65) that suggest additional works were required there to stabilise the slope. The terracing works also apparently exposed a small spring or seep at the foot of the slope on the west side of the yard, which is still active today and keeps this area wet. The water from this seep runs off the edge of the terrace, and this combined with rainfall runoff appears to have caused the south side of the terrace to slip away: 'C' in Figure 63 shows where slip scarring was still clearly visible in 1942, and Figure 64 shows how much further the slip had progressed by 2007. The extent of the slip is visible today when viewed from the south (Figure 66). As described above, the area under the building still had an obvious erosion gully, a legacy of this instability and possibly the product of water continuing to run under the building at times.

The 1942 and 2007 aerial photos of the farmstead, annotated to indicate significant features:

- A The barn/woolshed building, as it stood before being truncated to half its length (above) and in its final form (below).
- B Two areas of stone revetment constructed to support the farmyard terrace.
- C Visible scour due to water run off from the farmyard, probably both from the natural seep in this area and rainfall draining off the access track and yard surface. Note how the slip has become worse in the 2007 image, causing the loss of the half of the structure.

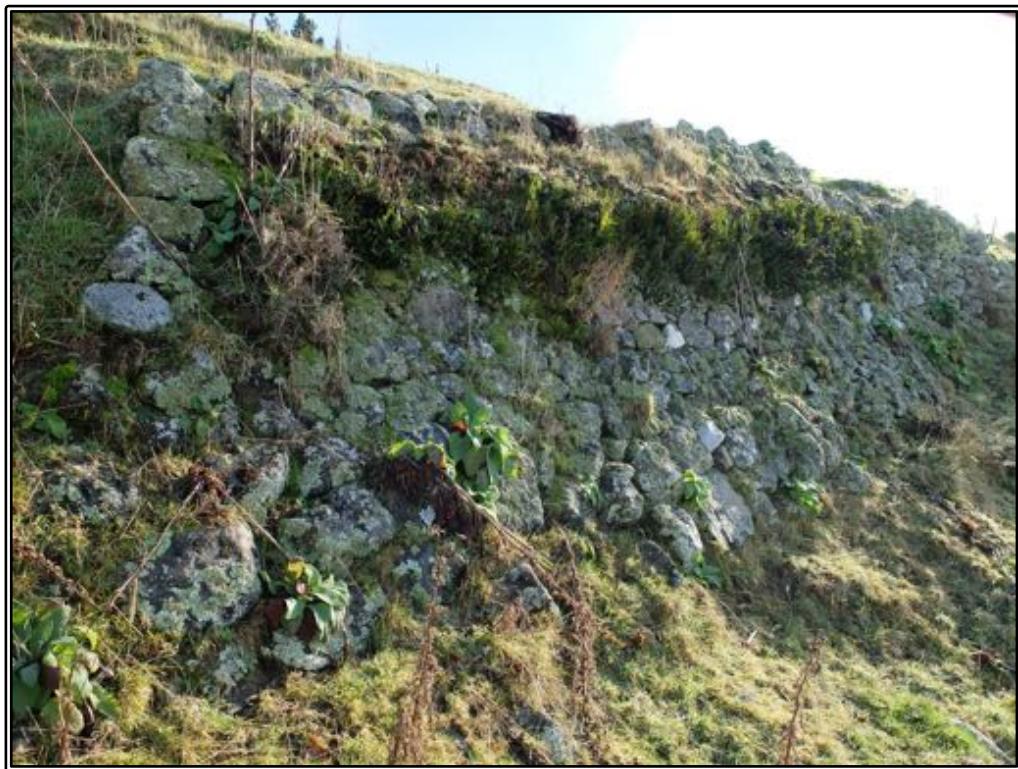
Figure 65

One of the sets of stone revetment indicated as 'B' in the Figure above.

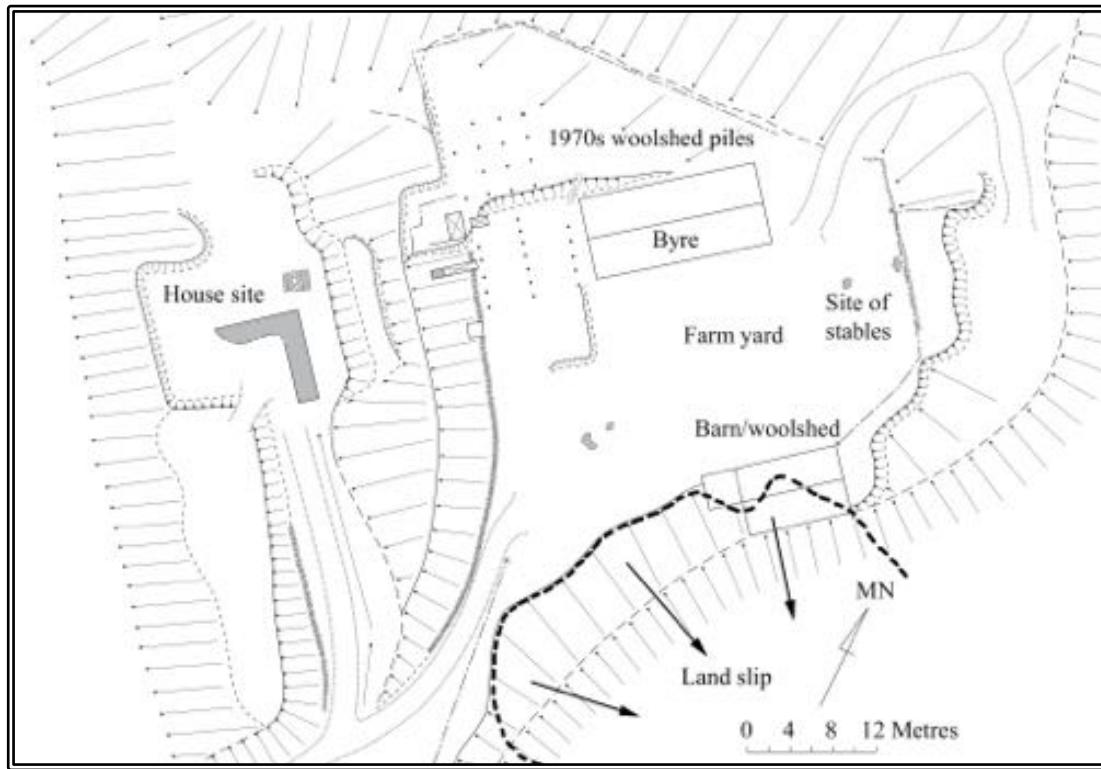
Figure 67

Annotated farmstead plan showing the slip site (adapted from Gosling 2009). Note that the slip probably happened in several separate episodes.

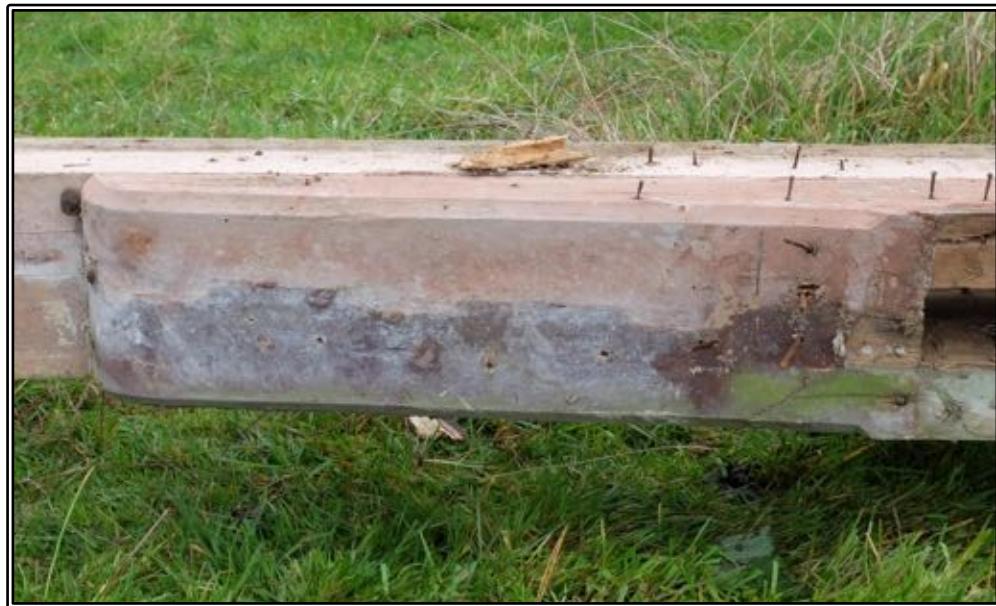
Figure 71

Underside of corbel removed from the building during demolition, showing the paint shadow of board and batten infill walling. The fact that a layer of paint was applied prior to the board and batten being installed suggests that the building was partially enclosed during its life.
