Condition Report: Rutherford's Farm (I44/426)

By Carl Murray and Stuart Griffiths (March 2019)

**Report for Hereweka/Harbour Cone
Management Trust**

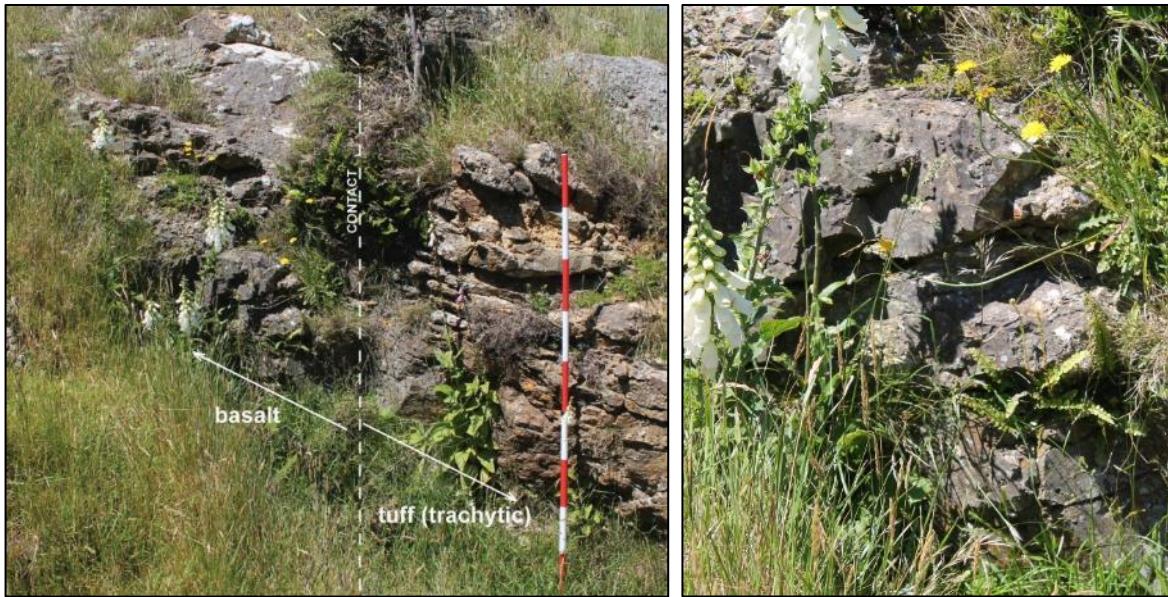
The geology in the vicinity is associated with the Dunedin volcanics, with Port Chalmers breccia outcropping in several areas around Hooper's inlet along with a variety of Phonolitic based extrusive rocks with varying clast sizes (Price et al, 2003: 2053-2055). The outcropping material along the northern bank of the road (I44/423: see Figure 2) leading into Rutherford's Farm is a volcanic (trachytic) tuff emplaced during the Initial Eruptive Phase of the Dunedin volcanics (Price et al, 2003: 2055). This material is the predominant rock which has been used in the construction of stone structures around the Rutherford's site complex and has been quarried extensively along the northern bank of I44/423 with tool marks still apparent on the rock surface. The rock consists of angular clasts usually less than <2cm and is supported by a matrix of volcanic ash (Price et al, 2003: 2055). A quarry area northeast of the Rutherford's site complex (see Figure 2: basalt quarry) exhibits a contact between the volcanic tuff and basalt (see Figure 4, left). The basalt outcrop exhibits quarrying from tool marks (Figure 4, right); however, no basalt has yet been observed in the structures at Rutherford's Farm.

Figure 4. Quarry area on the road (I44/324) to Rutherford's which exhibits a contact between basalt and volcanic tuff (left); straight cut edges and hammering marks on the basalt (right).
